**Monitoring Report No. 251**

**Monitoring of the mechanical excavation of service trenches  
Bellaghy Bawn  
Bellaghy  
Co. Derry**

**AE/12/136E**

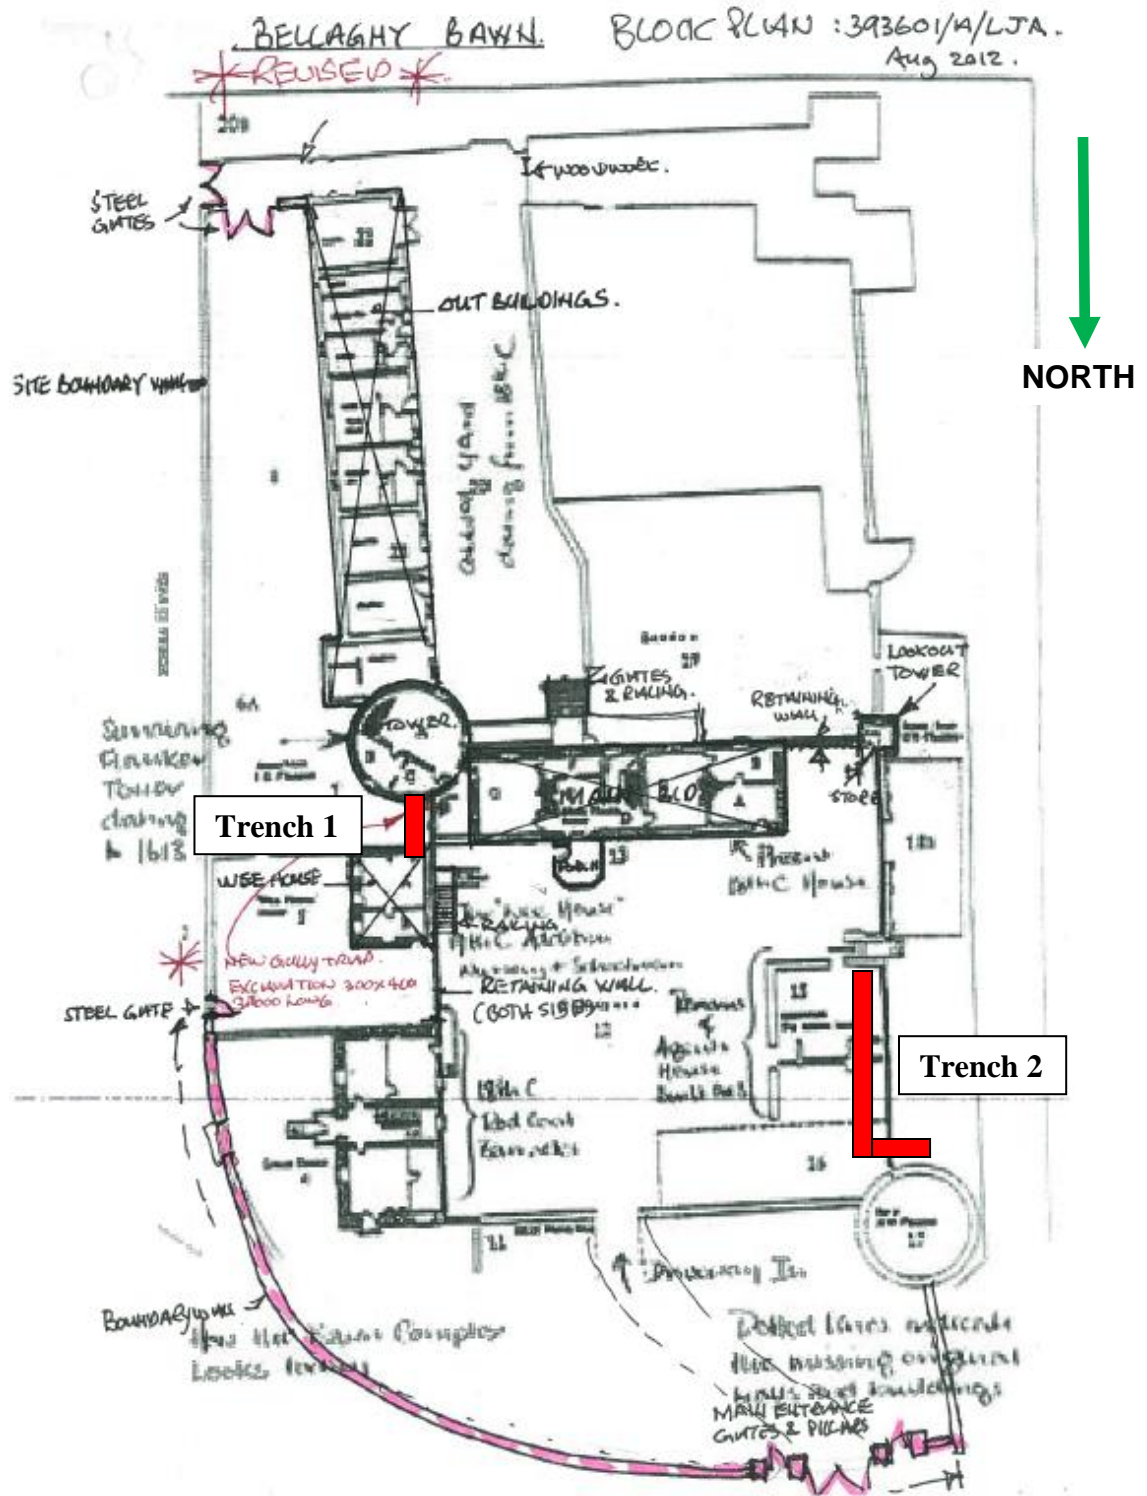
Figure Three: Block Plan (393601/A/LJA) overlain with the locations of trenches 1 and 2.

Trench One was located adjacent to the exterior of the eastern wall of the bawn, running north/south between the upstanding turret and the 'doctors house' (Figure 3). The trench was manually excavated to aid the installation of a drainage pipe, and measured 3m in length (north/south) by 0.3m in width (east/west) and had a maximum depth of 0.4m (Plates 1 & 2). A single deposit of light to mid brown sandy loam (Content No. 101) was encountered which produced sherds of nineteenth or twentieth century ceramics. Nothing of archaeological significance was encountered in this trench, which was backfilled following the installation of the drainage pipe (Plate 3).

Trench Two was aligned north-south and was positioned parallel to the upstanding remains of the western wall of the bawn (Figure 3), in an area that that previously undergone archaeological excavation by Nick Brannon following the acquisition of the site by the State in the late 1980s. The trench measured approximately 13m in length (north/south) by 0.5m in width (east/west) and had a maximum depth of 1m (Plate 4). At the northern end of the trench, it turned to the west for 3m to allow the runoff of water from the drainage pipe. A simple stratigraphic sequence was encountered during the excavation of this trench which consisted of a single deposit of mixed greyish brown sandy loam (Context No. 201). This deposit was interpreted as representing the backfill from the 1980s excavation and artefacts recovered included small fragments of animal bone, shell and plastic.

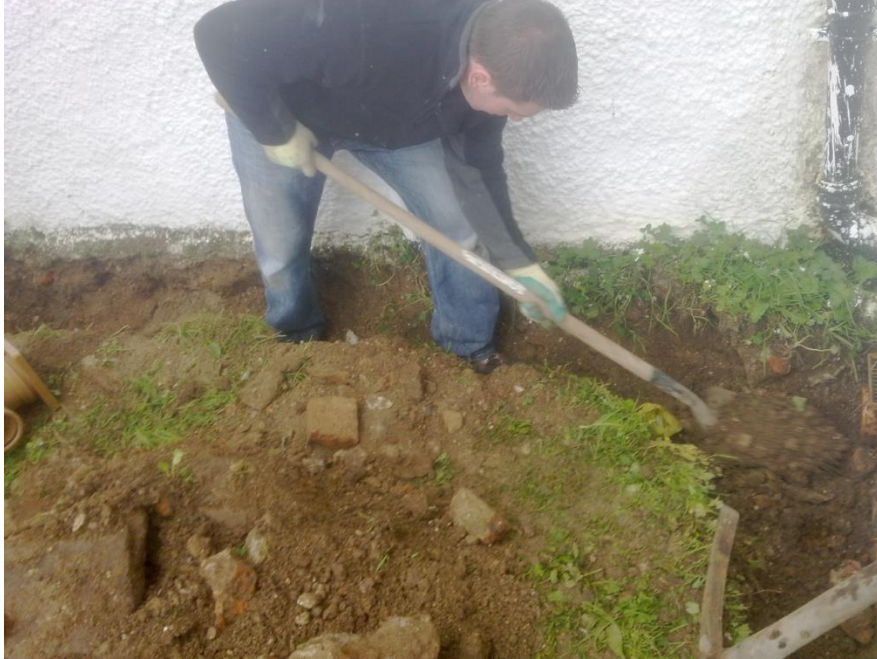
**Plate 1: Manual excavation of Trench One, looking west.**

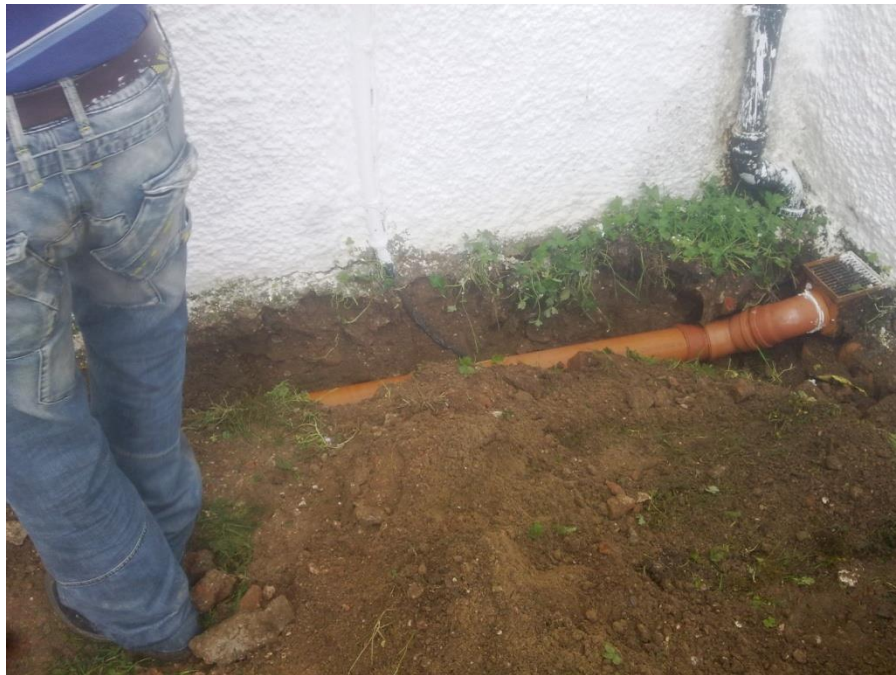
**Plate 2: Installation of drainage pipe in Trench One, looking north-west.**

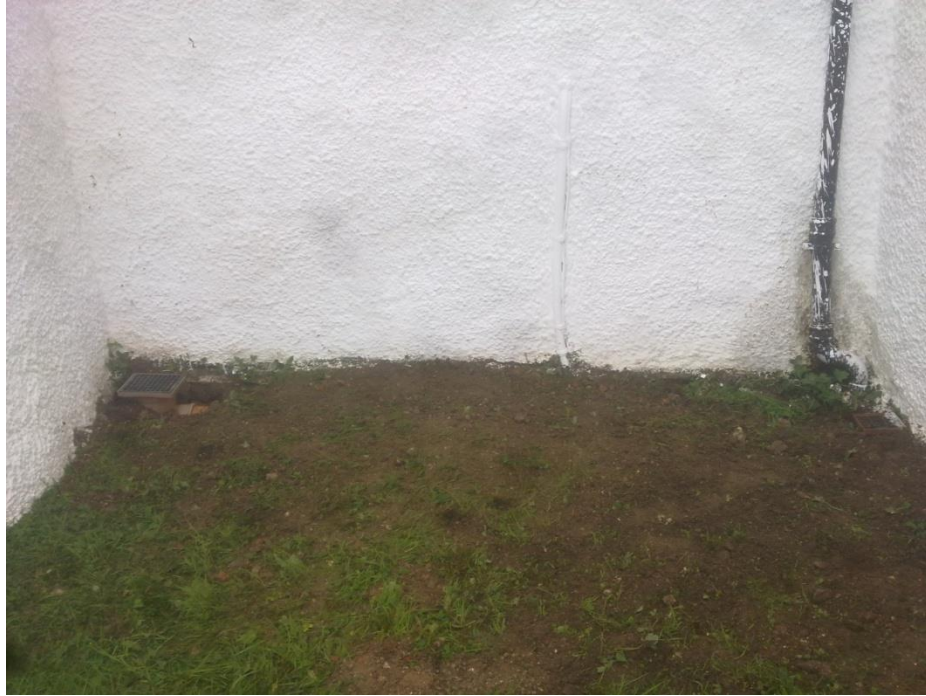
**Plate 3: Trench One following backfilling, looking west.**

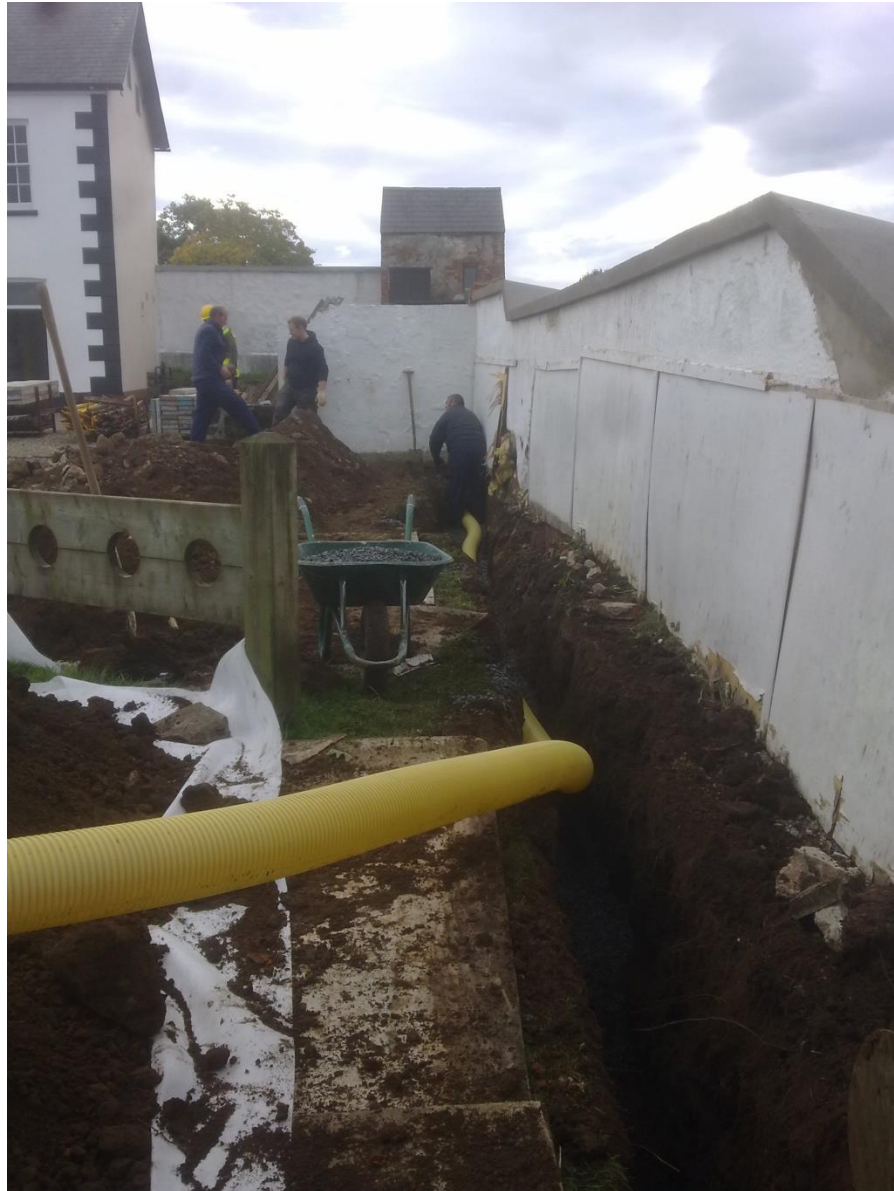
**Plate 4: Excavation of Trench Two and installation of drainage pipe, looking south.**

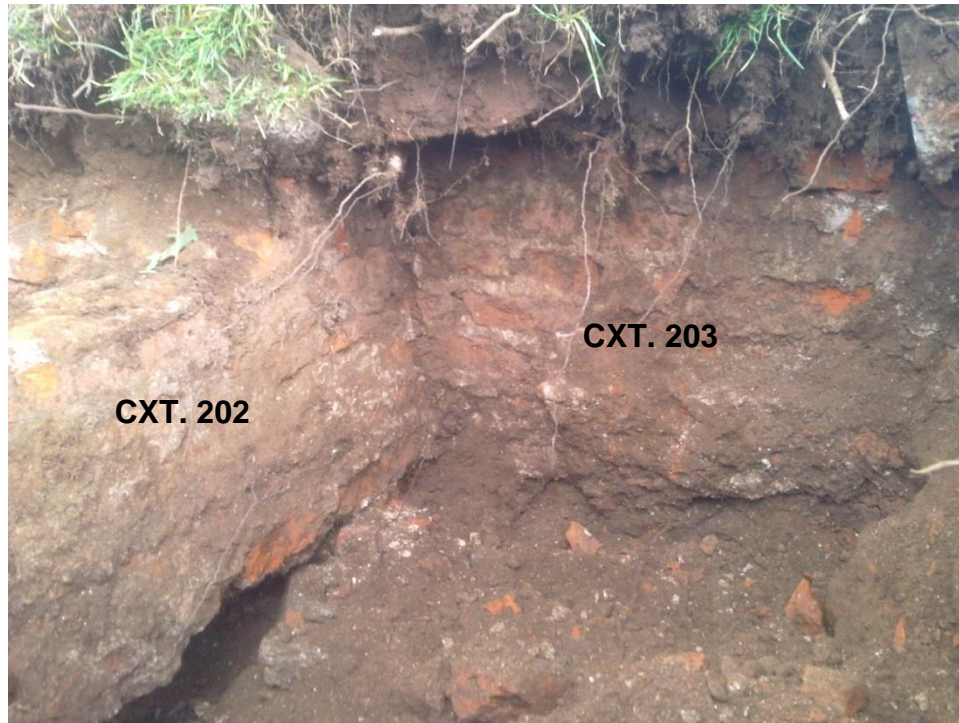
The east/west return of the service trench was located at the northern end and measured approximately 3m (east/west) by 0.5m (north/south). Excavation of this portion of the trench revealed a brick and mortar wall (Context No. 202) that followed the line of the upstanding remains of the bawn wall. This wall (Context No. 202) comprised of red handmade bricks bonded with a whitish buff mortar and survived to a depth of six courses. At the northern end of this wall (Context No. 202) it appeared to be bonded into another brick wall (Context No.203) that was orientated south-west/north-east (Plate 5). It is postulated that this wall (Context No.203) represents the remains of the circular turret that is depicted on Raven's map of 1622. As these walls (Context Nos. 202 and 203) were deemed to be archaeologically significant as construction elements of the bawn, they were left *in situ*. However, it was possible to install the drainage pipe under the foundations to aid the run-off of water (Plate 6). No finds or other features of an archaeological nature were encountered in this trench, which was backfilled following the installation of the drainage pipe.

The only archaeologically significant element encountered during this monitoring exercise was the extension to the bawn wall in Trench Two (Context No. 202) and the south-west/north-east aligned section of wall which has been tentatively identified as the sub-surface remains of the north-western turret (Context No. 203) that is depicted on Raven's map of 1622. These features were left *in situ* and the installation of the drainage pipe will not impinge on the features. No publication of this work is merited save a short summary in the annual *Excavations Bulletin*.

**Plate 5: Brick walls encountered at the northern end of Trench Two. Context No. 202 is interpreted as the remains of the bawn wall and Context No. 203 is interpreted as representing a circular turret, looking north-west.**

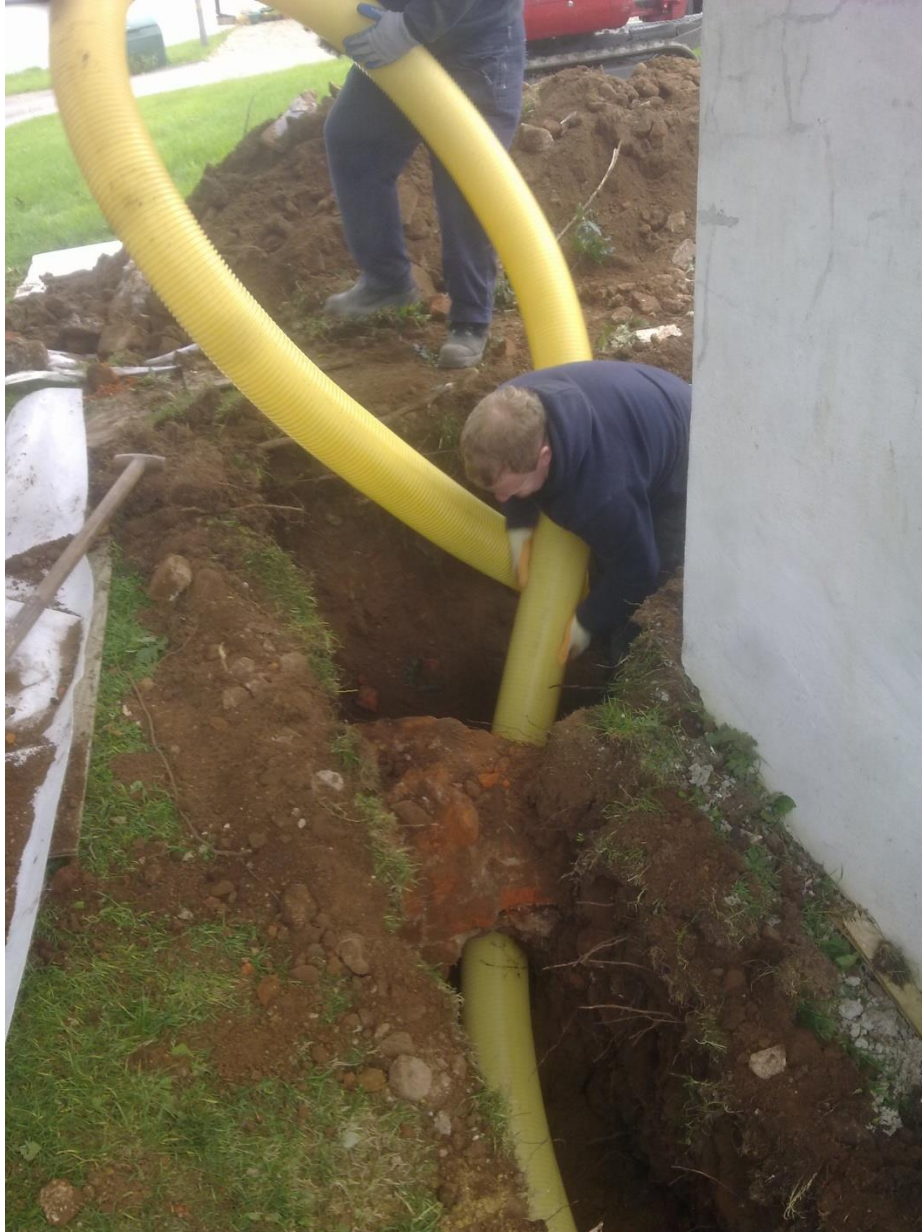
**Plate 6: Installation of the drainage pipe beneath the foundations of the red brick wall (Context No. 202) looking east.**
