Evaluation/Monitoring Report No. 279

**Vernacular House
Dunanney Lane
Newtownabbey
County Antrim**

LICENCE NO.: AE/14/53

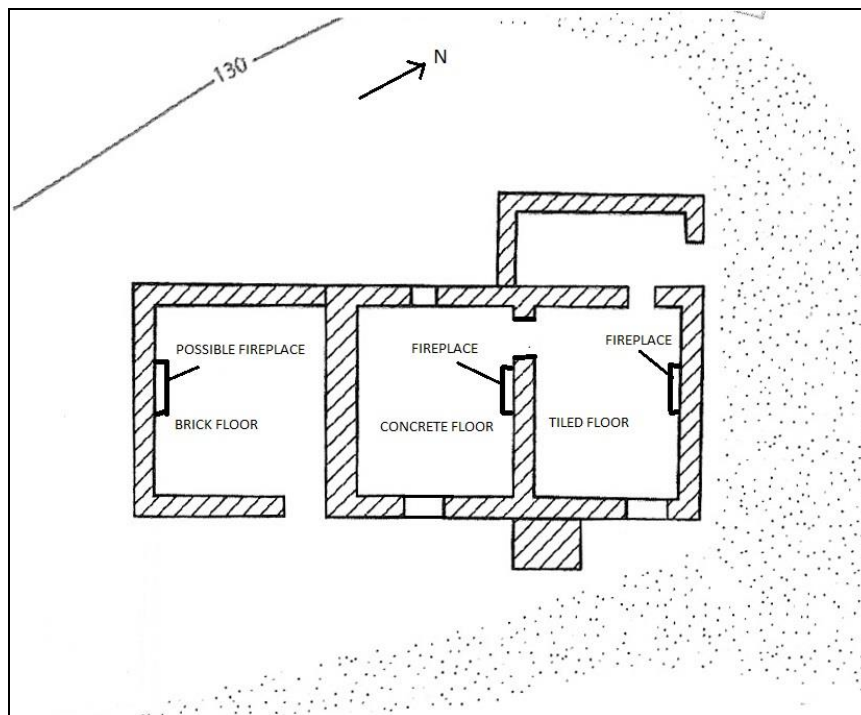
Figure 03: Revised plan of vernacular house

The monitoring site is located at Dunanney Lane, on the southern slopes of Dunanney Hill, which is itself located some 650m to the south of Carnmoney Hill. The building is located close to the 130m contour line around the hill, where it contacts a lane which forms part of a series of public pathways into the woodland area. It is aligned north-east/south-west and is approximately 16m in length by 6m in width. It has been severely damaged by fire, partial collapse and plant activity. The remains consist of three rooms, each approximately 5m in length by 5m in width (Figure 03).

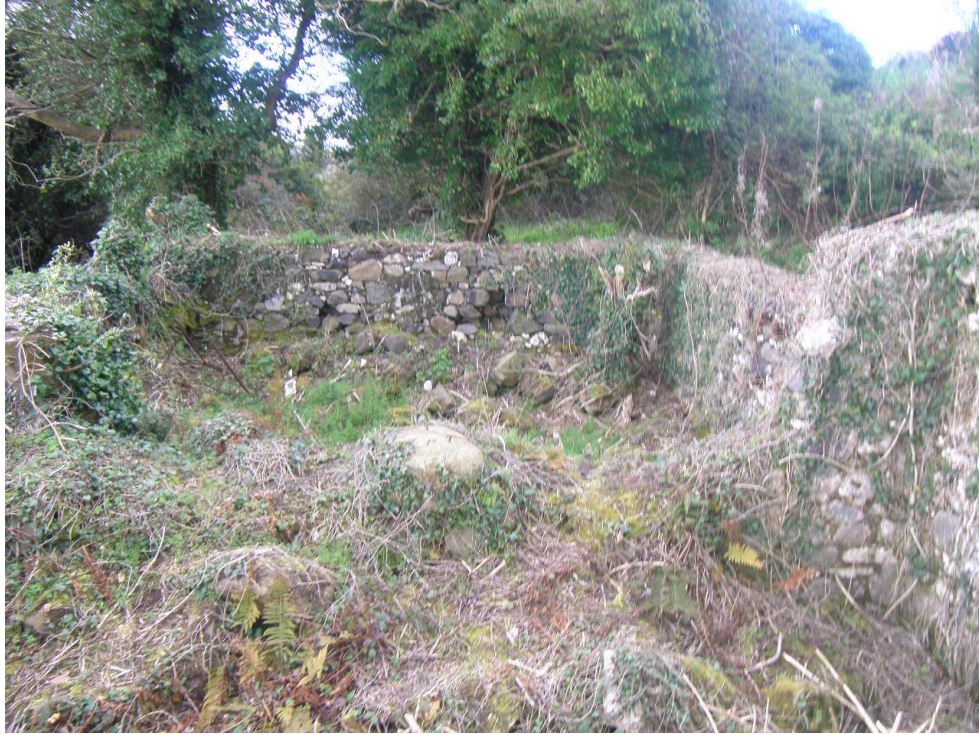
Plate 01: View of building remains before removal of rubble, looking south-west

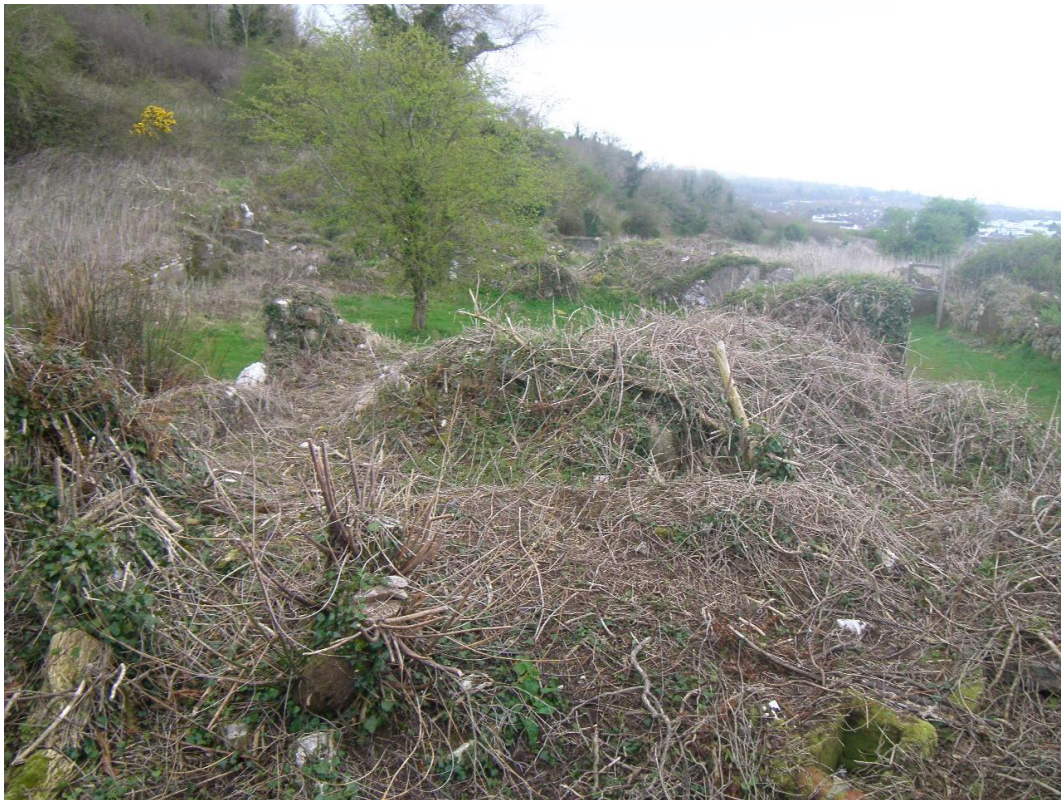
Plate 02: View of building remains before removal of rubble, looking north-east

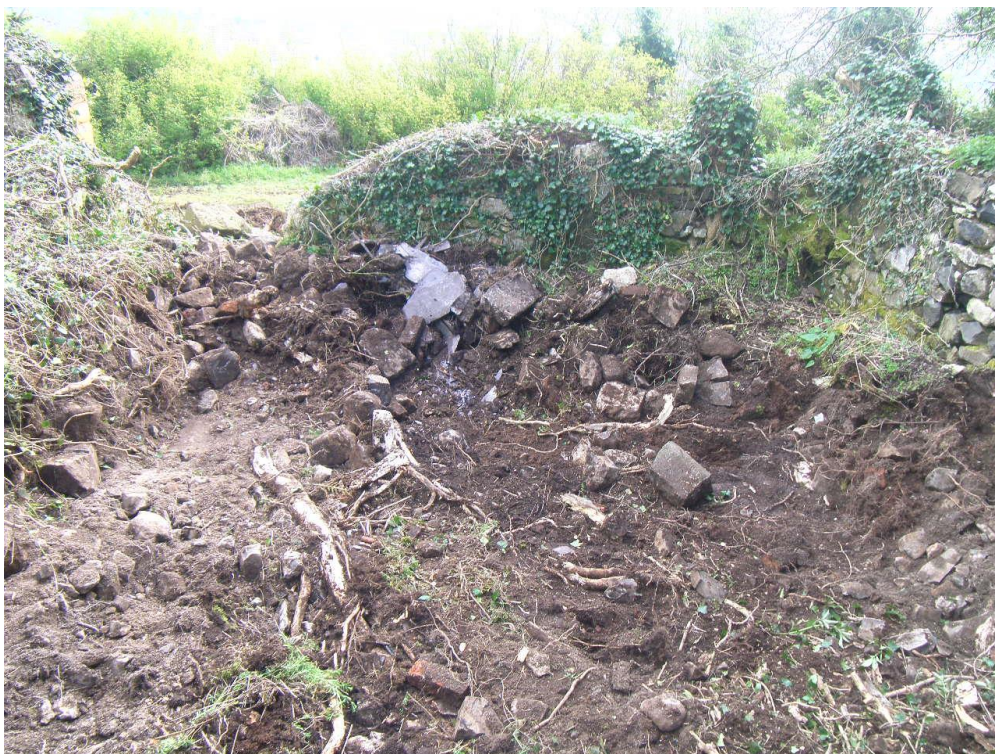
Plate 03: South-west room after removal of rubble, looking south

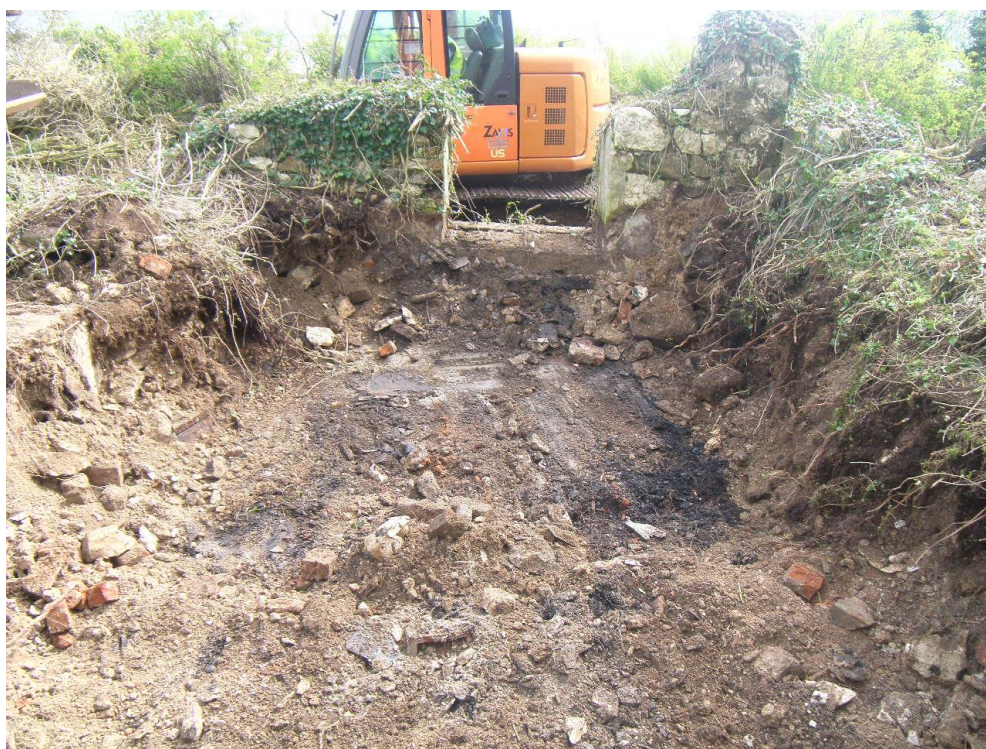
Following the removal of the rubble, particularly in the central and north-eastern rooms, a layer of burnt material, approximately 0.1m in depth, was observed just above floor level. Further, in the north-eastern room, several partially burnt roof timbers were observed. These confirm that the house had been severely damaged by fire, particularly in these two rooms.

Plate 04: Centre room after removal of rubble, looking south

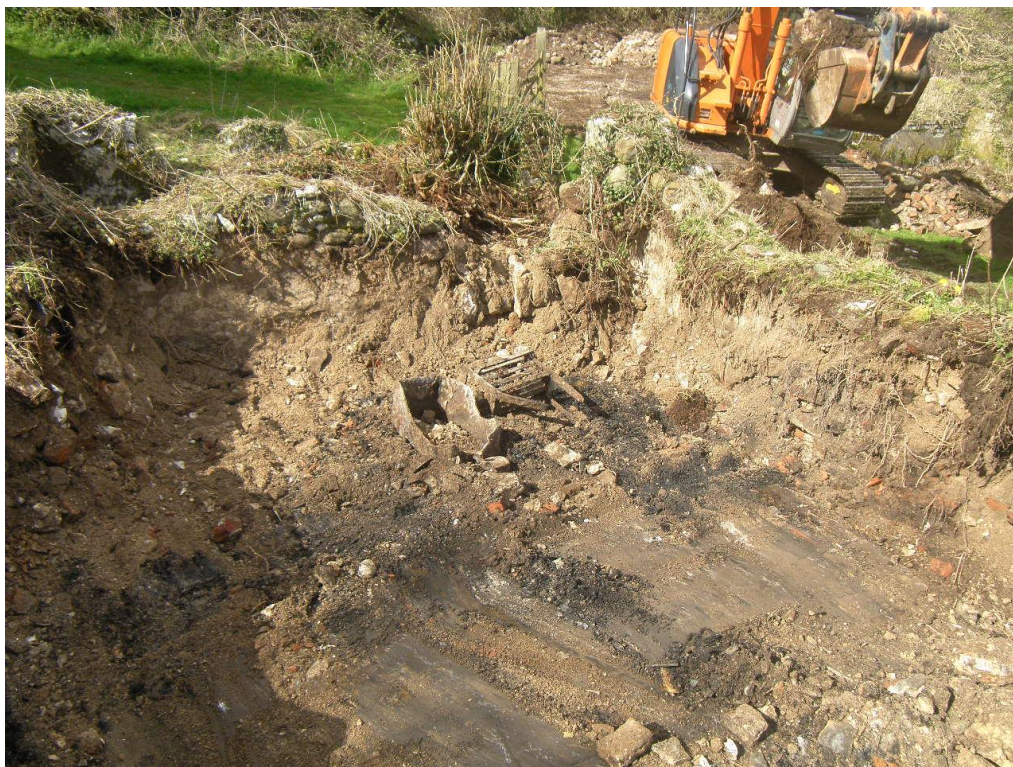
During its removal, the rubble was observed for artefactual evidence and several iron items were recovered. These included an iron trestle, winding handle and parts of a fire grate (Plates 05 & 06). The remains of a sewing machine were also recovered. These items have been temporarily stored at the offices of the Belfast Hills Partnership as theft and vandalism has been a problem at this site in the past.

Plate 05: North-east room after removal of rubble, looking north, showing remains of iron fire grate

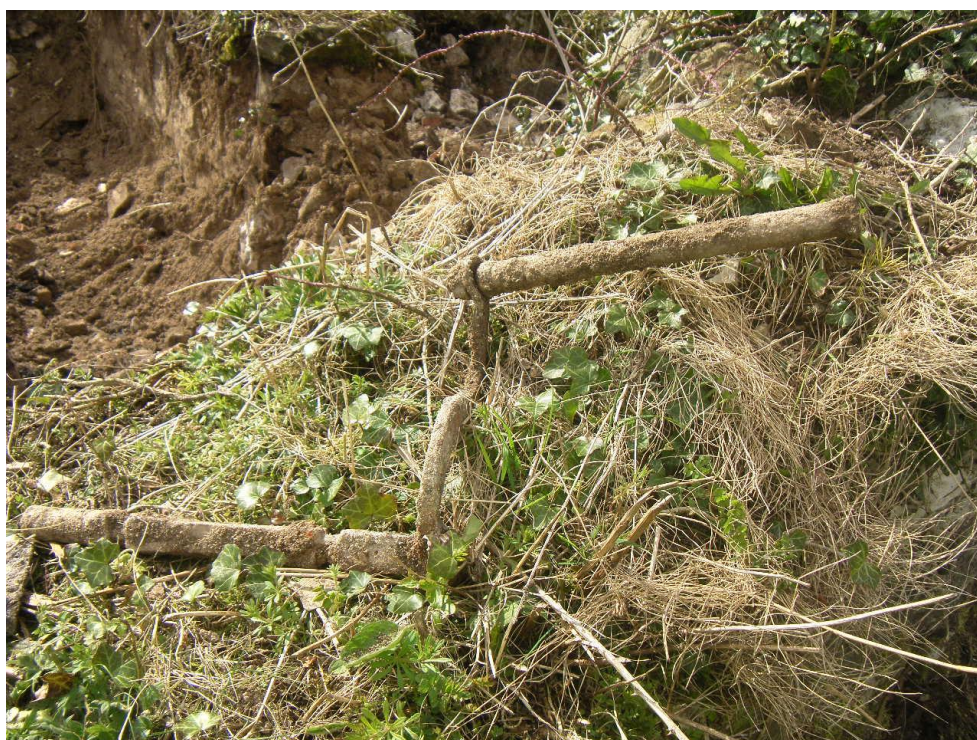
Plate 06: Iron winding handle recovered from north-east room
