A Community-based archaeological investigation at Newmills, Co. Tyrone

Centre for Community Archaeology Data Structure Report No. 139

Licence No. AE/21/115

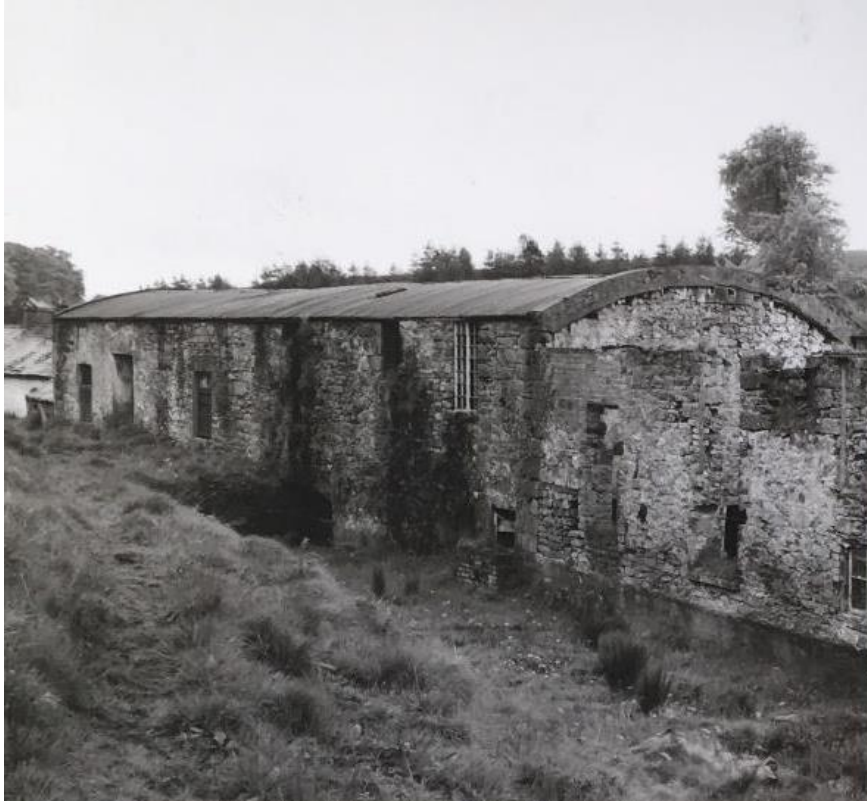
Figure 2: Photograph of the rear of the structure prior to its demolition (possibly 1970s). this picture illustrates the terrace cut into the slope to accommodate the mill structure (image provided by Keith Beattie LNLP).

The site is located to the immediate south of the village of Newmills. The field is bounded by mature hedgerows along its northern and western edges and the River Torrent along the southern boundary. A water treatment plant is located along the south-eastern boundary which also acts as the entrance into the site. The topography of the site is dominated by a steep slope along the northern side of the field which slopes to the south towards the River Torrent. An area of flat ground is located between the base of the slope and the river. Photographic evidence suggests that the mill structure was nestled against this slope rather than being constructed on the flat ground between the slope and the river (Figure 2).

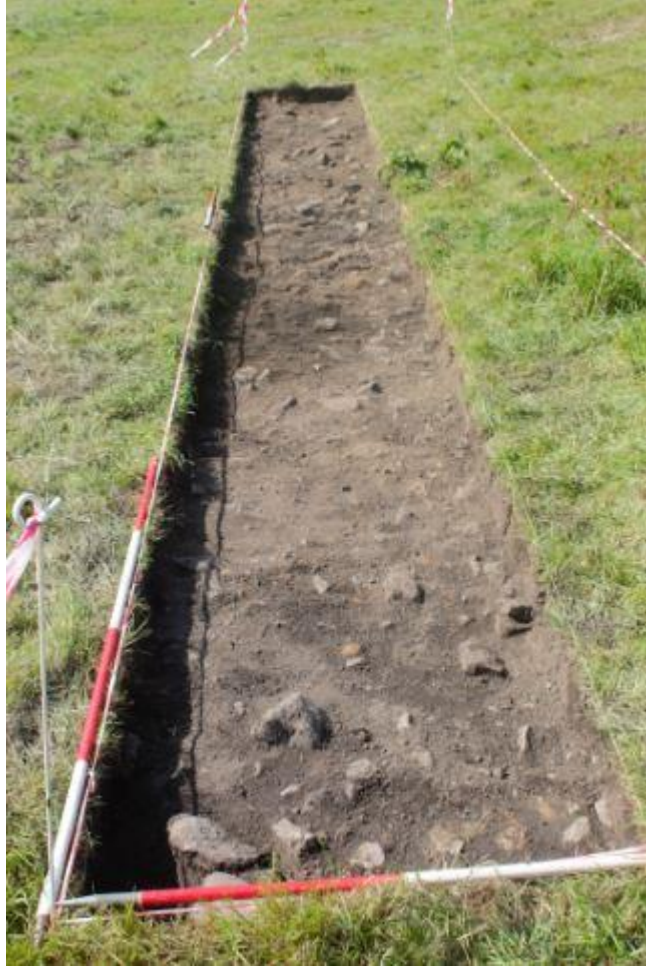
Plate 2: Trench 1 following removal of the sod and topsoil deposit (Context No. 101) showing the top of the mixed rubble deposit (Context No. 102), looking north-west.

The stratigraphically latest deposit encountered in this trench was the sod and topsoil (excavated as a single stratigraphic unit Context No. 101). This deposit (Context No. 101) consisted of active grass roots within a matrix of mid to dark brown clay loam which was on average 0.15m thick. Frequent small to medium angular and sub-rounded stones were observed throughout this deposit, as well as the frequent inclusion of charcoal flecking and larger chunks/lumps. Removal of the sod and topsoil deposit (Context No. 101) revealed a deposit of rubble (Context No. 102) which is interpreted as representing the demolition of the houses dating to the 1980s.

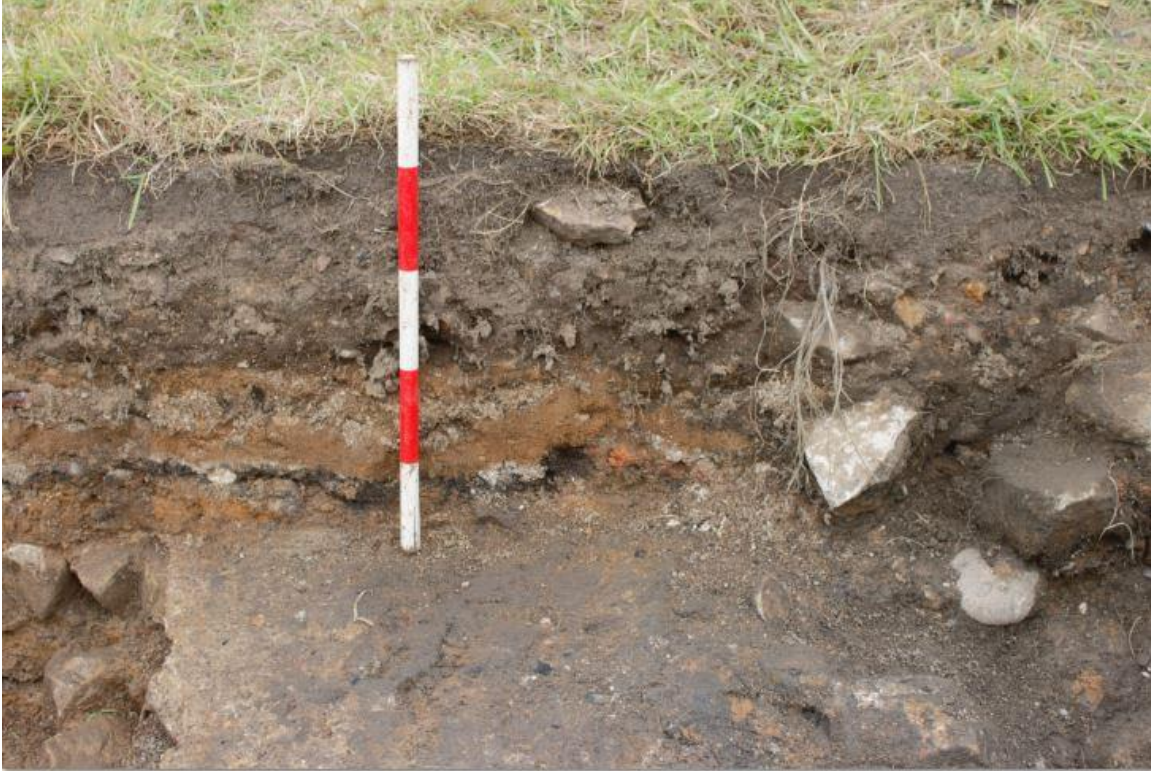
Plate 3: South-east facing section off Trench 1 showing the cut (Context No. 106) filled with the demolition rubble (Context No. 102).

The rubble deposit (Context No. 102) measured 17.8m north-west/south-east and spanned the 1m width of the trench. The full depth of the deposit (Context No. 102) was not recorded with the majority being left *in situ* due to the size of some of the rubble. Artefacts from this deposit (Context No. 102) included a corpus of post-medieval pottery sherds, glass fragments and corroded iron, all of which appear to be nineteenth and twentieth century in date. The rubble deposit (Context No. 102) was the single fill of a cut (Context No. 106) which was observed in the south-east facing section face. This cut (Context No. 106) had a gently sloping side and the base was not encountered due to the size of some of the rubble comprising Context No. 102. The profile of the cut (Context No. 106) observed in section would suggest that it was produced by a mechanical excavator and relates to the demolition of the structure in the 1980s.

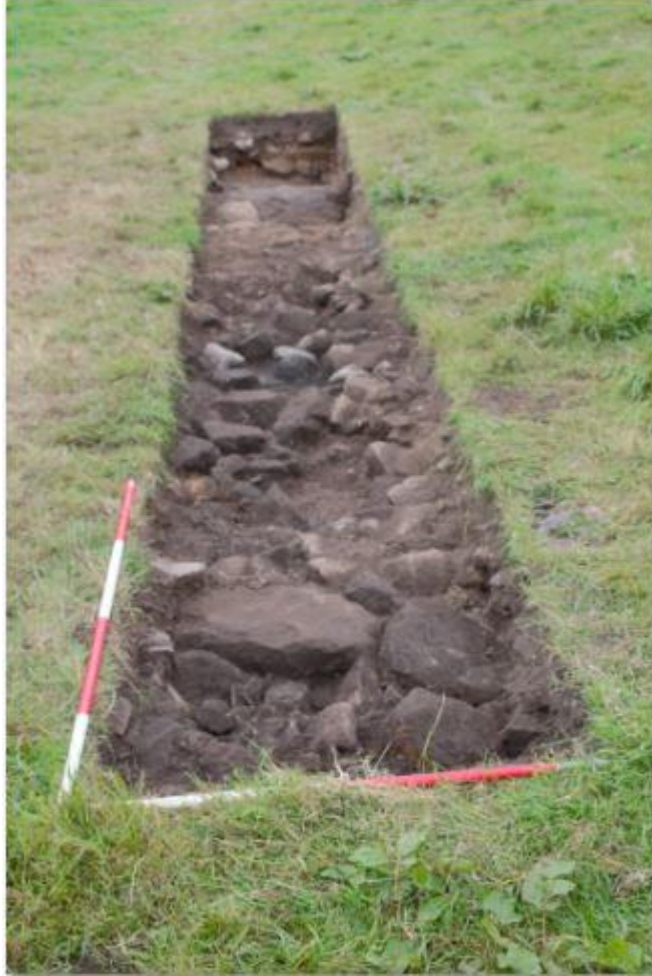
Plate 4: Post-excavation view of Trench 2 looking north-west. The rubble demolition deposit (Context No. 102) is visible in the foreground with the exploratory sondage visible at the top of the picture.

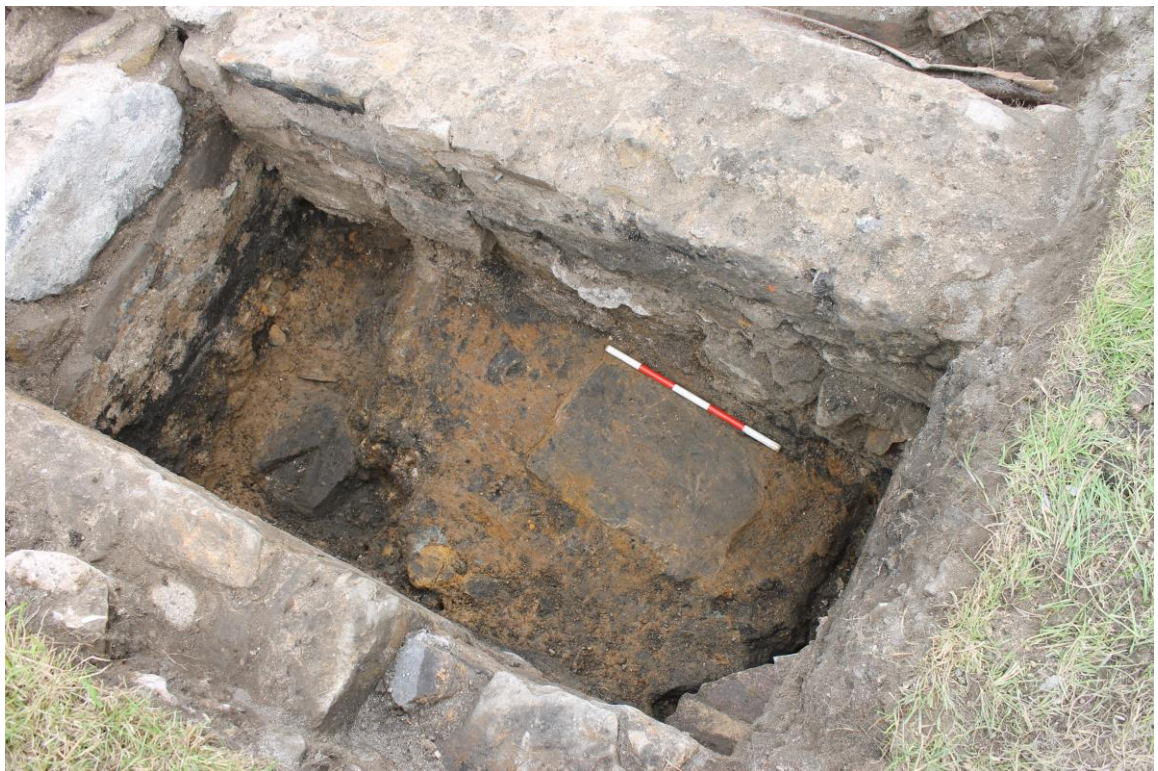
Plate 5: Overhead view of the clay deposit (Context No. 222) showing the flat flagstone and sloped nature of the deposit, looking north-east. The Phase 2 wall (Context No. 204) is visible at the top of the picture.

length and formed a single layer. A 'domed' deposit of clay (possible redeposited subsoil – Context No. 222) was directly above the layer of stones. This deposit (Context No. 222) had a relatively flat surface with pronounced slopes to the north and south. During the excavation it was initially thought that the slopes in the clay deposit (Context No. 222) represented cut features (initially assigned Context Nos. 214 and 218), although it became apparent that this was a misinterpretation and these numbers were voided. A large flat flagstone was also encountered pressed into the surface of the clay deposit (Context No. 222). The function of the flagstone, clay deposit and layer of stones is not clear, but may have provided a footing for machinery (with the clay perhaps acting as a 'muffler' for noise).

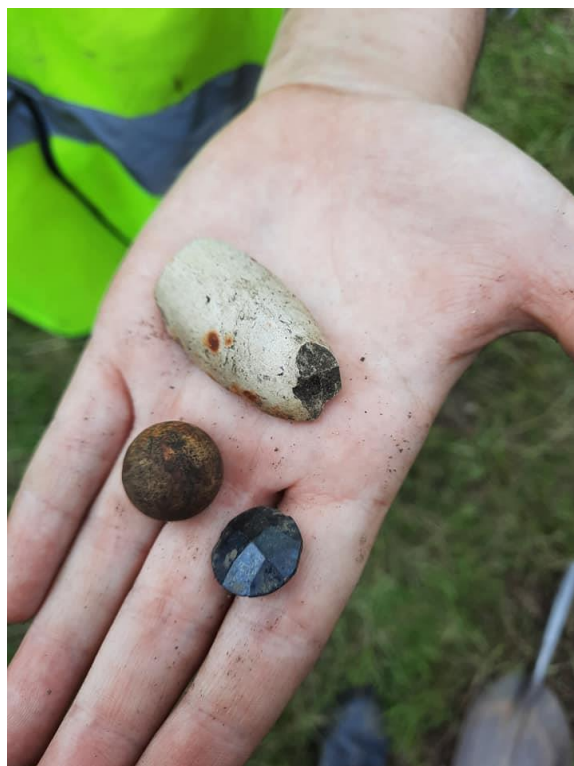
Plate 6: Artefacts recovered during the excavation of Context No. 213, including a clay bottle stopper, a button and fragment of clay tobacco pipe dating to between 1780-1840.

fragments of slag were recovered during the excavation of this deposit (Context No. 213) which also produced sherds of white glazed ceramics and fragments of clay tobacco pipes/stems. These have been dated to 1780-1840 (Ruairi O'Baoill *pers comm*) indicating this is a working surface dating to the period when the structure was a spade manufactory.

The fragment of clay tobacco pipe bowl is missing its spur/heel but enough of the bowl survives to suggest that the clay tobacco pipe probably dates from between 1780-1840. A median date of circa 1800 is proposed for this artefact.

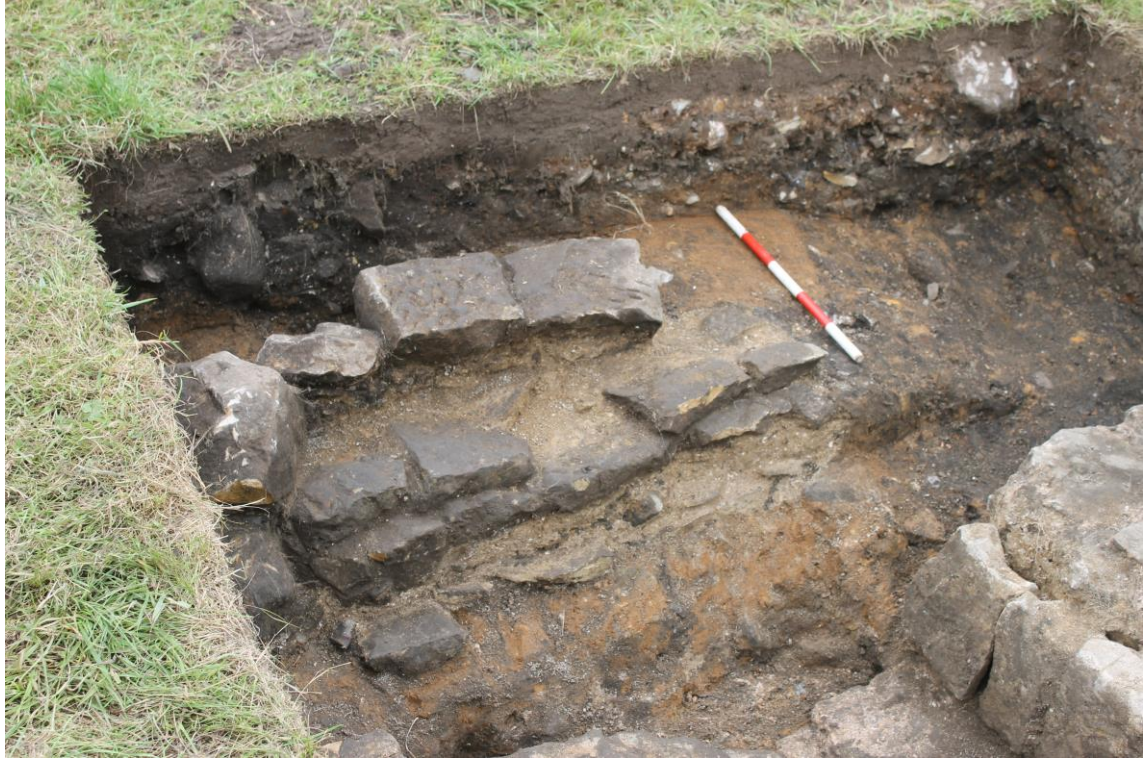
Plate 7: Portion of the millrace (Context No. 208) looking north. The disturbance caused by the Phase 3 pit (Context No. 211) can be seen to the right of the picture.

Also associated with Phase 1 activity was the remains of the mill race (Context No. 208) which was encountered along the northern edge of the trench. This feature comprised three courses of roughly squared stones that were bonded together with a buff creamy mortar. The millrace (Context No. 208) ran parallel to the north-west/south-east wall (Context No. 203) and measured 1.22m in length and was truncated by the pit associated with Phase 3 activity (Context No. 211 – see below). This is interpreted as the southern edge of the millrace with the corresponding northern edge lying beyond the limit of the excavation.

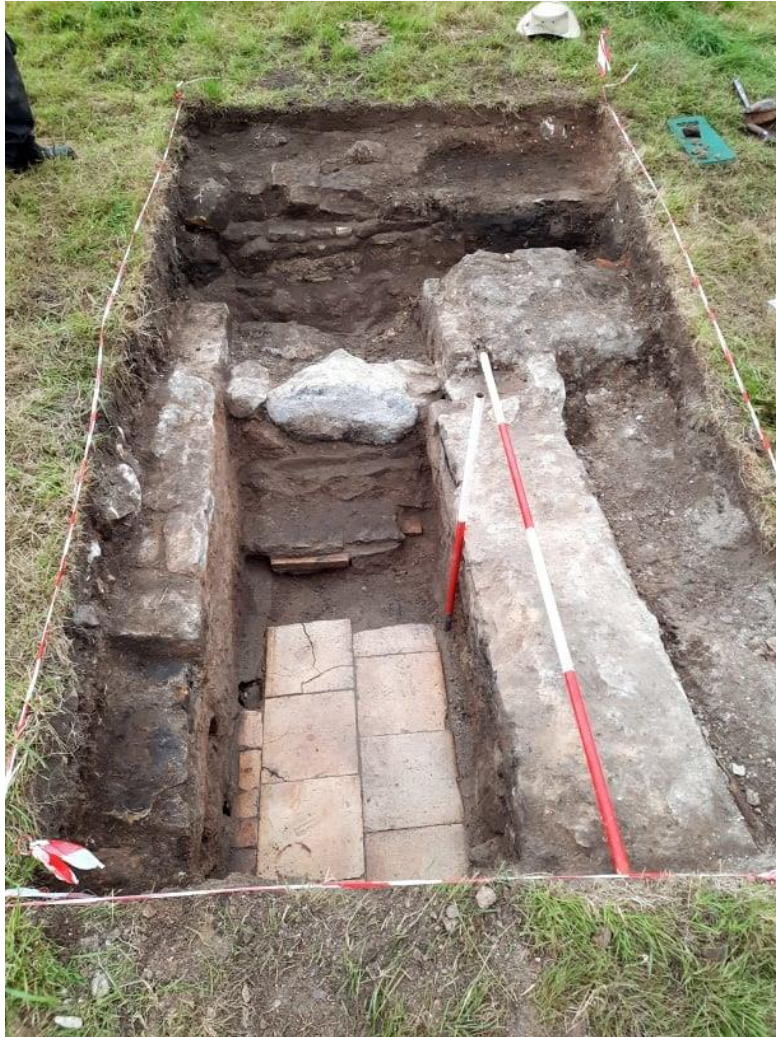
Plate 8: Mid-excavation photograph of Trench 2 showing phase 2 features including the tile floor (Context No. 210) and wall (Context No. 204), looking north-east.

The stratigraphically earliest feature associated with Phase 2 activity was a wall (Context No. 204) that was constructed to sub-divide the room associated with Phase 1 activity (see above). This wall (Context No. 204) was orientated north-east/south-west, ran parallel to the Phase 1 wall (Context No. 205) and measured 1.92m in length by 0.52m in width and was 0.86m deep. The construction of the wall (Context No. 204) was similar to the Phase 1 walls (Context Nos. 203 and 205) with large angular stones bonded together with a whitish cream mortar. The wall (Context No. 204) was built up against Context No. 203 but was not bonded into it in any way.

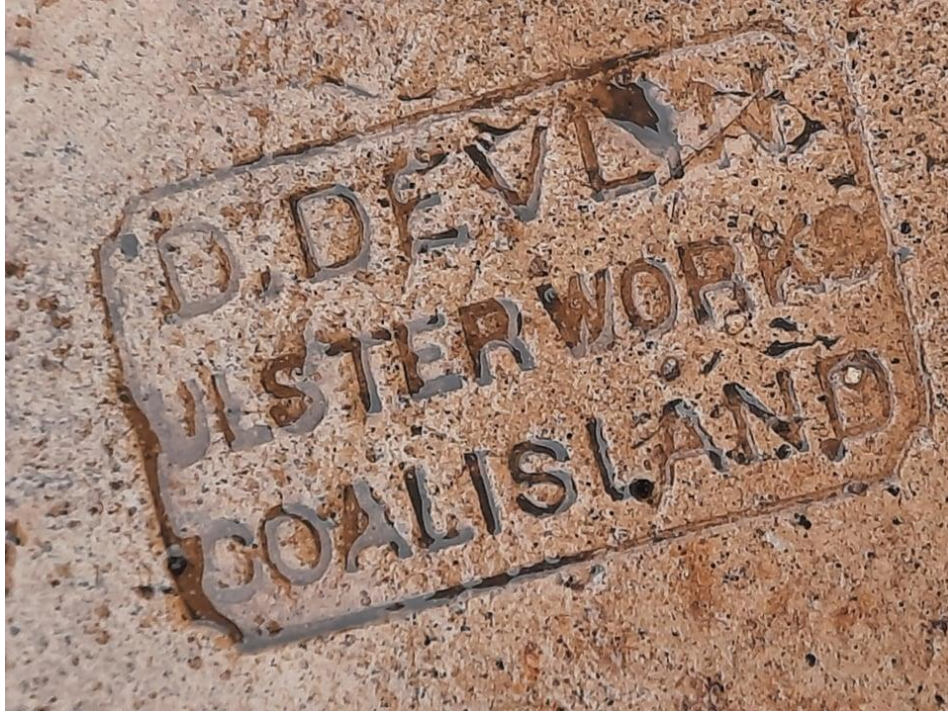
Plate 9: Stamp of 'D. Devlin Ulsterworks Coalisland' visible on the tile floor Context No. 210.

The tile floor encountered in Trench 2 (Context No. 210) is provisionally dated to the mid to late nineteenth century, particularly between the years 1874-1884. This is primarily based on the maker's stamp impressed into some of the tiles stated that they were manufactured by 'D.Devlin' of Coalisland (Plate 9). The Belfast Newsletter, dated 12th September 1874 details:

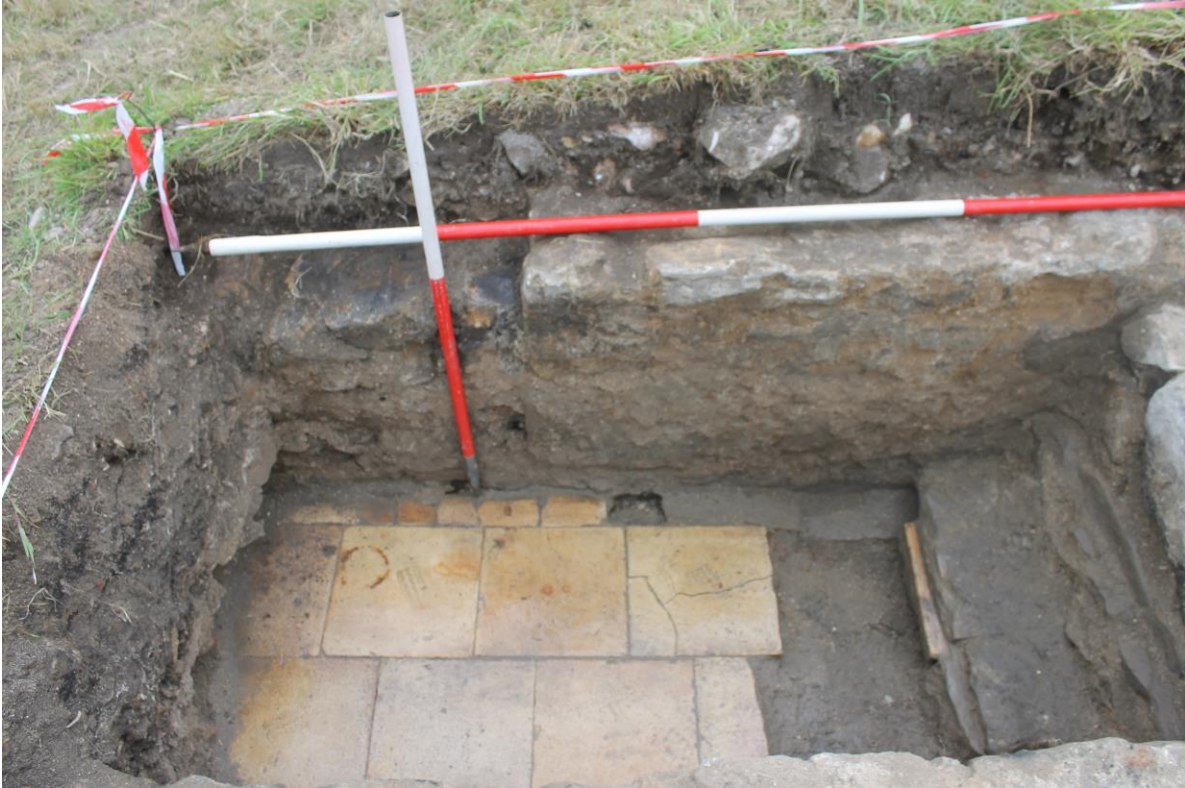
Plate 10: Trench 2 showing the blocked up doorway (Context No. 221) in wall (Context No. 205) looking north.

Also associated with Phase 2 activity was the infilling of the ledges/shelves in the Phase 1 walls (Context No. 203 and 205). The ledge/shelf in wall Context No. 203 measured 0.9m in length (north-west/south-east) and 0.6m in width (north-east/south-west). The infilling of this feature consisted of large angular stones bonded together with a buff/cream coloured mortar (Context No. 206). This deposit (Context No. 206) was not bonded into the north-east/south-west aligned wall (Context No.205), but built up against it. The infilling of wall Context No. 205 consisted of medium to large angular stones bonded together with a buff/cream coloured mortar (Context No. 221). This deposit was not fully exposed and continues to the south-west beyond the limits of the trench. It is not apparent what purpose these ledges performed during the Phase 1 life of the structure. However, it is apparent that that function was no longer necessary when the tile floor was laid down in the 1870s, and they became blocked up.

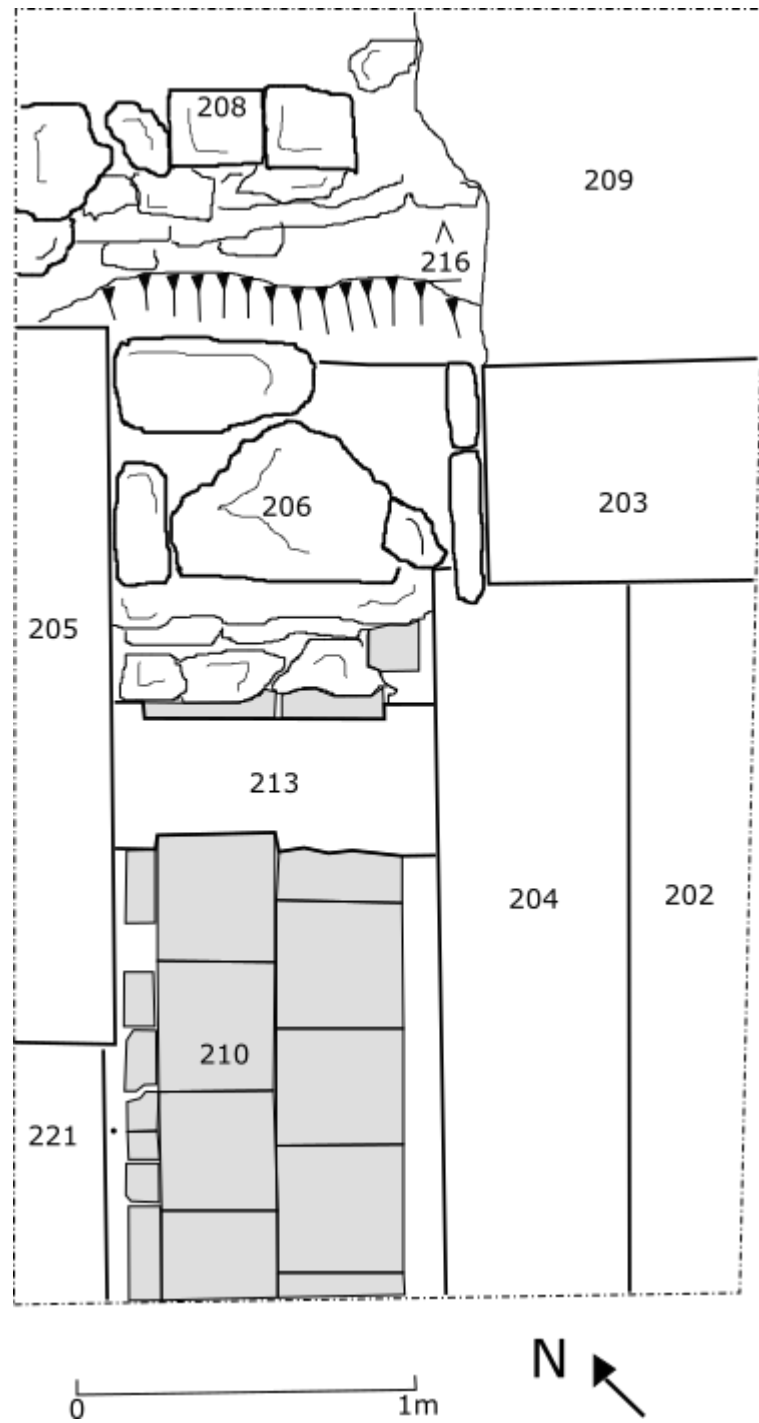
Figure 11: Mid-excavation plan of Trench 2 showing features associated with the tiled floor (Context No. 210).

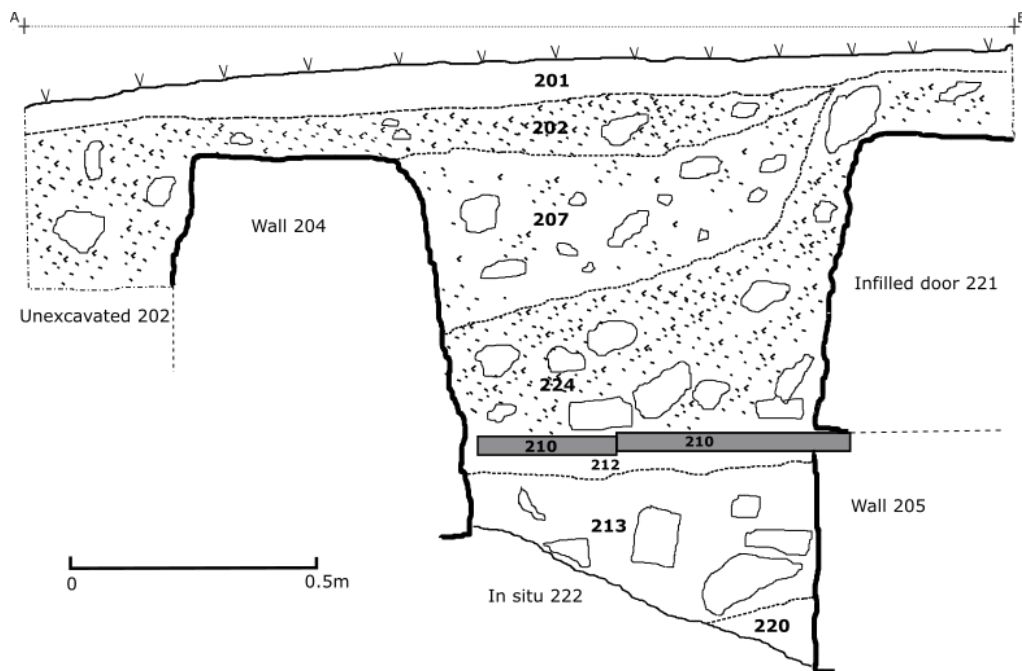
Figure 12: North-east facing section of Trench 2.

Phase 3 activity represents the demolition of the structure and the deposition of a number of layers of rubble. Directly above the Phase 2 tiled floor (Context No. 210) was a thick deposit of rubble and mortar (Context No. 224). This deposit (Context No. 224) was on average 0.8m thick and comprised a mixture of brick and angular stones within a whitish creamy mortar rich loam. Directly above this demolition deposit (Context No. 224) was another deposit of rubble (Context No. 207) which was similar in appearance to the underlying rubble (Context No. 224) but exhibited a greater concentration of charcoal (both flecks and chunks were abundant in this deposit). This deposit (Context No. 207) was on average 0.7m thick and underlay an upper deposit of demolition rubble (Context No. 202) which varied in thickness from 0.22 – 0.6m in thickness. This deposit (Context No. 202) was similar in appearance and texture to the basal rubble deposit (Context No. 224) but stratigraphically separated by the charcoal rich demolition deposit (Context No. 207). The upper rubble deposit (Context No. 202) was not fully excavated, especially along the eastern edge of the trench.
