**Data Structure Report: No.8.**

**Investigations at Carrickfergus Castle, Co. Antrim**  
*AE/02/106*

**Data Structure Report: Carrickfergus Castle, Co. Antrim**

John Ó Néill and Ruth Logue

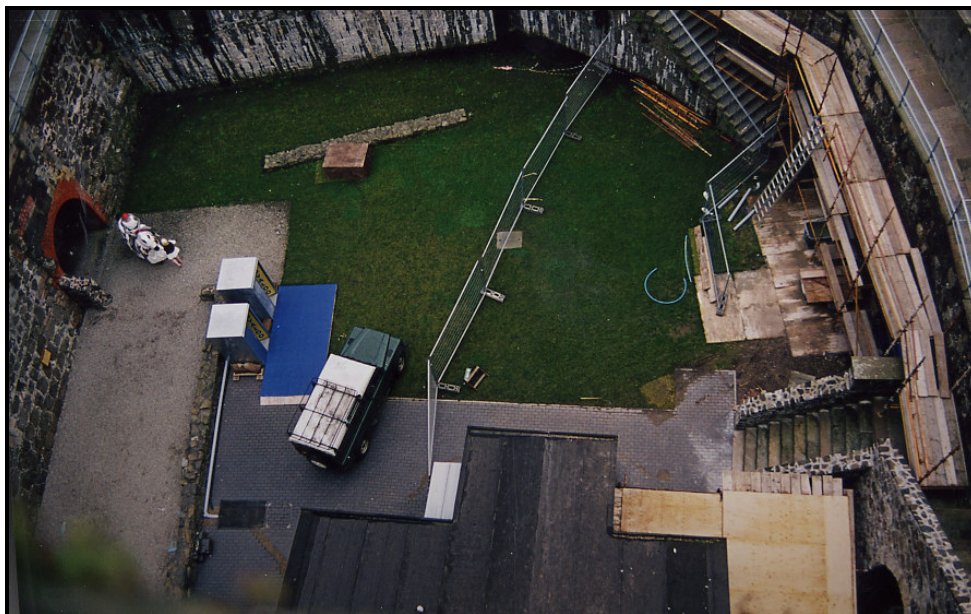
**Plate 1:** View of the magazine and inner ward from the roof of the keep.

2.2.1 Carrickfergus Castle is recorded in the Northern Ireland Sites and Monuments Record as ANT052:059 and is located at National Grid Reference J 4143 8725 (see figure 1). The excavation took place in advance of the construction of a lift shaft, within a single storey building abutting the south wall of the keep (see figure 2 and Plate 1). The excavation took place during November 2002, under licence number AE/02/106.

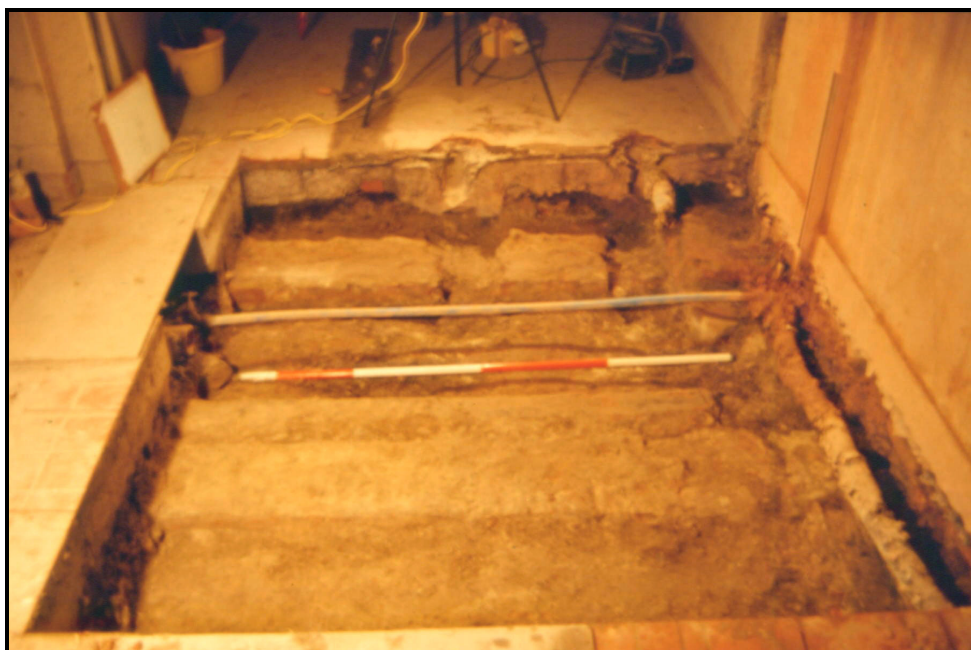
**Plate 2:** View of the Phase 4 walls and mortared floor during excavation (from the east).

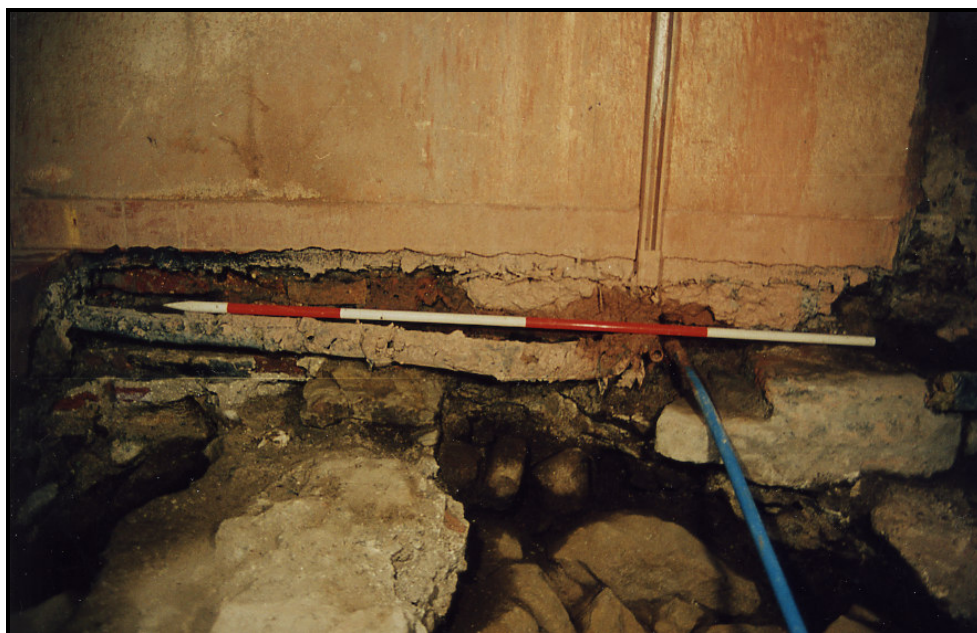
**Plate 3:** View of the visible traces of the plinth at the base of the keep wall.

present where the bedrock had to be levelled off by the insertion of deposit of stones and sandy mortar (recorded as 129). The maximum visible depth of the foundation deposit was around 0.30 m. Some plinth stones (106) from the keep wall rested on the foundation deposit or bedrock (see Plates 3 and 4).

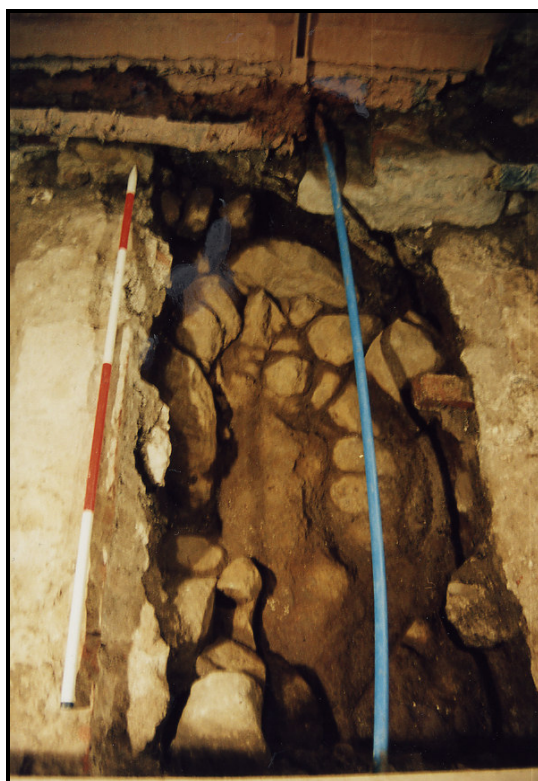
**Plate 4:** The exposed bedrock at the base of the excavation trench (from the south).

- 3.2.8 The foundations of the keep had been inserted into a fine, peat-derived clay subsoil which was present to a depth of 0.35 m. To the east of wall 104, this was recorded as 126, and to the west it was recorded as 125. This soil contained some struck flint but was mainly sterile. The soil overlay the basalt bedrock which was present to depths of 0.98 m below the modern ground surface.
