CAF Data Structure Report No. 47
Excavations at Greencastle, County Down
(DOWN 057: 003)

Excavations at Greencastle, County Down

**CAF DSR No. 47
J 2473 1184
SMR: Down 057: 003
AE/ 01/ 13**

January 2007

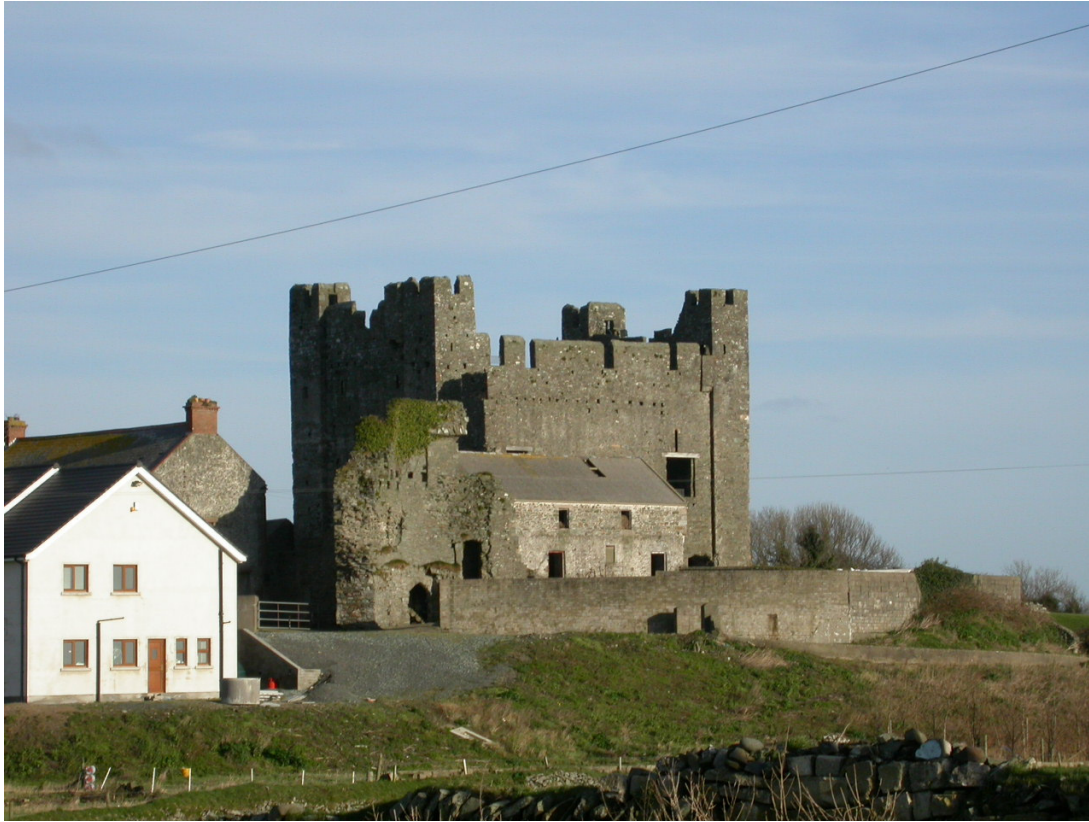
Plate 3: Photograph taken in 2005 showing the new development (white building at left of shot) adjacent to the castle and on the site of the 2001 excavation
