**Monitoring Report No. 02**  
St John's Point Church,  
May 2004.

**Monitoring Report: St John's Point Church, Co. Down**

**SMR: DOW 045:013**

**CAF MR 02**

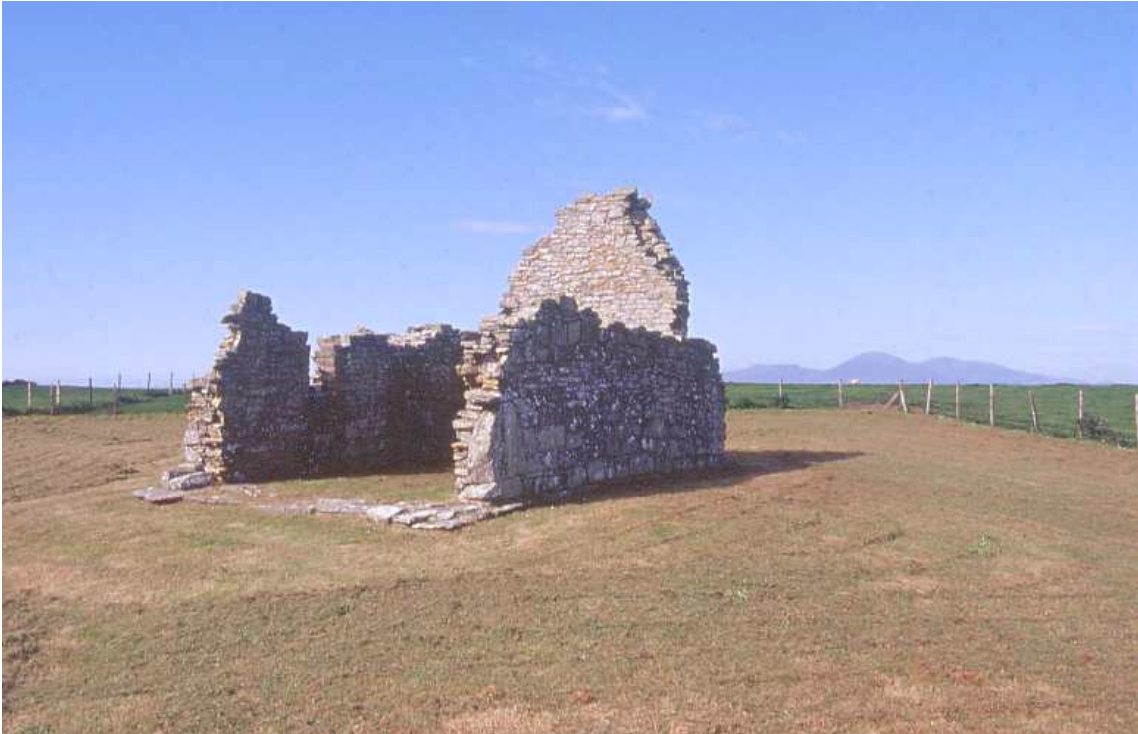
Plate 1: St John's Point Church facing south west.

- 1.1 Archaeological monitoring of the excavation of the footprint of an information board at St John's Point Churchyard, Co. Down (Plate 1), took place on the 18<sup>th</sup> May 2004. The monitoring was undertaken by Nicholas Beer of the Centre for Archaeological Fieldwork, Queen's University Belfast. The monitoring was conducted on behalf of the Protecting Historic Monuments branch of the Environment and Heritage Service: Built Heritage, who funded the work.

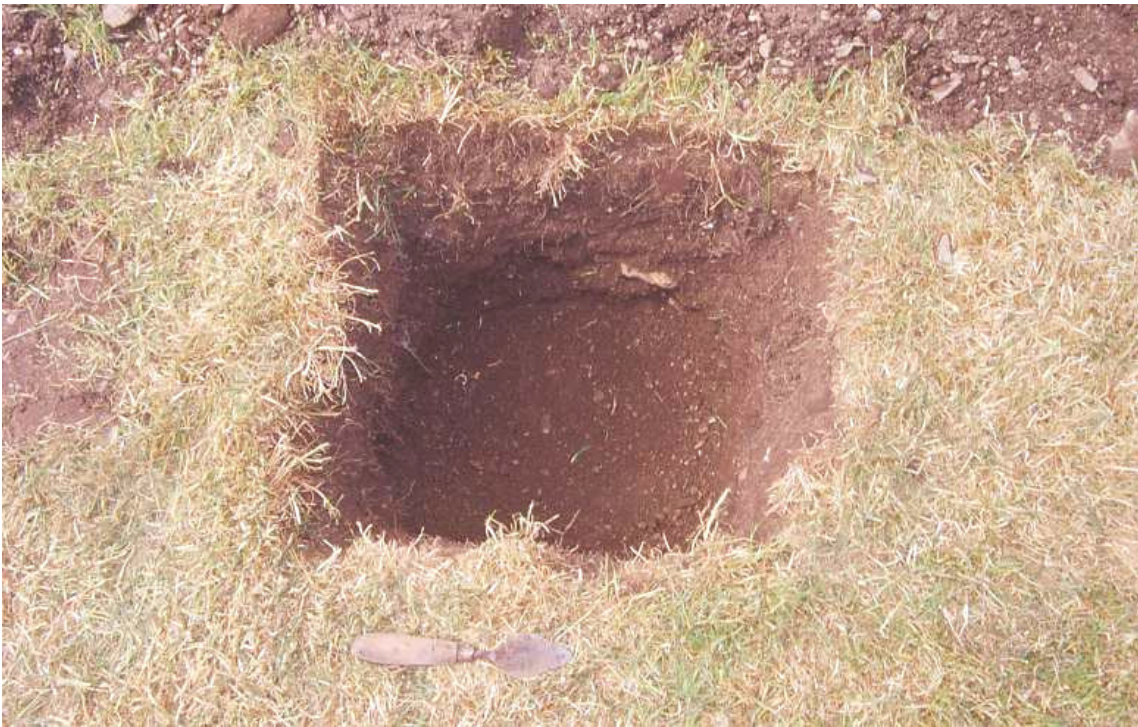
- 3.2 The footprint (Trench 1) was excavated by hand. Its final dimensions were 0.5 m x 0.5 m and it extended to a depth of 0.5 m (Plate 2). The stratigraphic sequence consisted of two deposits; a dark brown humic topsoil (Context No. 101) overlying, at a depth of 0.4 m, an orange brown sandy loam subsoil (Context No. 102), which was excavated to a depth of 0.1 m. A cattle tooth was the single find recovered from Context No. 101.

Plate 2: Trench One, Context No. 102, excavated to a depth of 0.5 m.

- 4.1 The deposits excavated in the process of installing a new information board at St John's Point Church contained no features of archaeological importance. The stratigraphic sequence demonstrated an undisturbed natural stratigraphy, which contained only a single find.
