Monitoring Report No. 51

**Ballyvicknacally
Co. Down**

AE/06/44

Site Specific Information

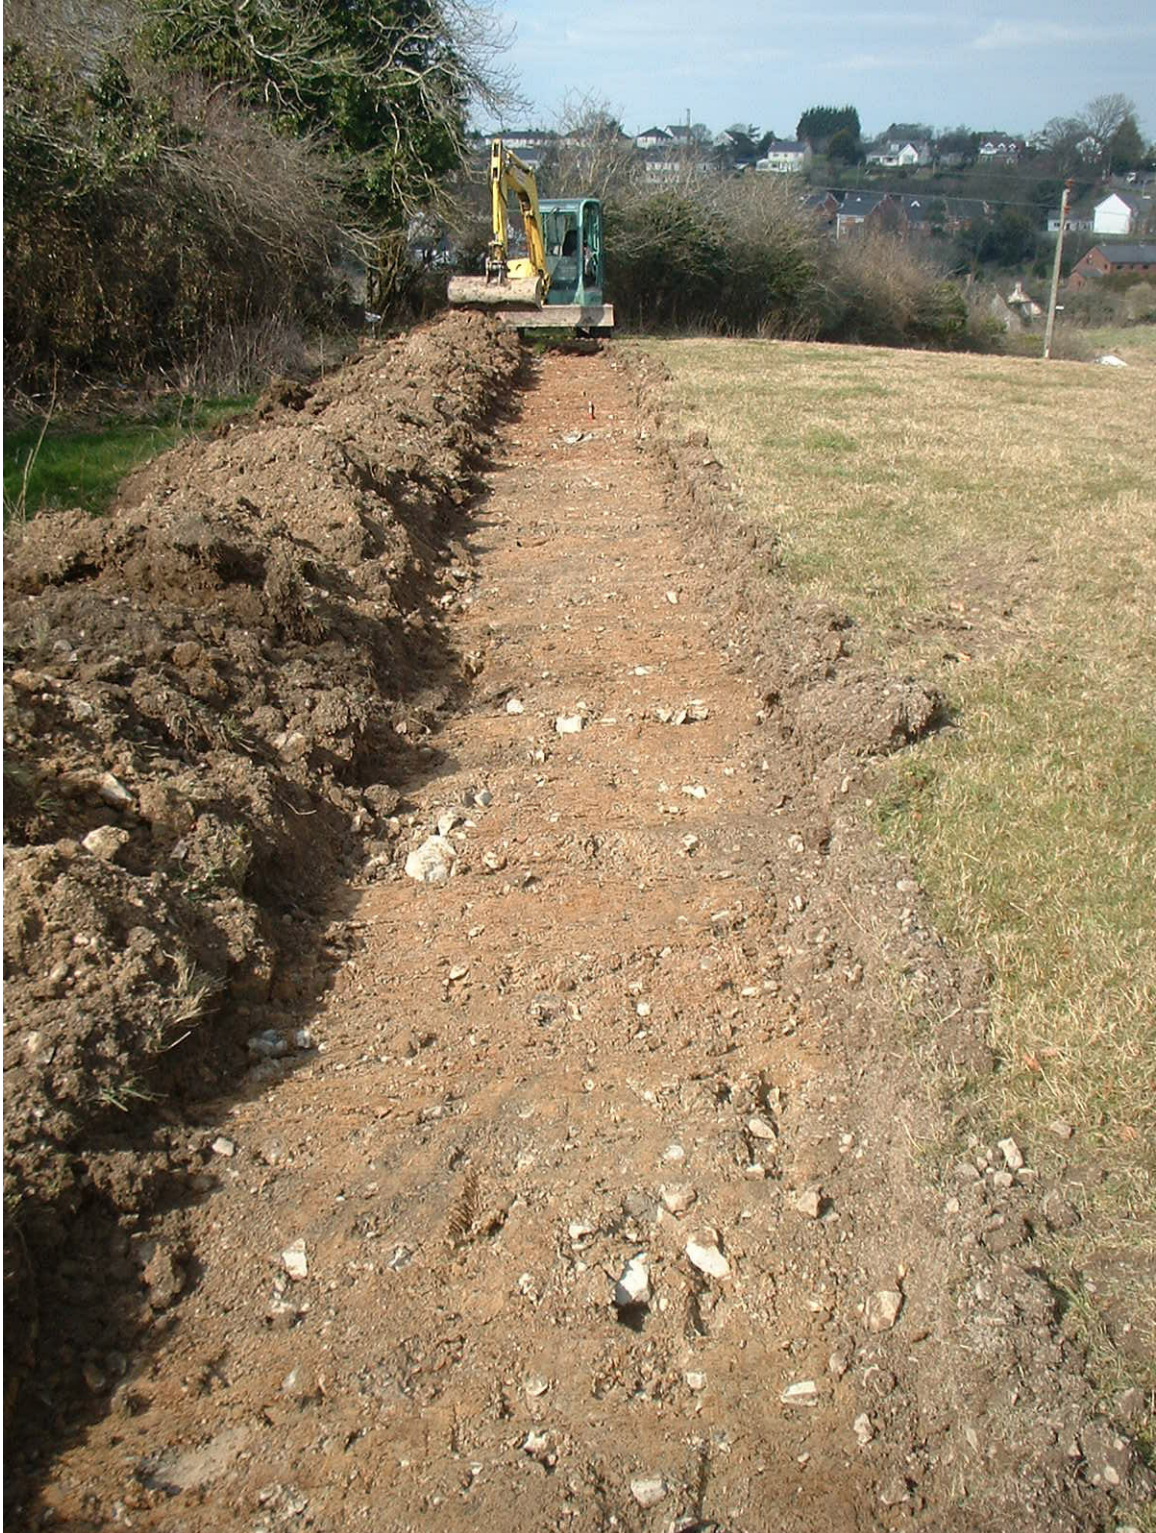
Trench 1: This trench was 2m wide by 30m long. It ran northwest - southeast and was located 5m to the east of the enclosure (DOW 021:047). The topsoil was a grayish-brown sandy loam (Context 101), approximately 20cm in depth. The topsoil sat directly on the subsoil (Context 102). The subsoil consisted of an orange / buff coloured sandy clay which became progressively more reddish towards the northwest end of the trench. No archaeological artifacts or features were found during the excavation of this trench (Photo 1).

Photo 1: Excavation of Tr. 1 showing utilization of toothless “sheugh” bucket and surface of subsoil (Context 102).

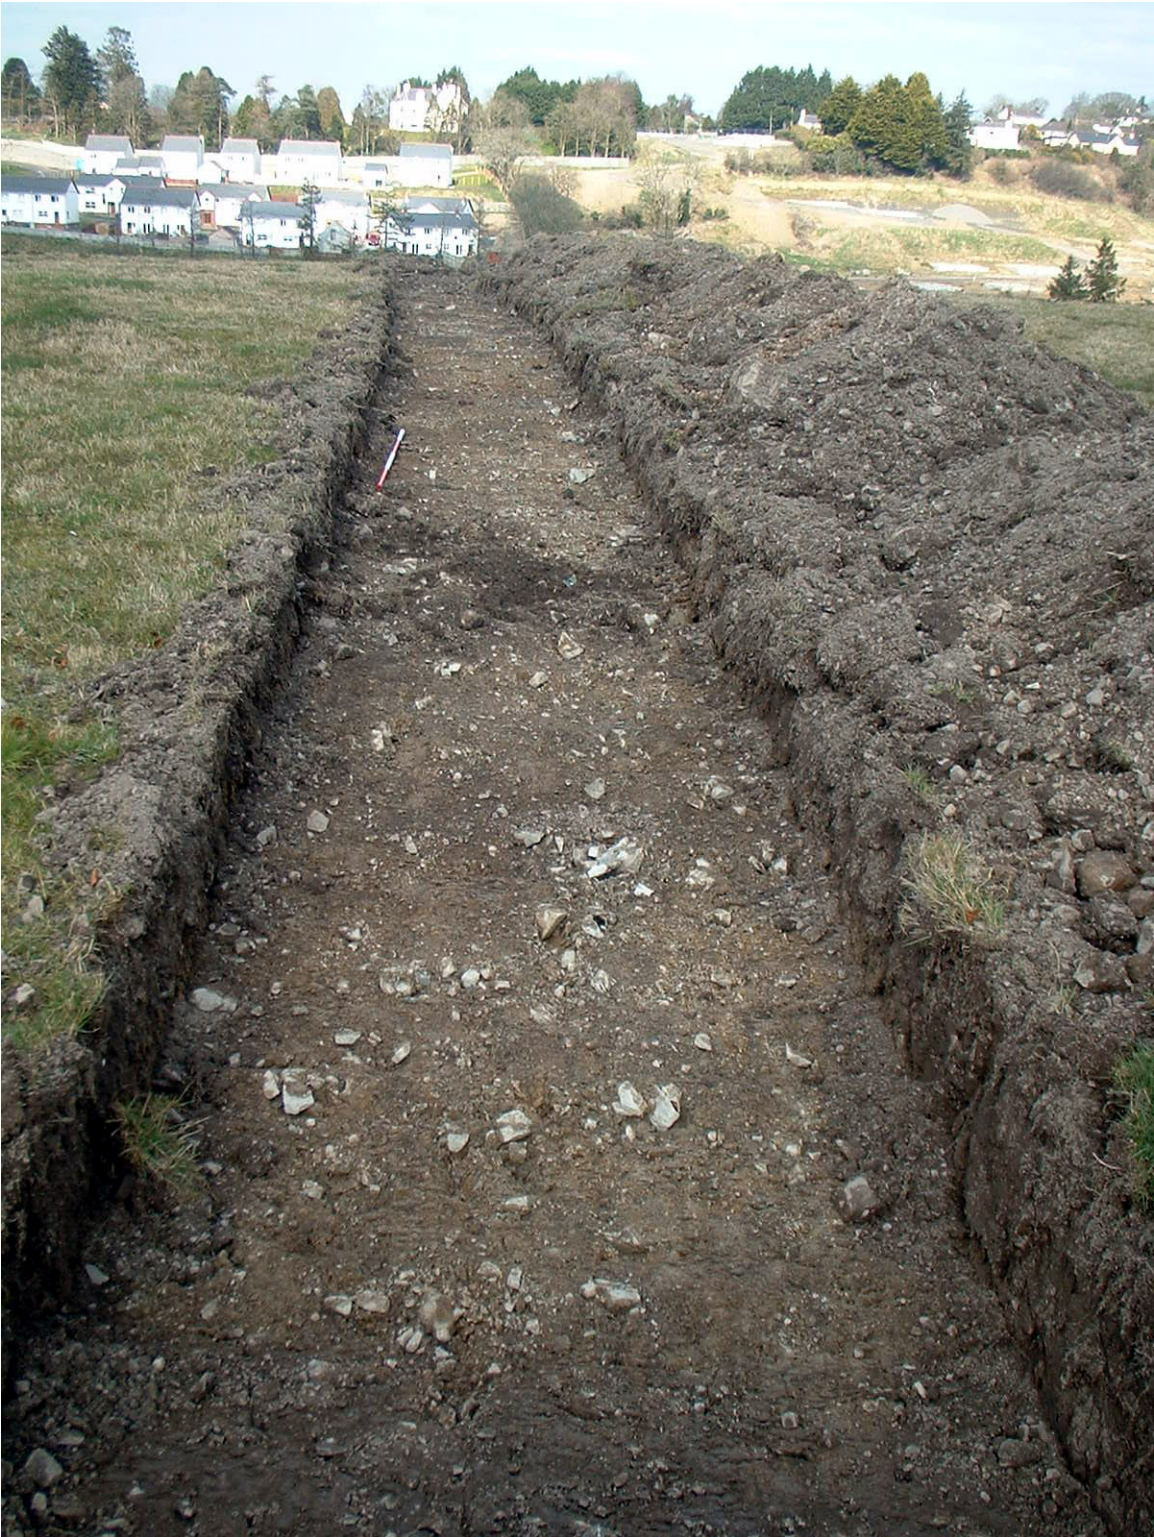
Trench 2: This trench was 2m wide by 30m long. It ran north - south and was located to the north of the boundary with the current cemetery. The topsoil in this trench was a grey-brown sandy loam (Context 201), which was up to 40cm in depth. The topsoil sat directly over the subsoil (Context 202), a light grey to buff stony clay. A drainage gully containing modern glass crossed this trench, running approximately northeast - southwest. No archaeological artifacts or features were found during the excavation of this trench (Photo 2).

Photo 2: Trench 2 after excavation showing surface of subsoil (Context 202).

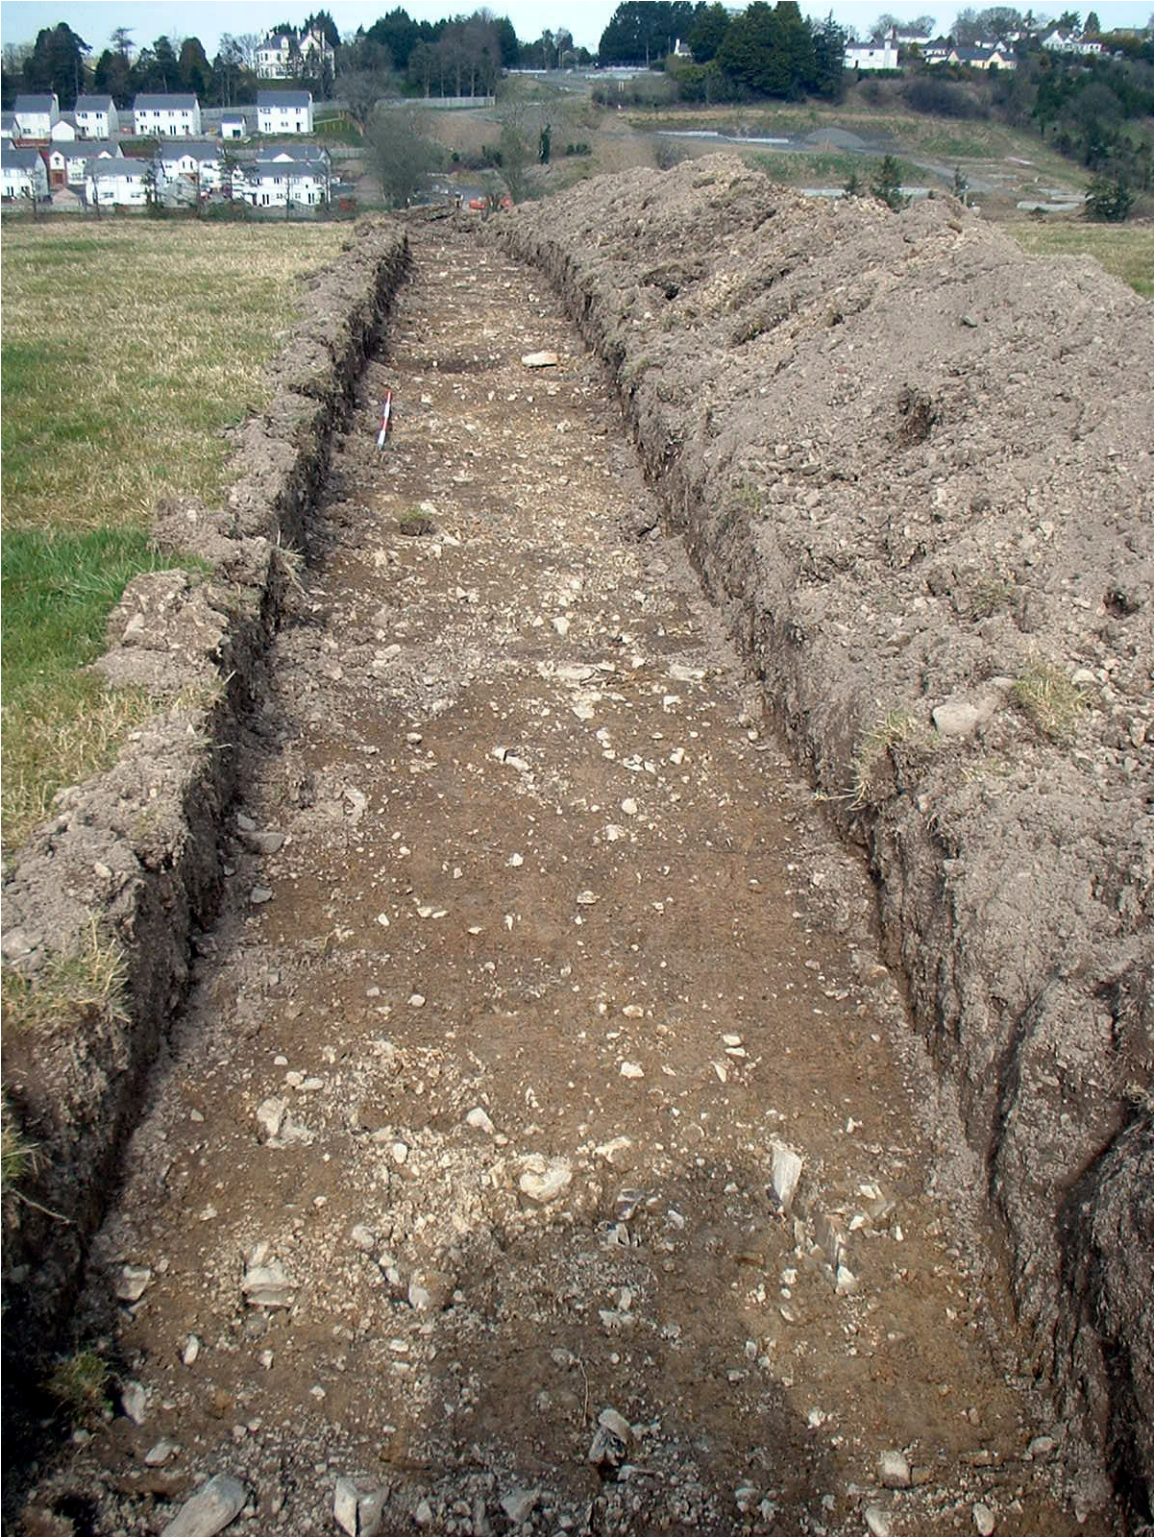
Trench 3: This trench was 2m wide by 30m long. It ran north - south and was located parallel to Trench 2. The topsoil in this trench was a grey-brown loam (Context 301), which was approximately 35cm in depth. The topsoil sat directly on the subsoil (Context 302) which consisted of a buff coloured sandy, stony, clay. Traces of cultivation, in the form of plough marks, were visible running east - west in this trench. No archaeological artifacts or features were found during the excavation of this trench (Photo 3).

Photo 3: Trench 3 after excavation showing surface of subsoil (Context 302).

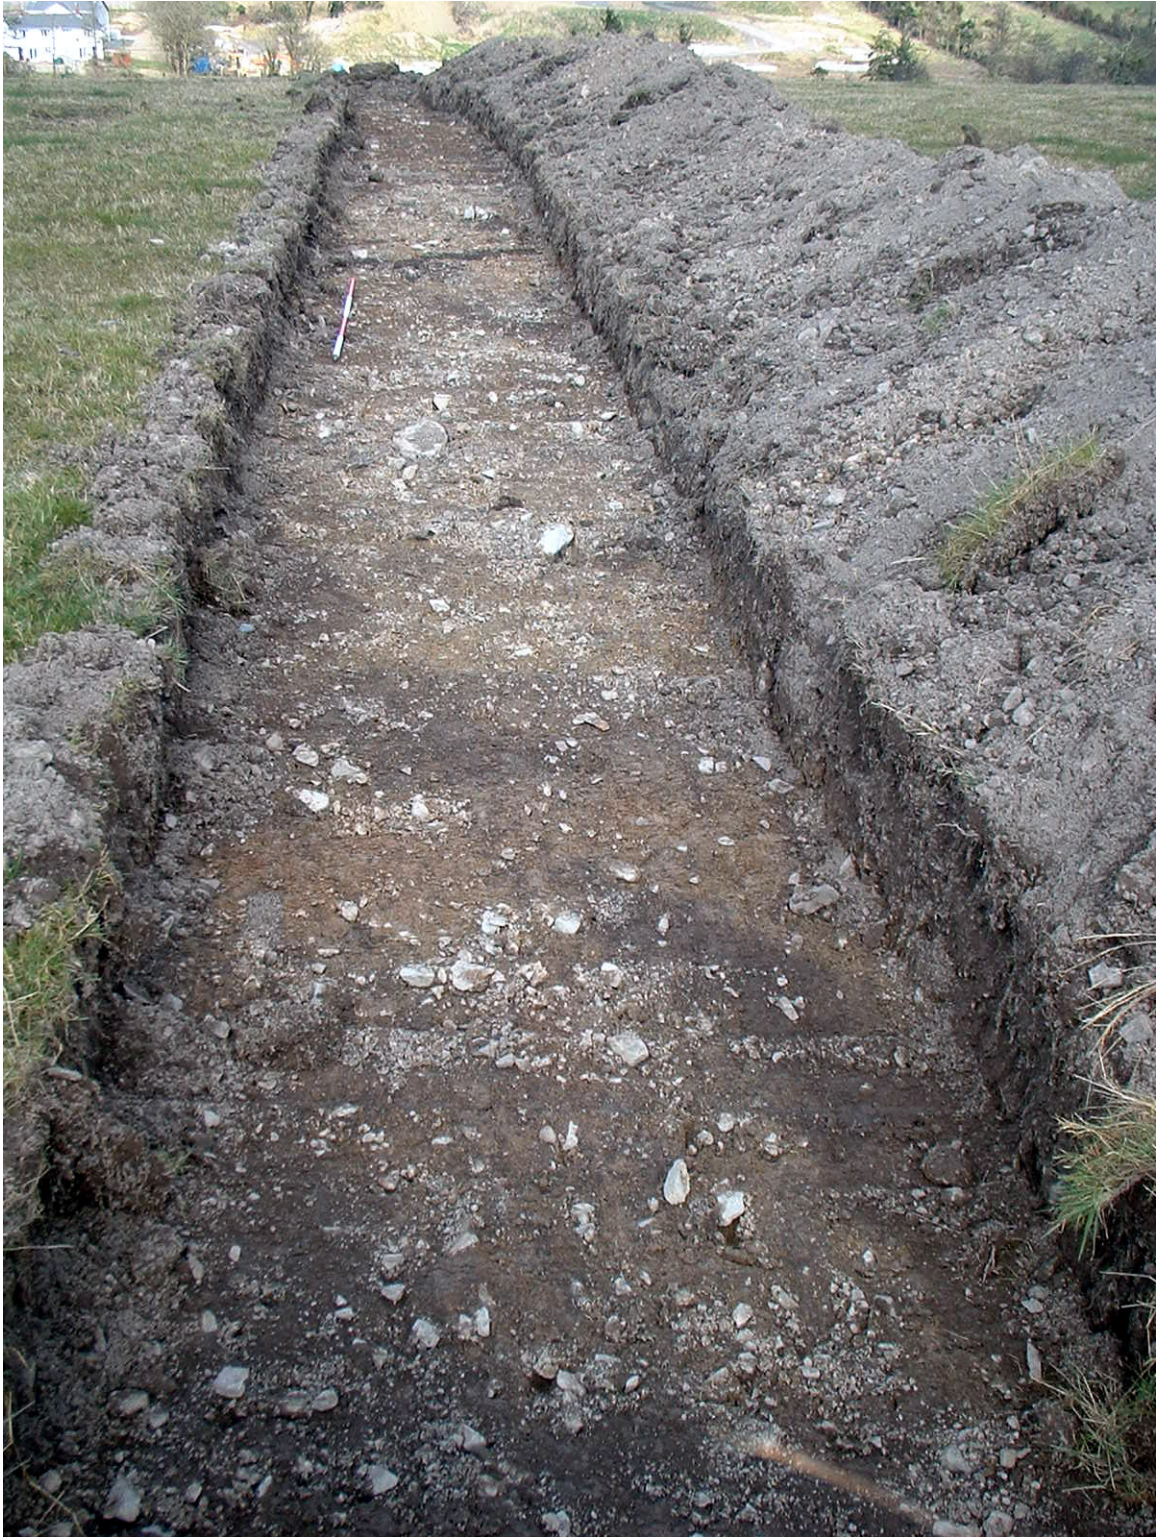
Trench 4: This trench was 2m wide by 30m long. It ran north - south and was located parallel to Trench 3. The topsoil in this trench was a grey-brown loam (Context 401), approximately 35cm in depth. The topsoil sat directly on the subsoil (Context 402) which consisted of a buff coloured sandy, stony, clay. A narrow field drain, containing modern pottery and glass fragments, was found running east - west in this trench. No archaeological artifacts or features were found during the excavation of this trench (Photo 4).

Photo 4: Trench 4 after excavation showing surface of subsoil (Context 402).

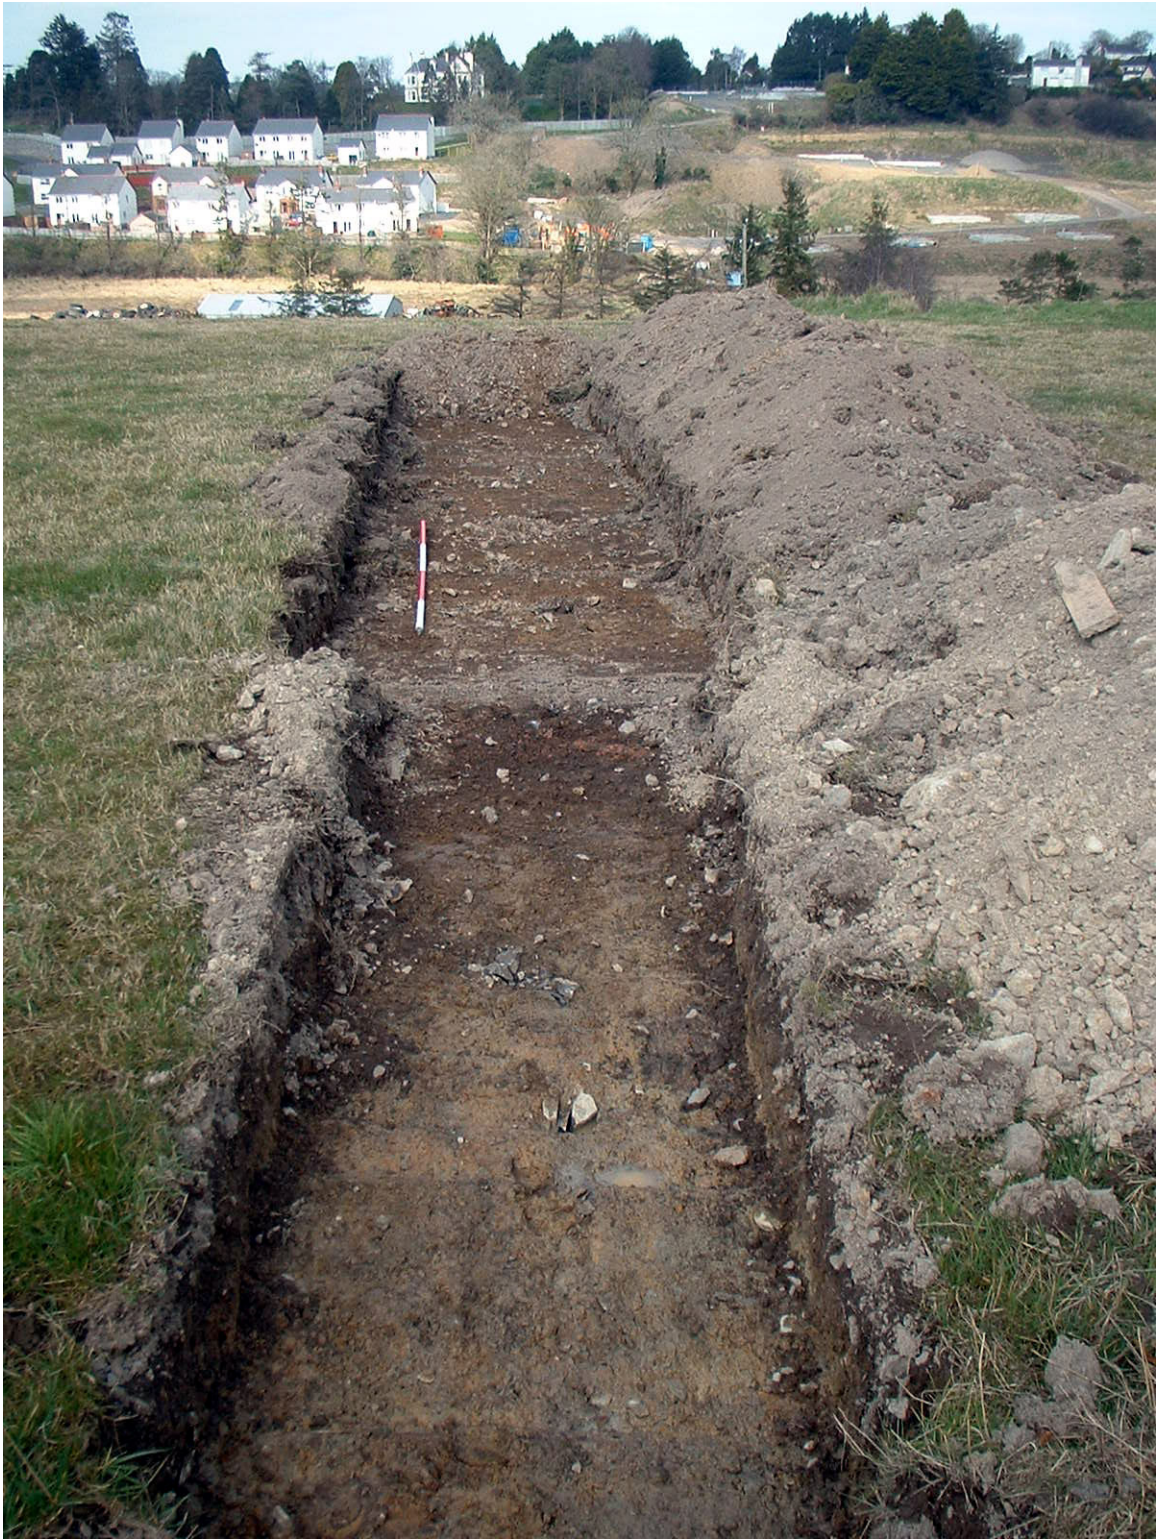
Trench 5: This trench was 2m wide and 15m long. It ran north-south and was located parallel to Trench 4. The topsoil (Context 501) in this trench was a grey-brown sandy loam, approximately 25cm deep. The topsoil sat directly on the subsoil, a buff sandy, stony, clay (Context 502). No archaeological artifacts or features were found during the excavation of this trench (Photo 5).

Photo 5: Trench 5 after excavation showing surface of subsoil (Context 502).

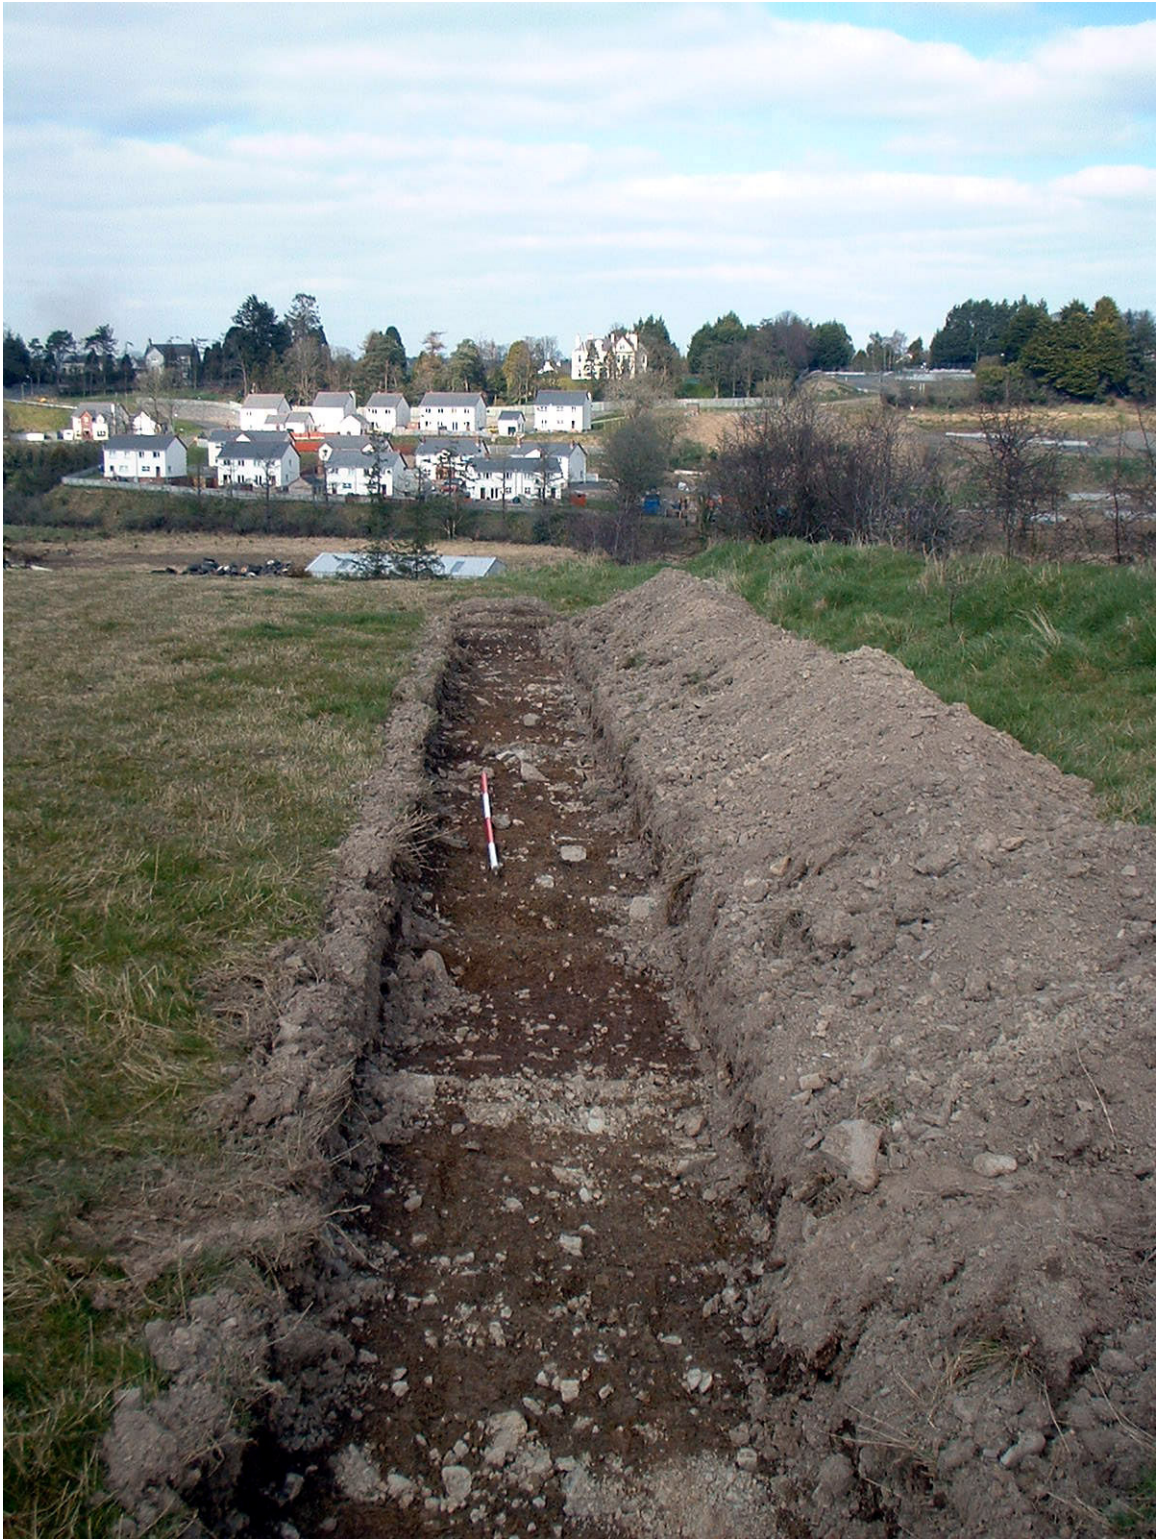
Trench 6: This trench was 2m wide and 15m long. It ran north-south and was located parallel to Trench 5. The topsoil (Context 601) in this trench was a grey-brown sandy loam which averaged approximately 20cm deep. The topsoil sat directly on the subsoil, a buff, sandy, stony, clay (Context 602). No archaeological artifacts or features were found during the excavation of this trench (Photo 6).

Photo 6: Trench 6 after excavation showing surface of subsoil (Context 602).

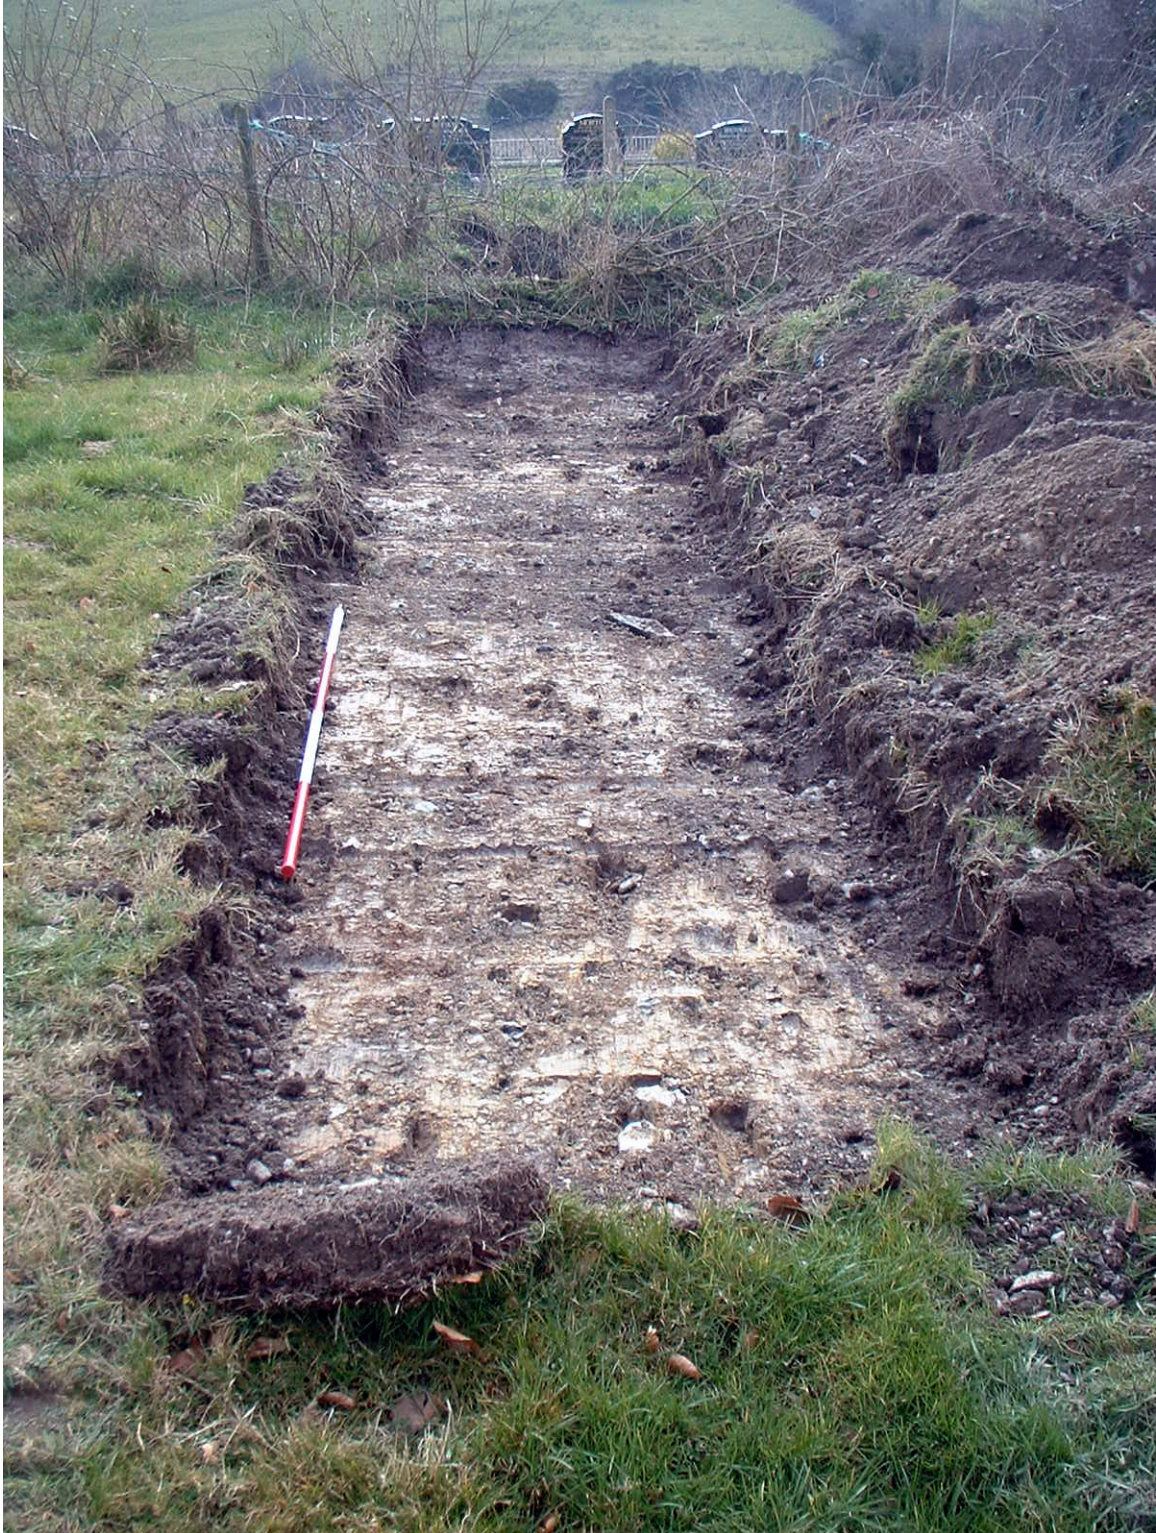
Trench 7: This trench was 2m wide and 10m long. It straddled the boundary of a strip of unused land at the northern edge of the existing cemetery and the field intended for the cemetery extension. A short break in the trench was left to allow the current boundary to remain in place. The topsoil in this trench (Context 701) was a grey-brown loam, which averaged 20cm deep. The topsoil sat directly on the subsoil (Context 702), which was a buff to light grey sandy clay. No archaeological artifacts or features were found during the excavation of this trench (Photo 7).

Photo 7: Trench 7 after excavation showing surface of subsoil (Context 702).
