## **Monitoring Report No. 60**

**Magherahar  
Co. Fermanagh**

**AE/06/87**

## **Brief account of the monitoring.**

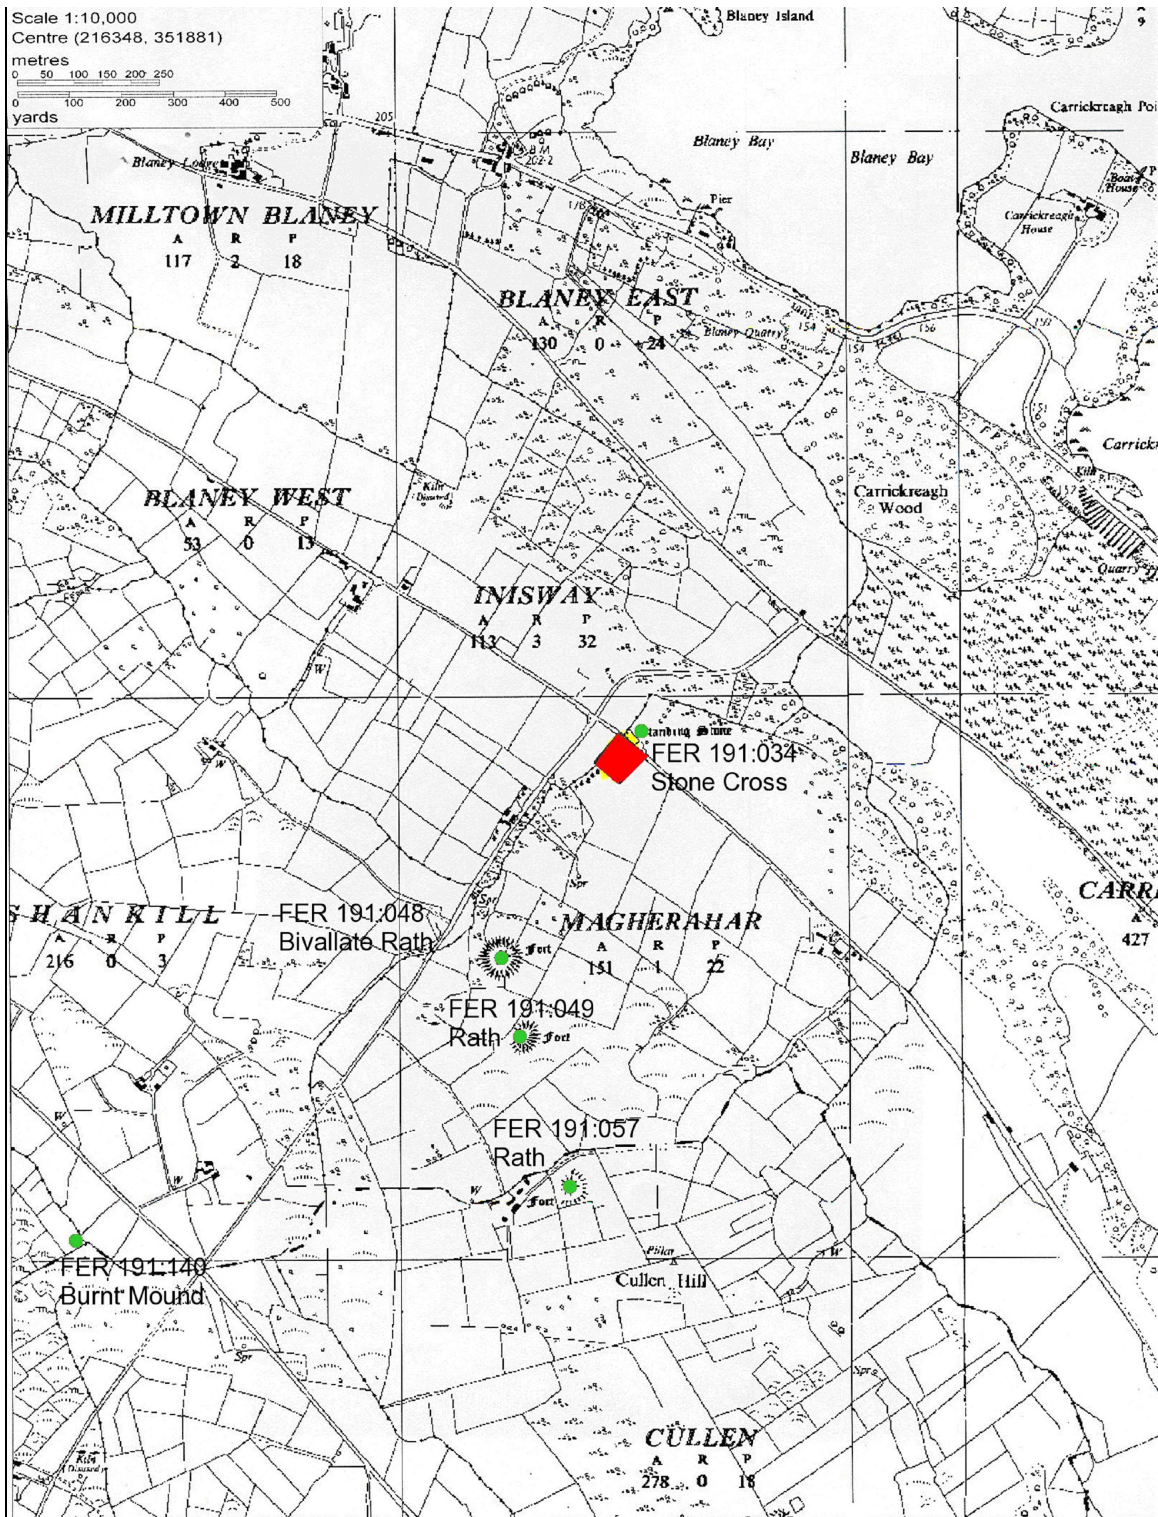
Figure 2: Map showing location of development site (red square), in relation to other monuments in the surrounding area

This proposed housing site is located in Magherahar, Co. Fermanagh, adjacent to the site of the base of a stone cross (FER 191:034) which may be associated with a larger church site (Figures 1 & 2). The evaluation was requested by Edith Gowdy, PHM caseworker, EHS: Built Heritage.

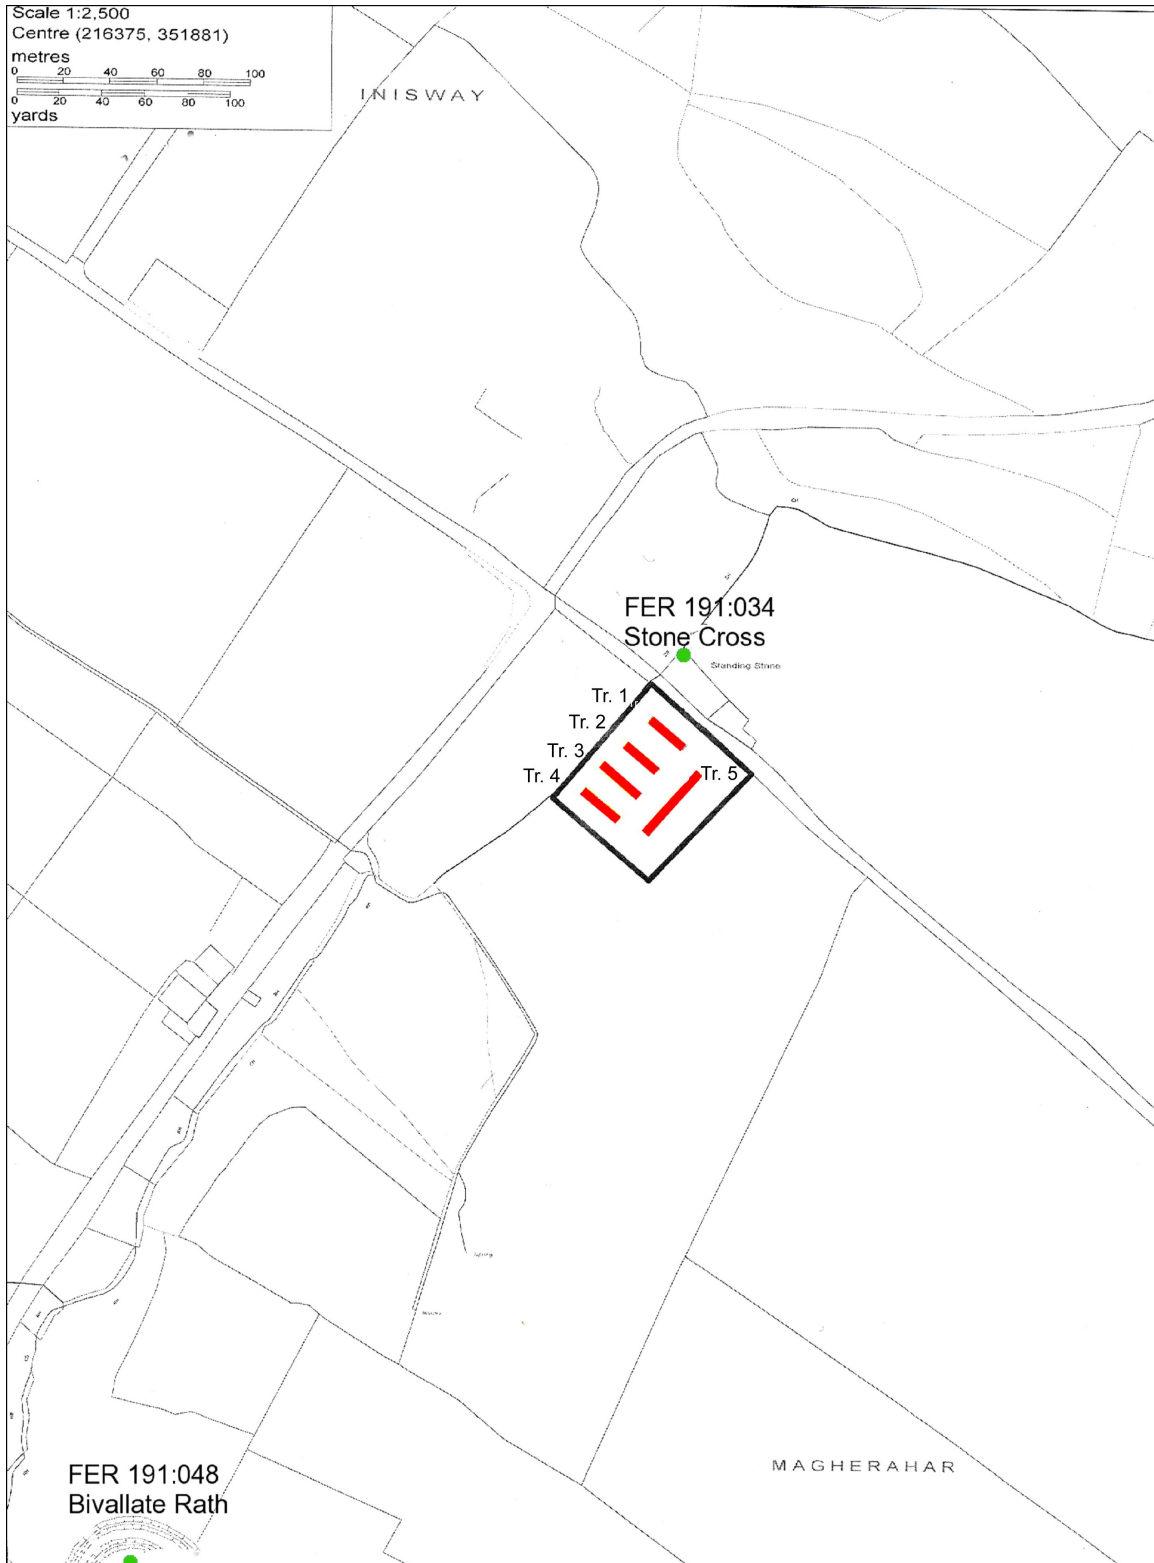
Figure 3: Plan of development site showing location of excavated evaluation trenches and recorded location of SMR FER 191:034

A total of five trenches were excavated as part of the evaluation procedure (Figure 3). The trenches were excavated using a mechanical digger equipped with a toothless "sheugh" bucket (Photo 1). Trenches 1, 2, 3 and 4 measured 2m by 20m; Trench 5 measured 2m by 30m.

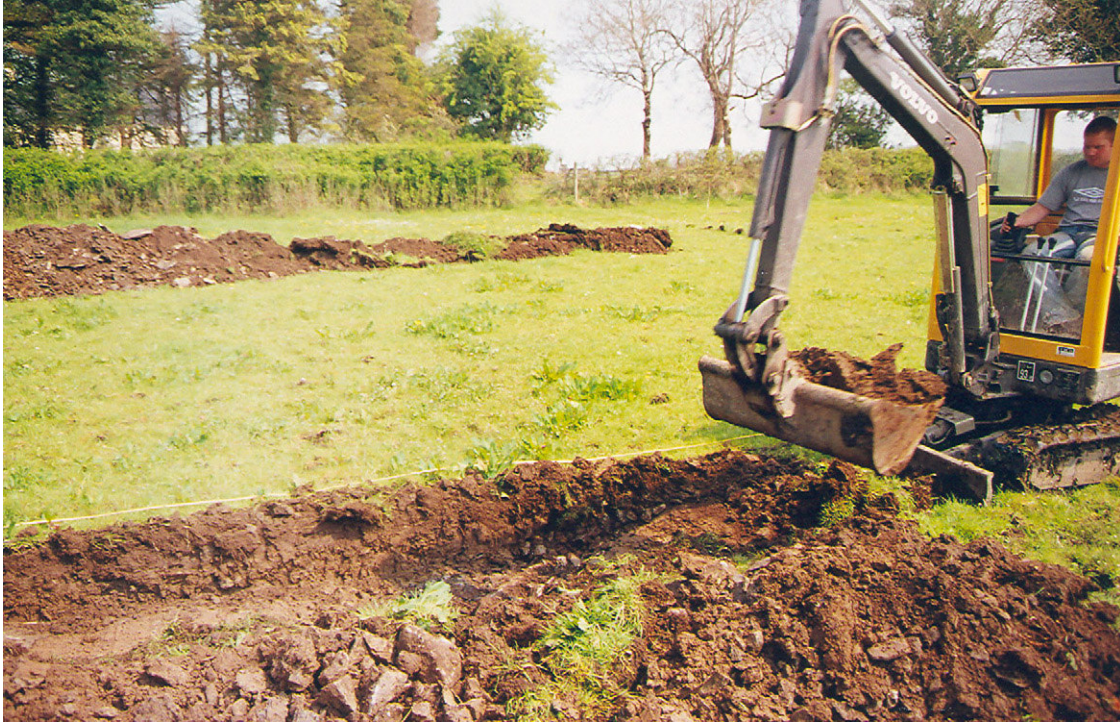
*Photo 1: Excavation of trench showing utilization of toothless “sheugh” bucket.*

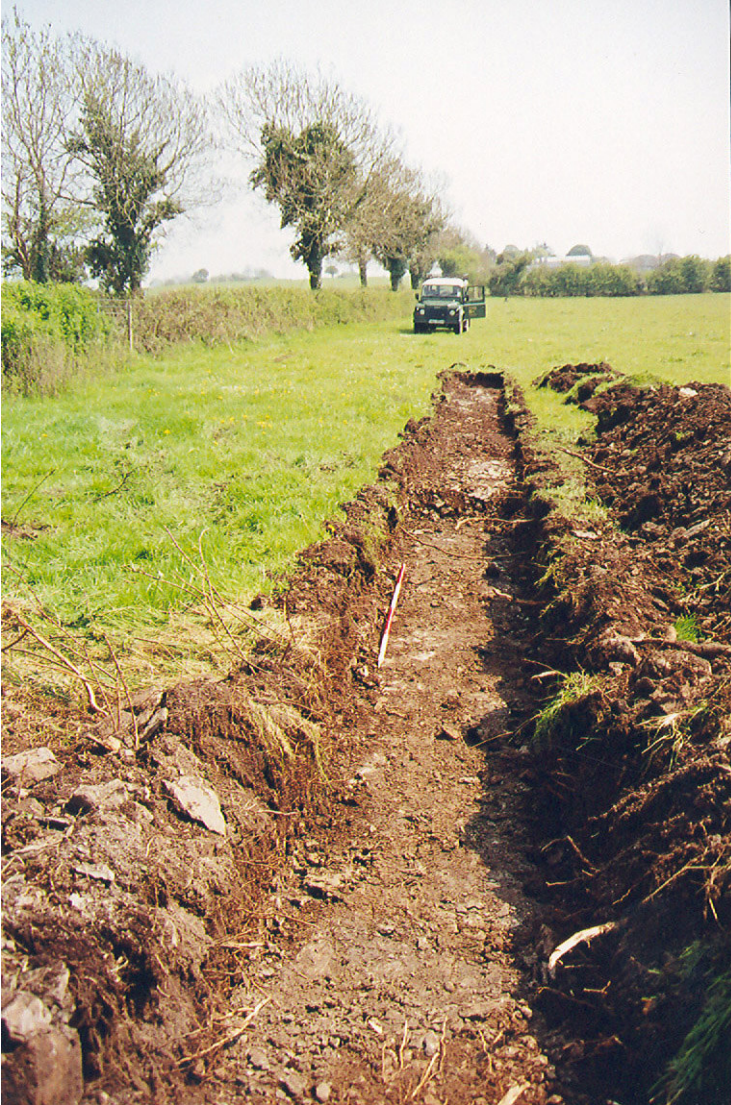
**Trench 1:** This trench was 2m wide by 20m long. It ran northwest-southeast and was located 5m from the northeastern boundary and 5m from the northwestern boundary of the field. The topsoil was a brown loam (Context 101), which was, at the northwest end of the trench, up to 30cm deep, but which was less than 20cm deep in the southeastern half of the trench. The topsoil sat directly on shale bedrock (Context 102). No archaeological artifacts or features were found during the excavation of this trench (Photo 2).

*Photo 2: Trench 1 looking southeast after excavation showing surface of bedrock (Context 102).*

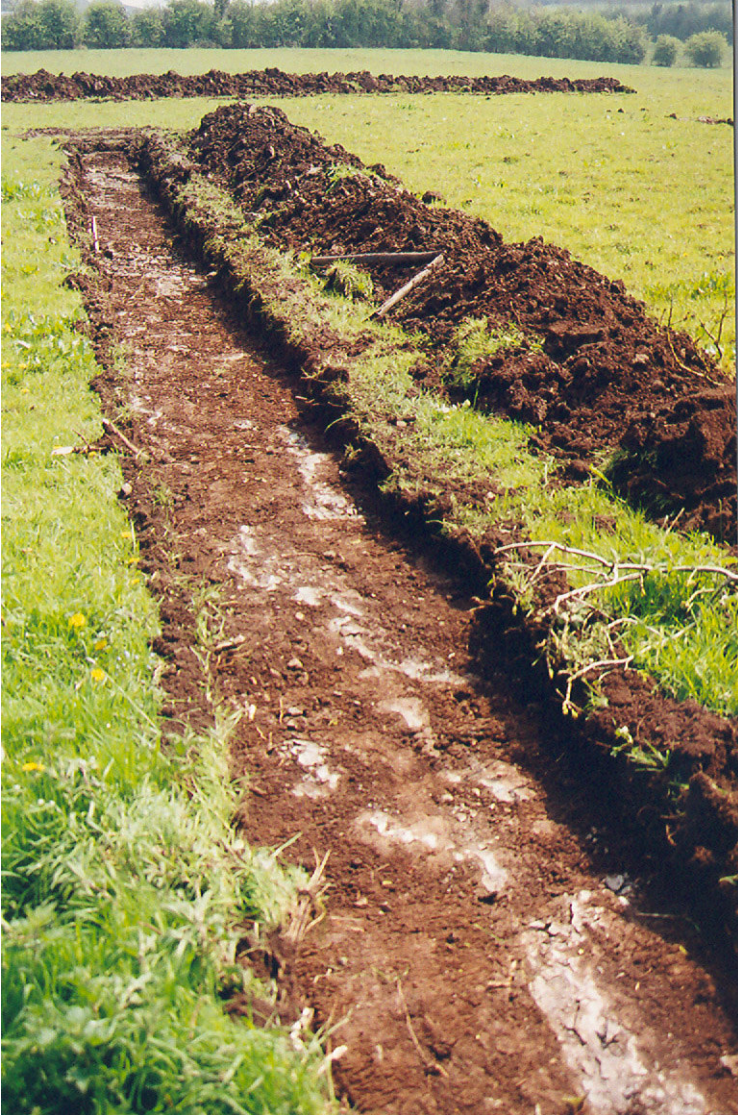
**Trench 2:** This trench was 2m wide by 20m long. It ran northwest-southeast and was located parallel to, and 7m southwest of, Trench 1. The topsoil in this trench was a brown loam (Context 201), which was up to 15cm deep. The topsoil sat directly over shale bedrock (Context 202). No archaeological artifacts or features were found during the excavation of this trench (Photo 3).

*Photo 3: Trench 2 looking southeast after excavation showing surface of bedrock (Context 202).*

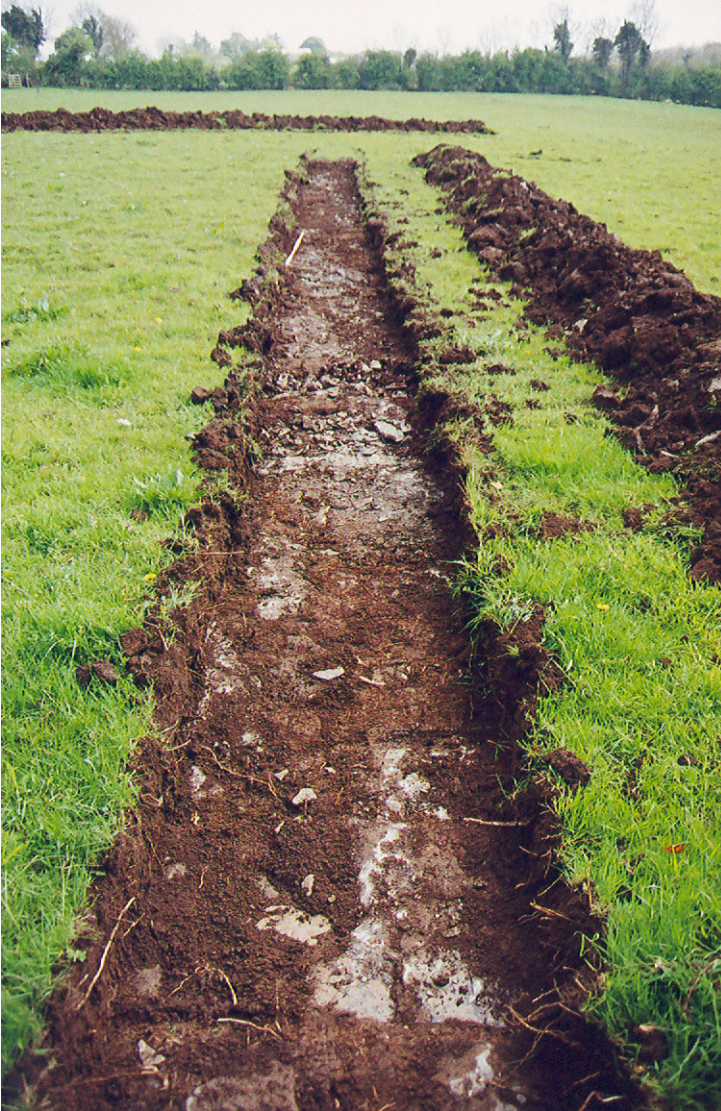
**Trench 3:** This trench was 2m wide by 20m long. It ran northwest-southeast and was located parallel to, and 7m southwest of, Trench 2. The topsoil in this trench was a brown loam (Context 301), which was 15cm in depth. The topsoil sat directly over shale bedrock (Context 302). No archaeological artifacts or features were found during the excavation of this trench (Photo 4).

*Photo 4: Trench 3 looking southeast after excavation showing surface of bedrock (Context 302).*

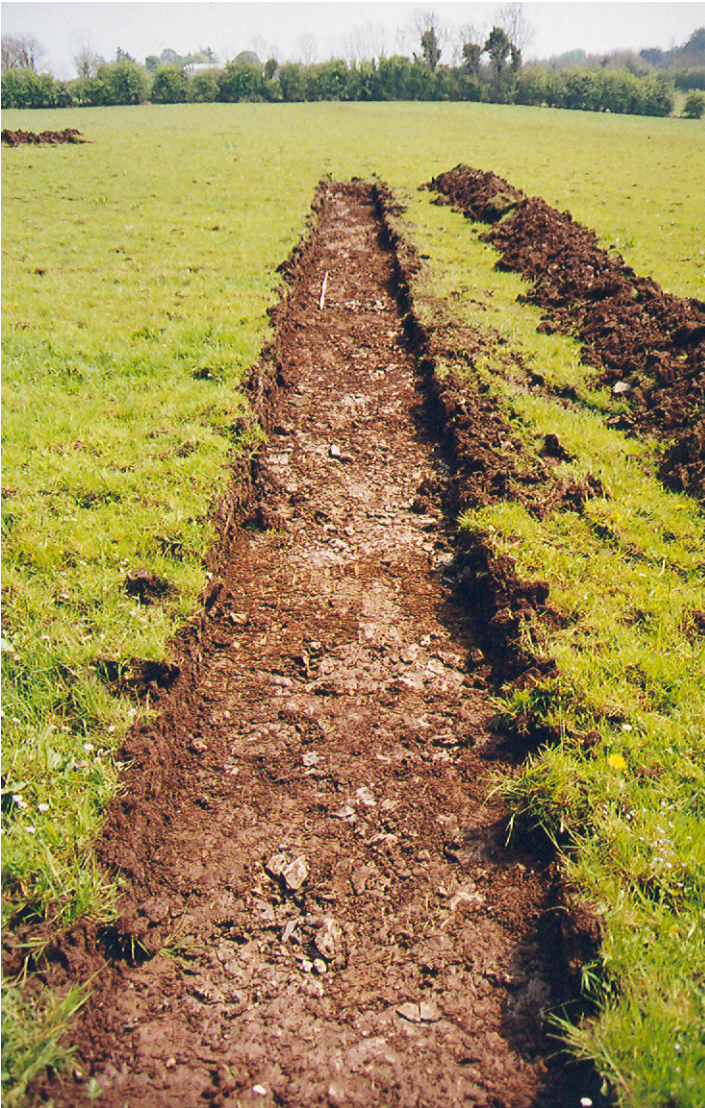
**Trench 4:** This trench was 2m wide by 20m long. It ran northwest-southeast and was located parallel to, and 7m southwest of, Trench 3. The topsoil in this trench was a brown loam (Context 401), which was 15cm in depth. The topsoil sat directly over shale bedrock (Context 402). No archaeological artifacts or features were found during the excavation of this trench (Photo 5).

*Photo 5: Trench 4 looking southeast after excavation showing surface of bedrock (Context 402).*

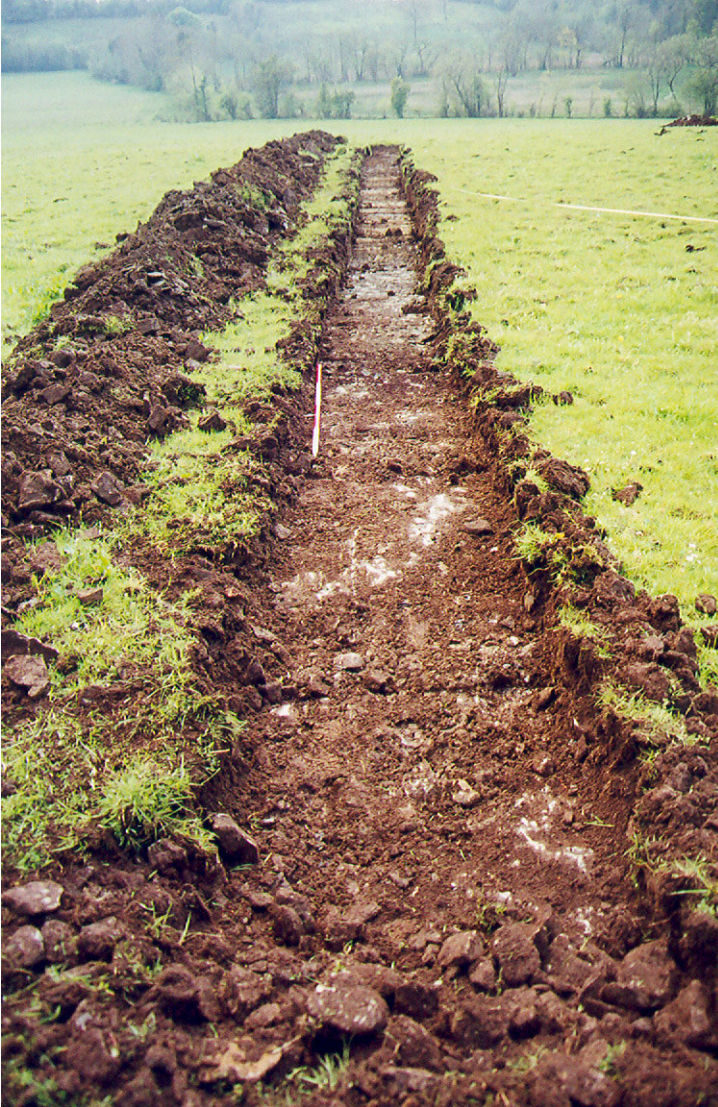
**Trench 5:** This trench was 2m wide by 30m long. It ran northeast-southwest and was located running at a right angle to, and 7m southeast of, Trenches 1- 4. The topsoil in this trench was a brown loam (Context 501), which was 20cm in depth. The topsoil sat directly over shale bedrock (Context 502). No archaeological artifacts or features were found during the excavation of this trench (Photo 6).

*Photo 6: Trench 5 looking southwest after excavation showing surface of bedrock (Context 502).*
