Monitoring Report No. 95

**Rakeeran Road
Rahony
Dromore
Co. Tyrone**

AE/06/222

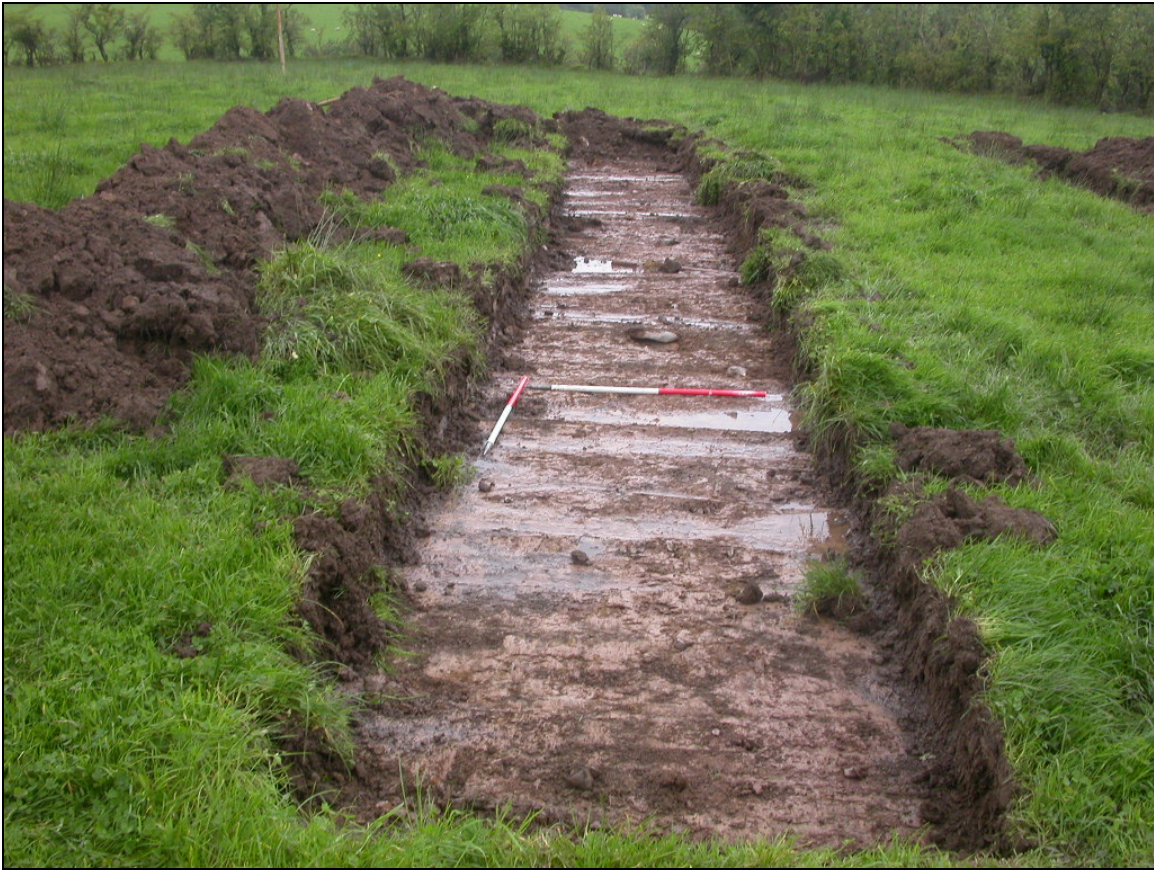
The soil stratigraphy was uniform across the three evaluation trenches. This consisted solely of a layer of dark brown loamy clay topsoil (C101) ranging between 0.20m and 0.25m in depth, immediately overlying the subsoil, which consisted of red boulder clay (Plates 1-3). A number of 3" plastic drainage pipes had been laid across the field and are visible in Plate 3. These had been covered with a shallow layer of gravel (Plate 4).

Plate 1: Trench 1 – C101 removed to reveal red boulder clay subsoil. Looking southwest

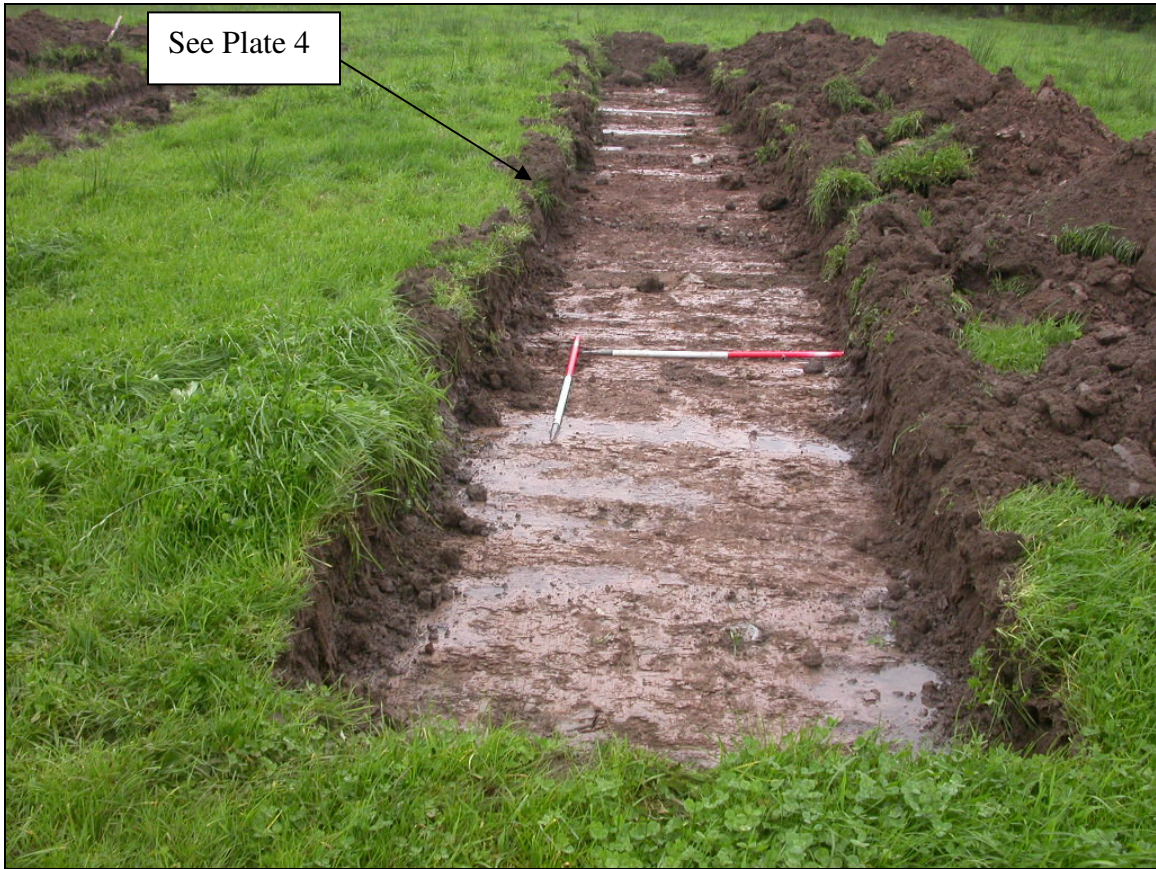
Plate 2: Trench 2 – C101 removed to reveal red boulder clay subsoil. Looking southwest

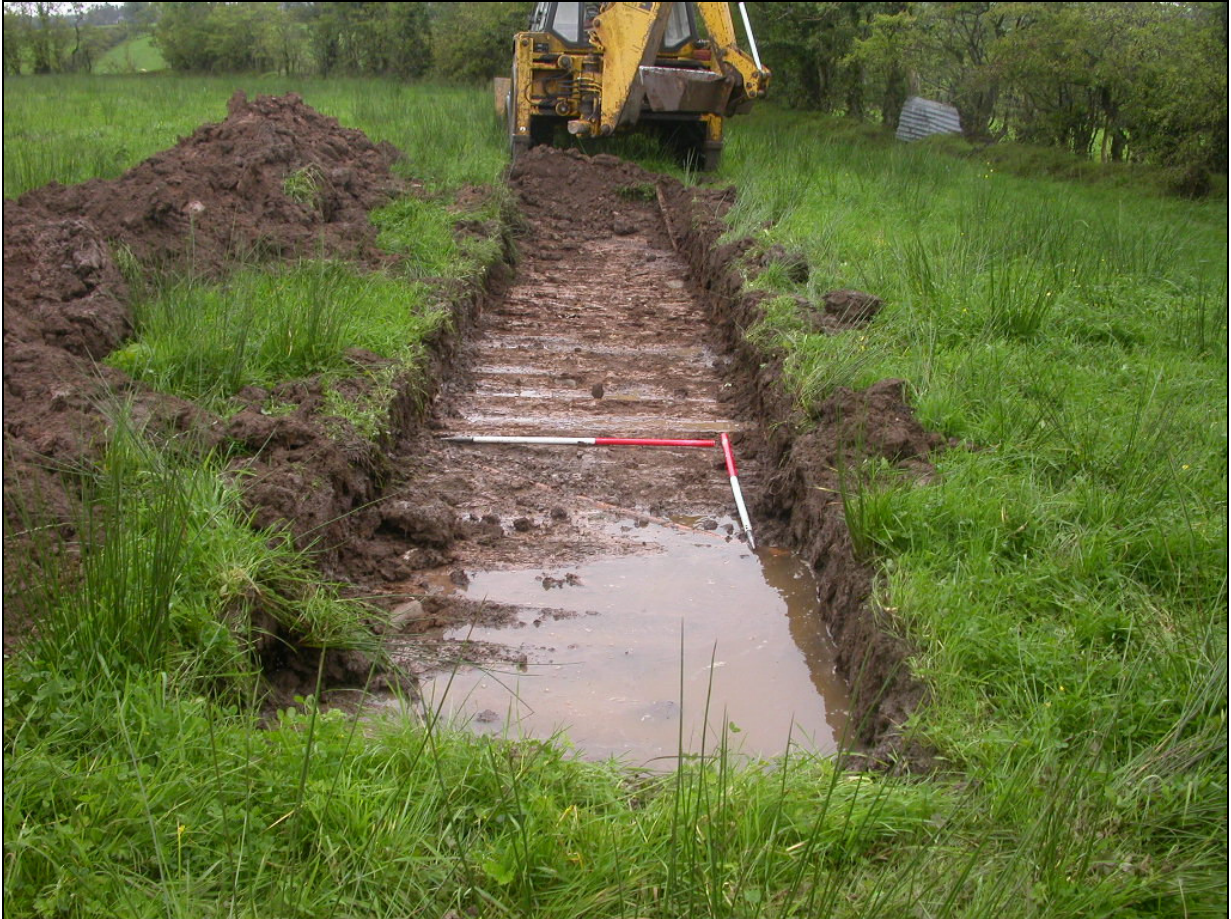
Plate 3: Trench 3 – C101 removed to reveal red boulder clay subsoil. Looking south

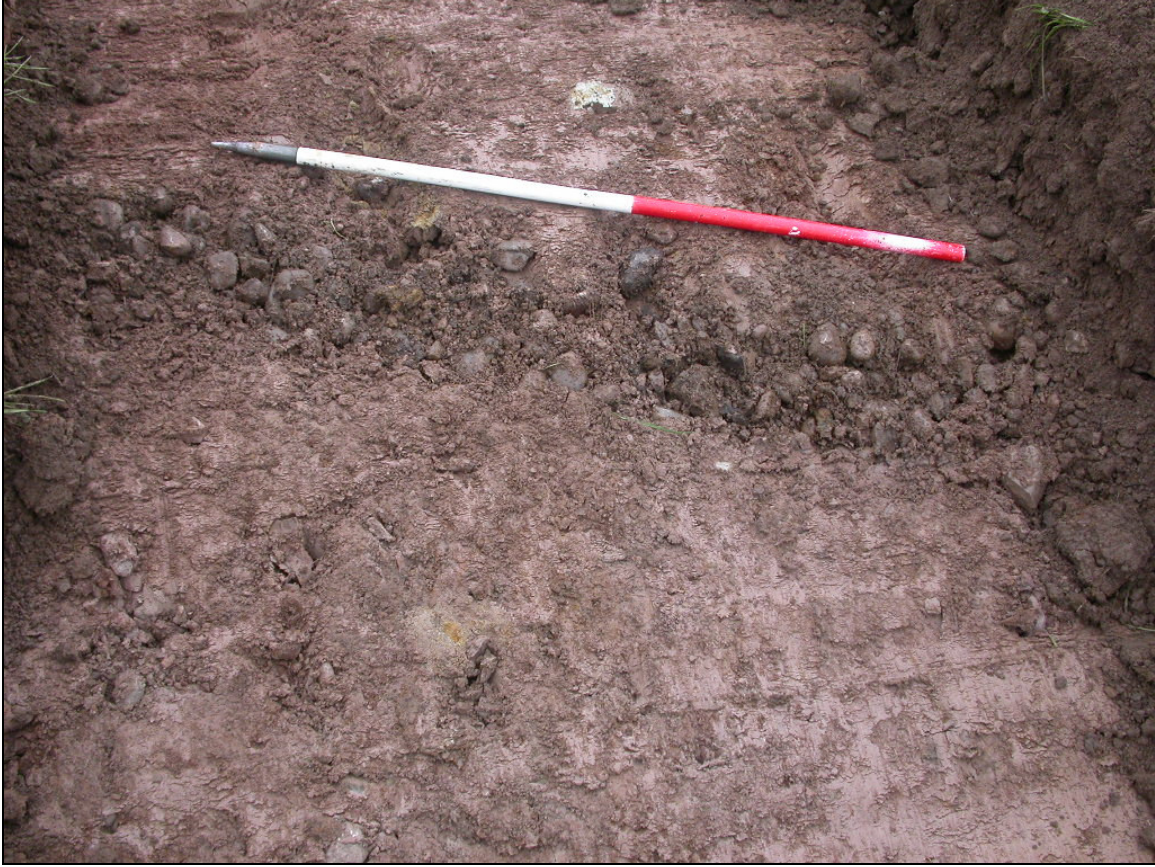
Plate 4: 3" drainage pipe in Trench 2 protected by gravel covering.
