**Monitoring Report No. 98**

**14 Derryhaw Road  
Tynan  
Co. Armagh**

**AE/07/137**

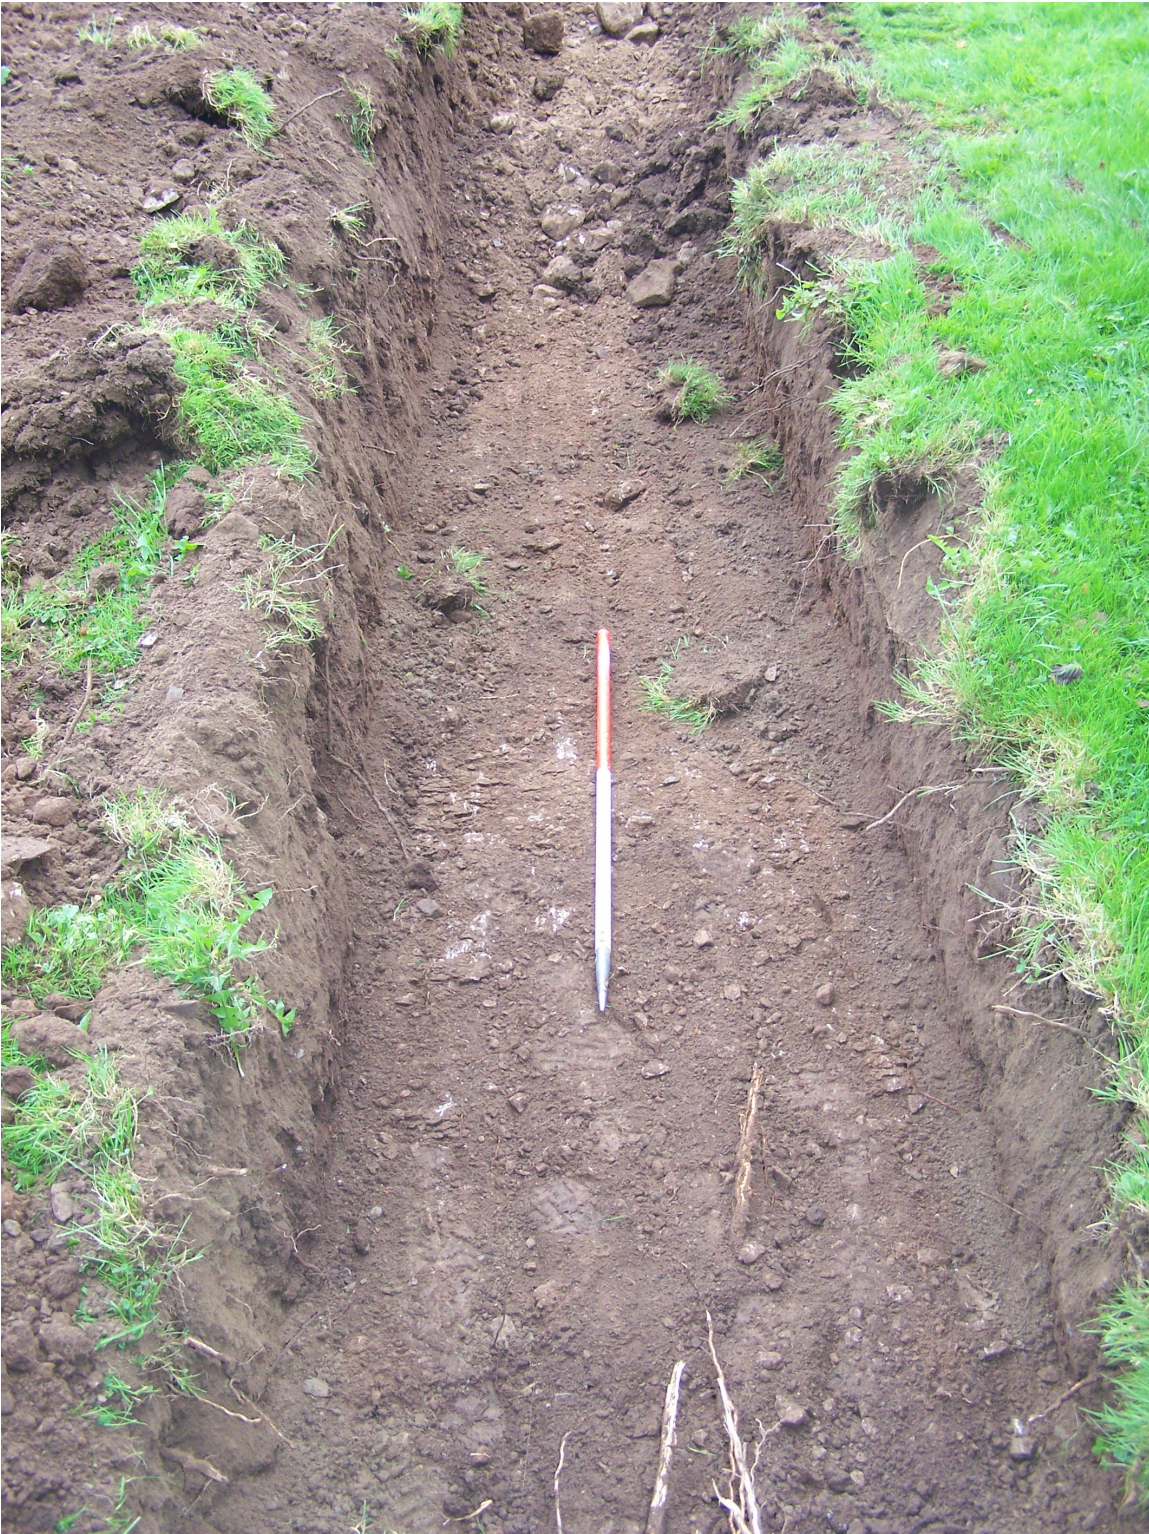
Plate 1: Trench 1 following excavation to the surface of the subsoil (Context No. 103) looking north-east.

Trench 1 was positioned to the south of the present dwelling and measured approximately 18m by 2m. The sod and topsoil layer in this trench (Context No. 101) consisted of a humic mid brown loam with few inclusions of small rounded and sub-angular stones (average size 40mm x 20mm x 10mm). This layer had an average depth of 0.4m.

Below the sod and topsoil (Context No.101) was the subsoil (Context No. 102). This consisted of a yellow orange sandy clay with few inclusions of small rounded and sub-angular stones and pebbles (average size 60mm x 40mm x 15mm). There were no finds or features of an archaeological nature encountered in this trench.

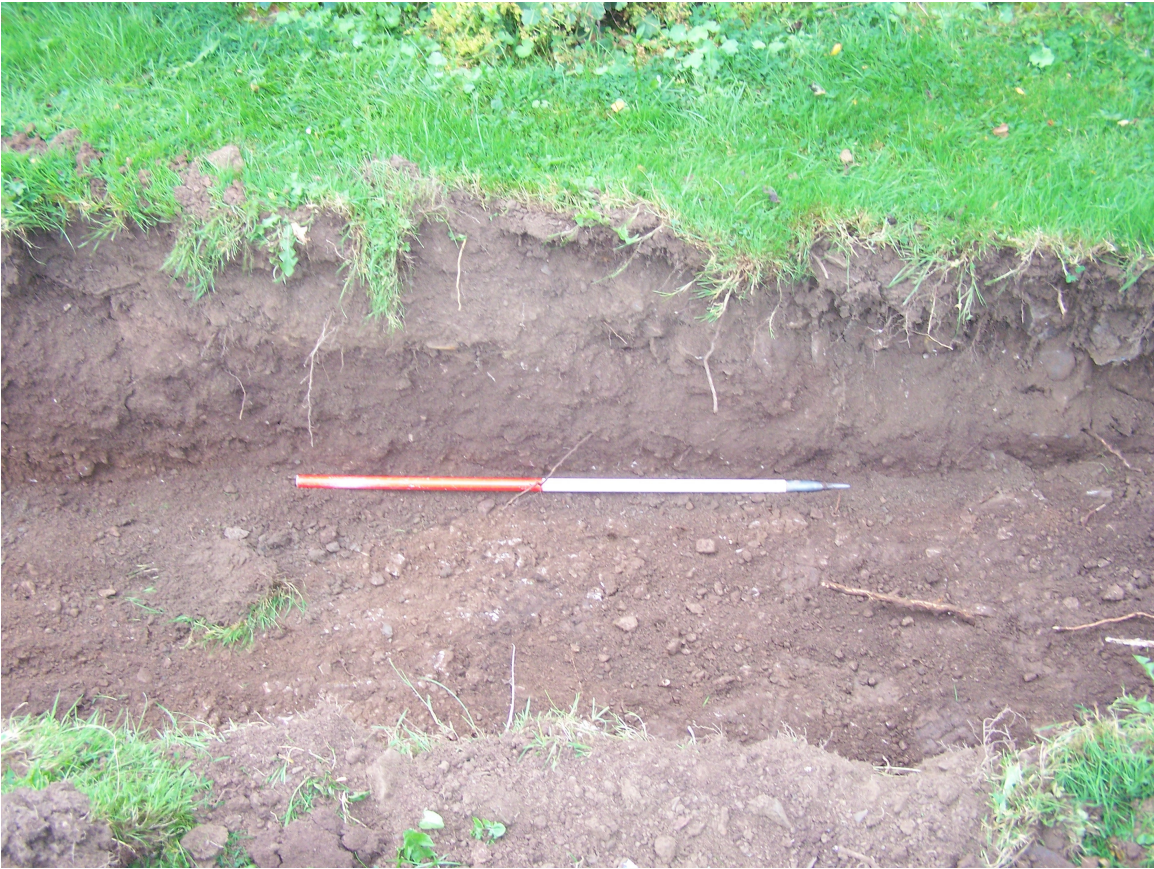
Plate 2: North-west facing section of Trench 1

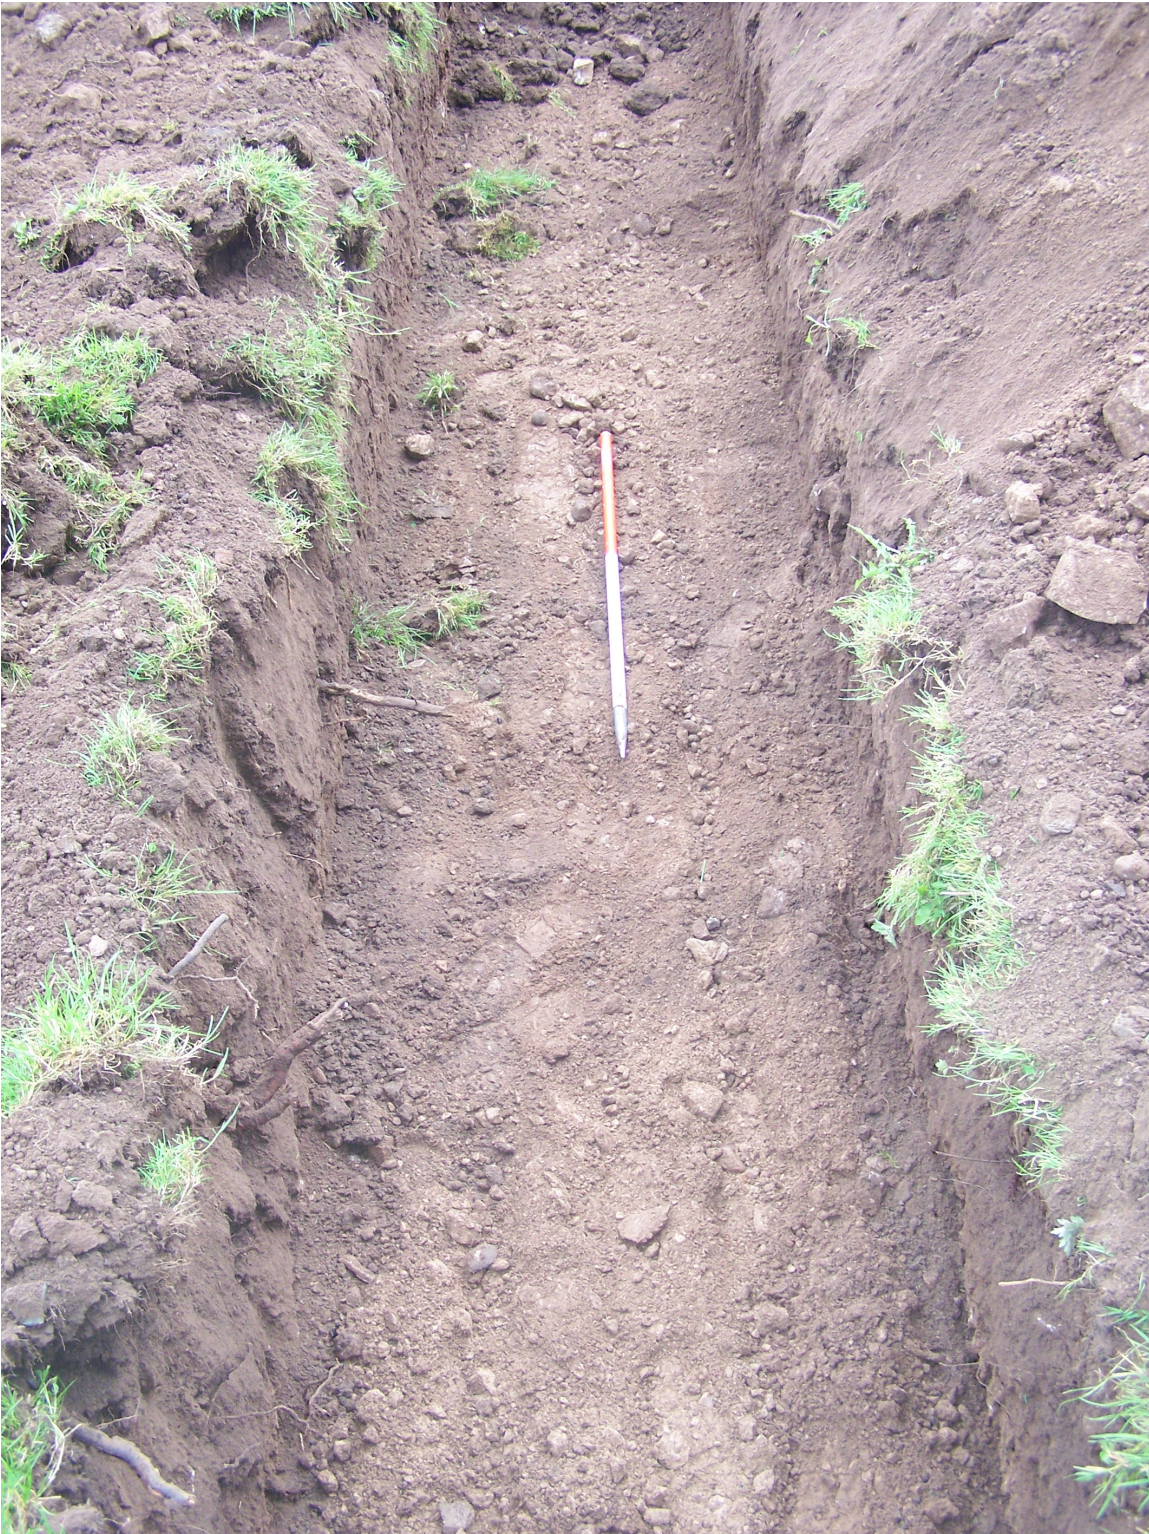
Plate 3: Trench 2 following excavation to the surface of the subsoil (Context No. 202), looking north-east.

Trench 2 was positioned approximately 2m north-west of Trench 1 and measured 19m x 2m. The sod and topsoil layer in this trench (Context No. 201) consisted of a humic mid brown loam with few inclusions of small rounded and sub-angular stones (average size 40mm x 20mm x 10mm). This layer had an average depth of 0.4m.

Below the sod and topsoil (Context No.201) was the subsoil (Context No. 202). This consisted of a yellow orange sandy clay with few inclusions of small rounded and sub-angular stones and pebbles (average size 60mm x 40mm x 15mm). There were no finds or features of an archaeological nature encountered in this trench.

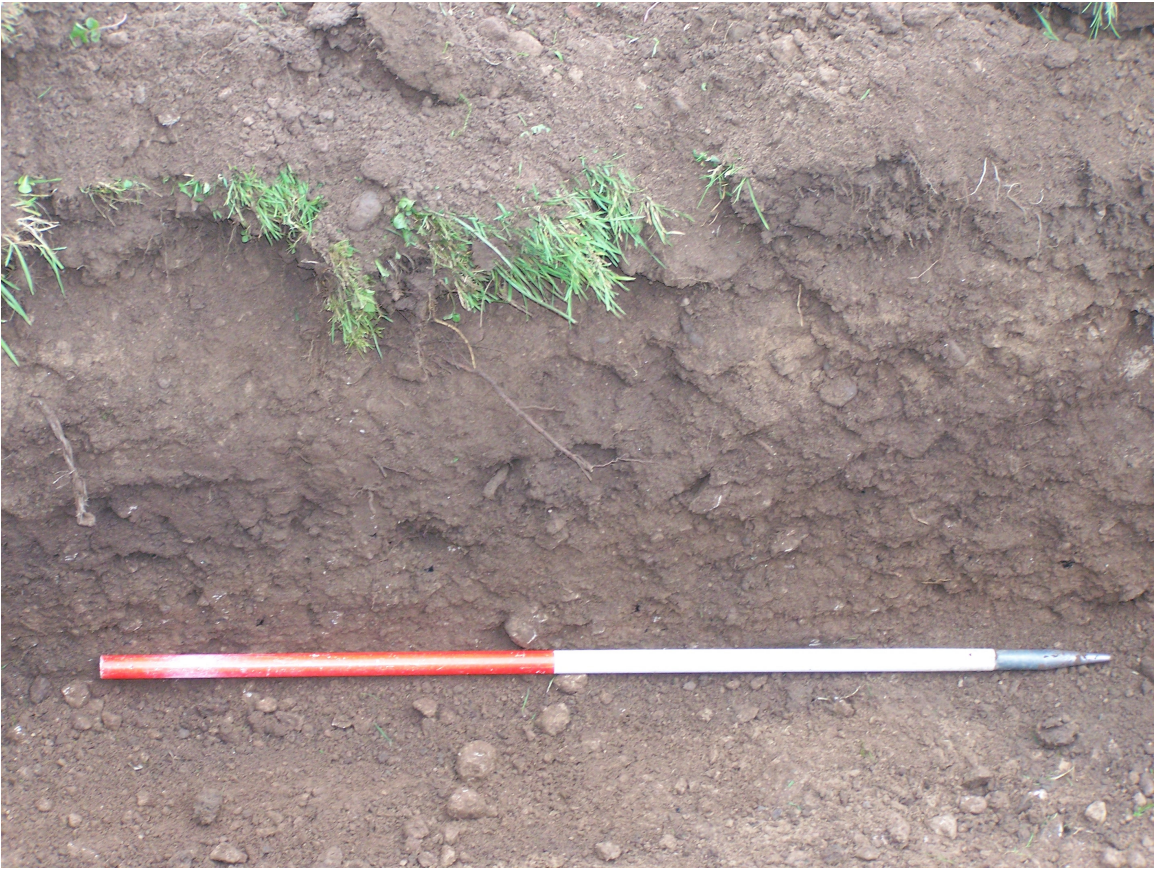
Plate 4: North-west facing section of Trench 2

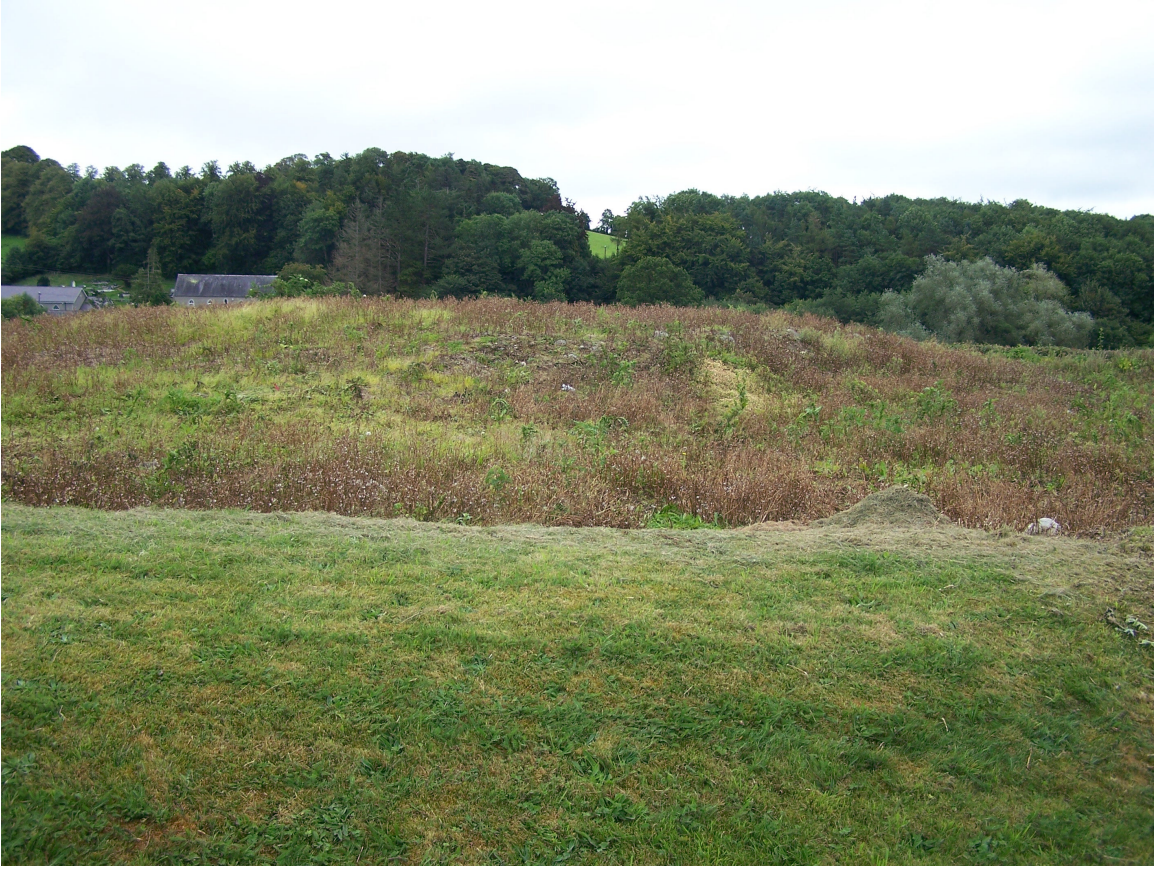
Plate 5: Possible ring barrow (ARM 015:004), looking north. This photo is taken from the top of the bank looking across the internal ditch towards the central mound of the monument.
