Evaluation/Monitoring Report No. 144

**150m NE of 86 Glasdrumman Road
Crossmaglen
Newry
County Armagh**

LICENCE NO. : AE/07/168

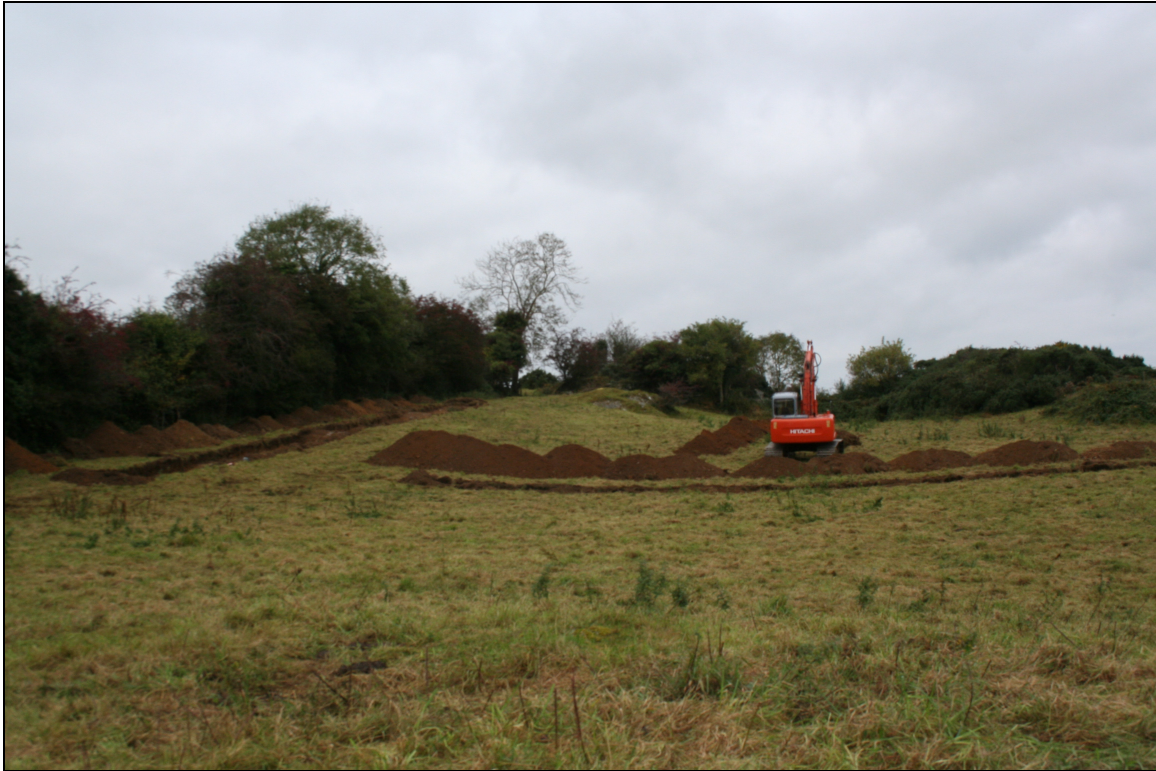
Plate 1 General shot of proposed development site looking NW during excavation of Trench C. Note the entrance 'ramp' to the left of shot along which Trench A was excavated.

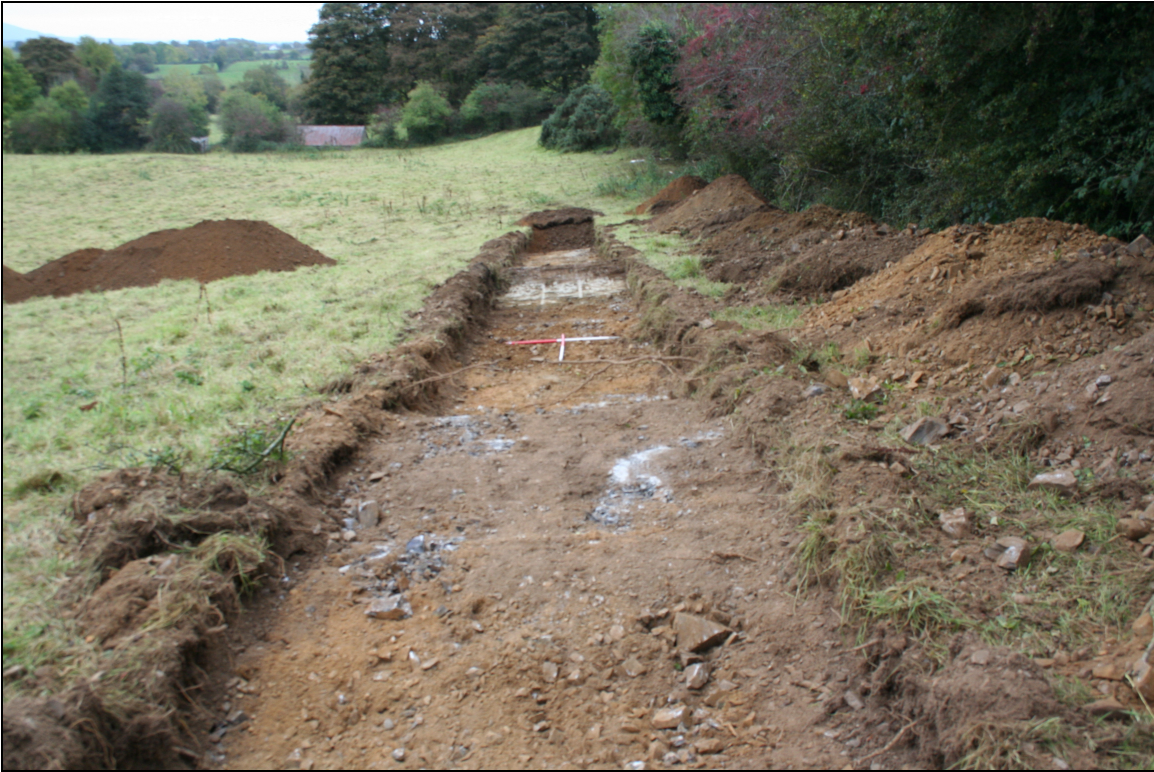
Plate 2 Excavation of Trench A, looking SW, showing unmodified rock outcropping.

The feature archaeologically excavated in Trench A is considered to be a modern leveling deposit, used to fill a natural hollow at the base of the entrance 'ramp' to the proposed development site. The rock outcropping noted in Trench A is considered to be unmodified. Both Trenches B and C showed no evidence of previously unrecorded archaeological remains.

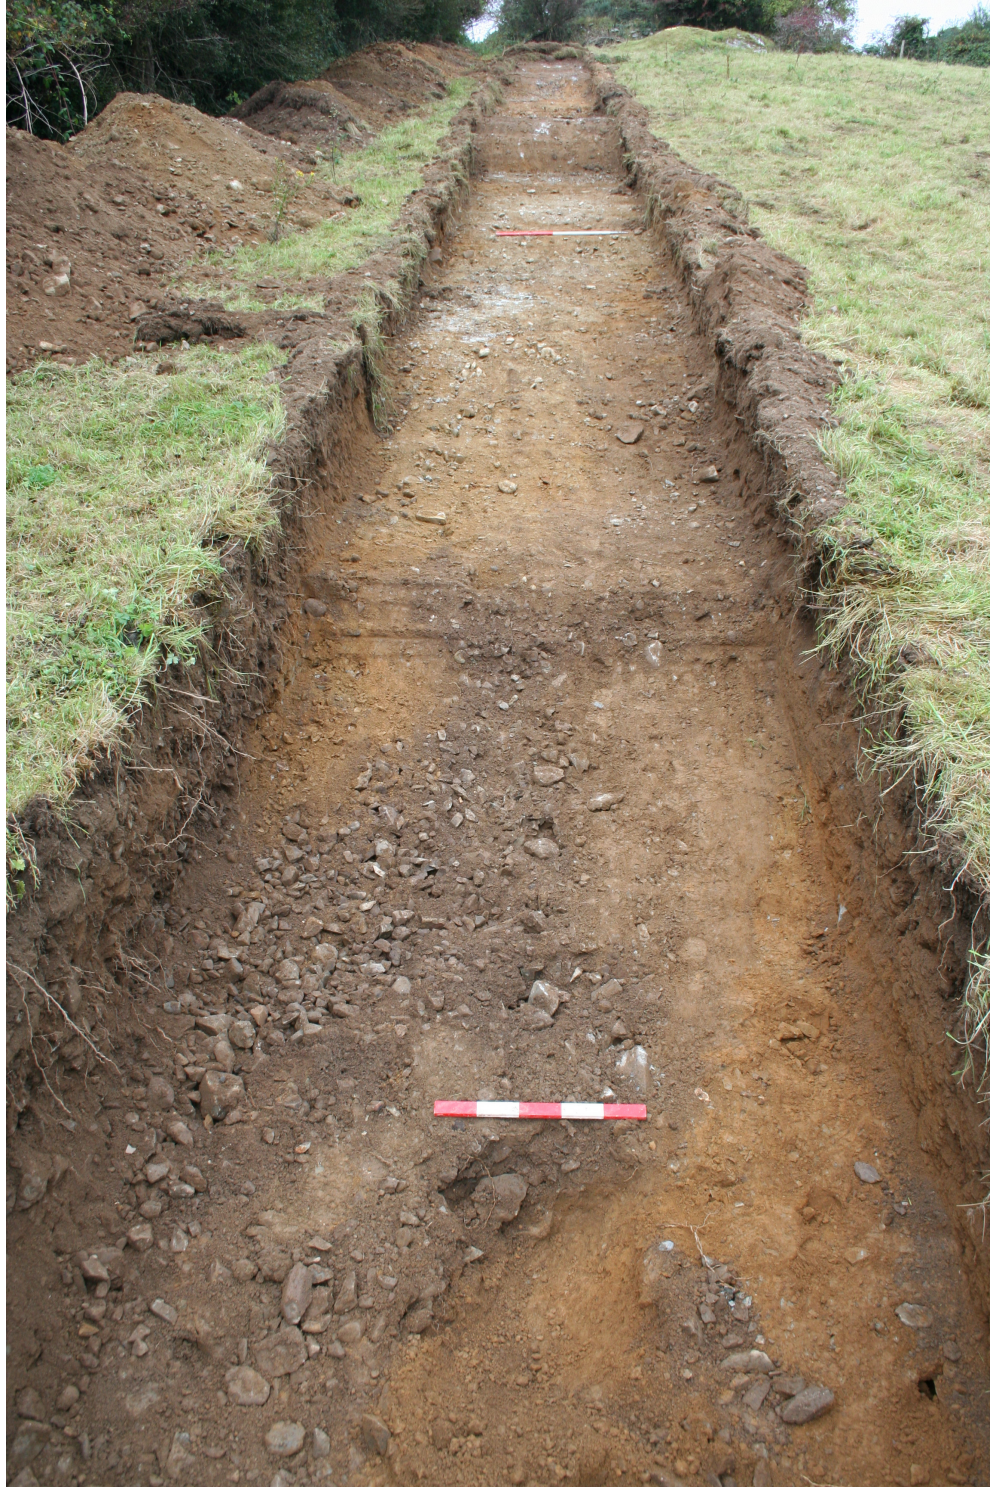
At the SE extremity of Trench 1 an irregular feature was noted running across the trench, with an indistinct terminus. The main body of the feature was approximately 1

m wide, and the exposed area ran for approximately 1.5 metres. The fill of the feature was a light grey sandy loam with stone inclusions (Context No. 103). The fill was almost analogous with the topsoil for the trench, however, there were noticeably higher stone inclusions. No finds were recovered from this trench.

Plate 3 Excavation of feature (Context No. 103) at NE end of Trench A, interpreted as a leveling deposit.

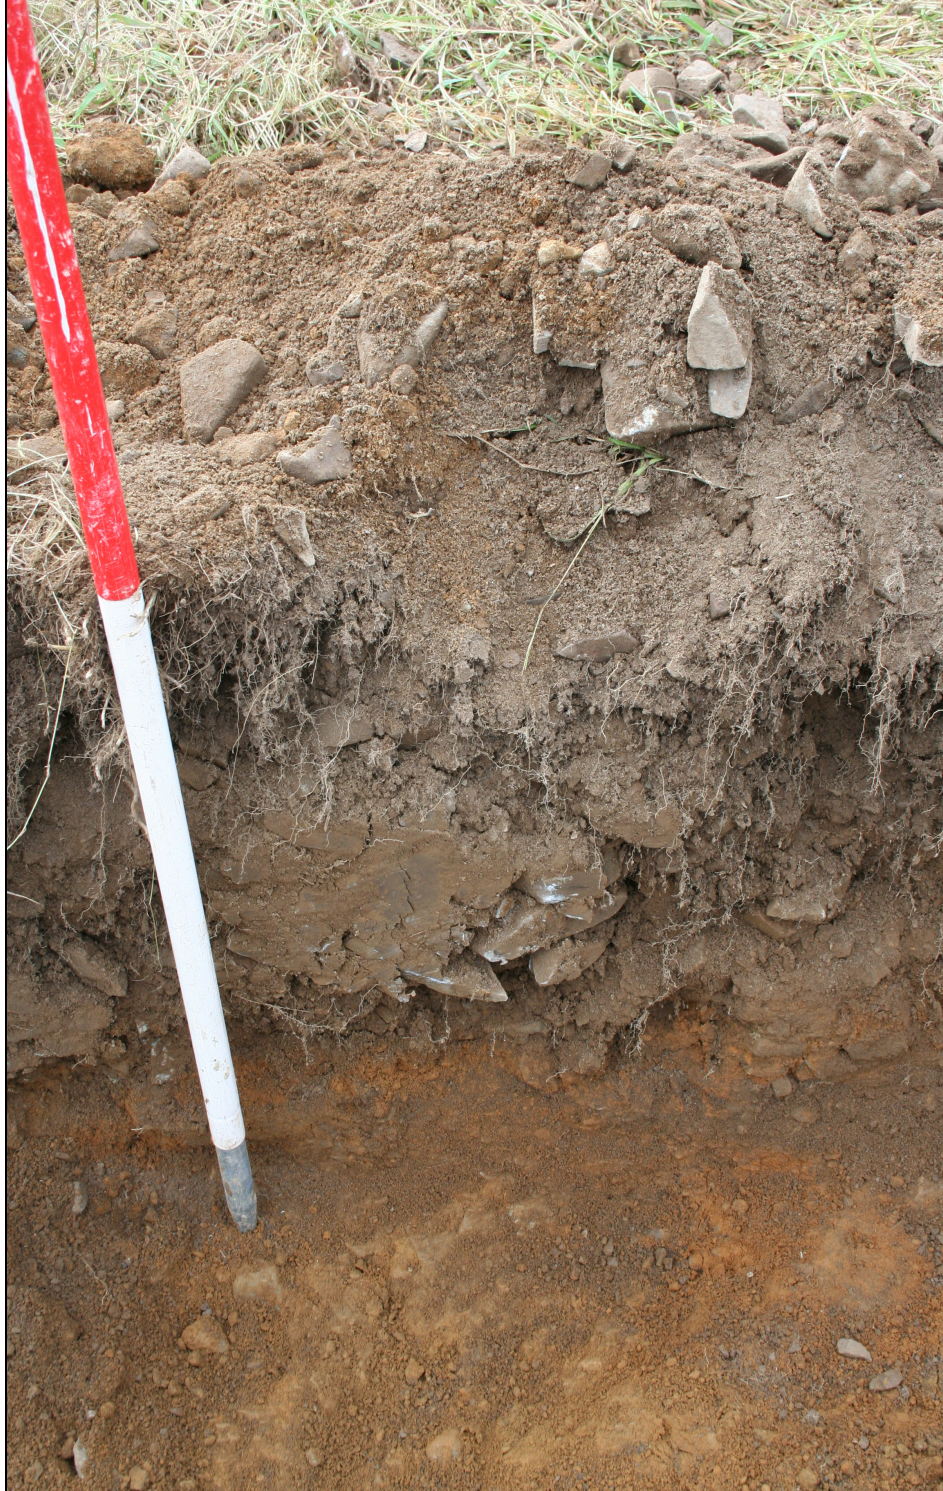
Trench B was excavated running 30m NE – SW, along the proposed limit of the house footprint. The topsoil (Context No. 201) was a light brown sandy loam (approximately 70 / 30 % sand:loam), approximately 40 cm in depth. Little organic content was observed in the layer, and frequent, well distributed stone inclusions c. 5 x 3 x 3 cm were observed. The layer is considered analogous with the topsoil layer (Context No. 101) in Trench A. The topsoil layer (Context No. 201) directly overlay the glacial subsoil (Context No. 202), a reddish orange boulder clay with frequent stony inclusions.

Plate 4 Excavation of Trench B showing the depth of topsoil (Context No. 201) and frequent stony inclusions.

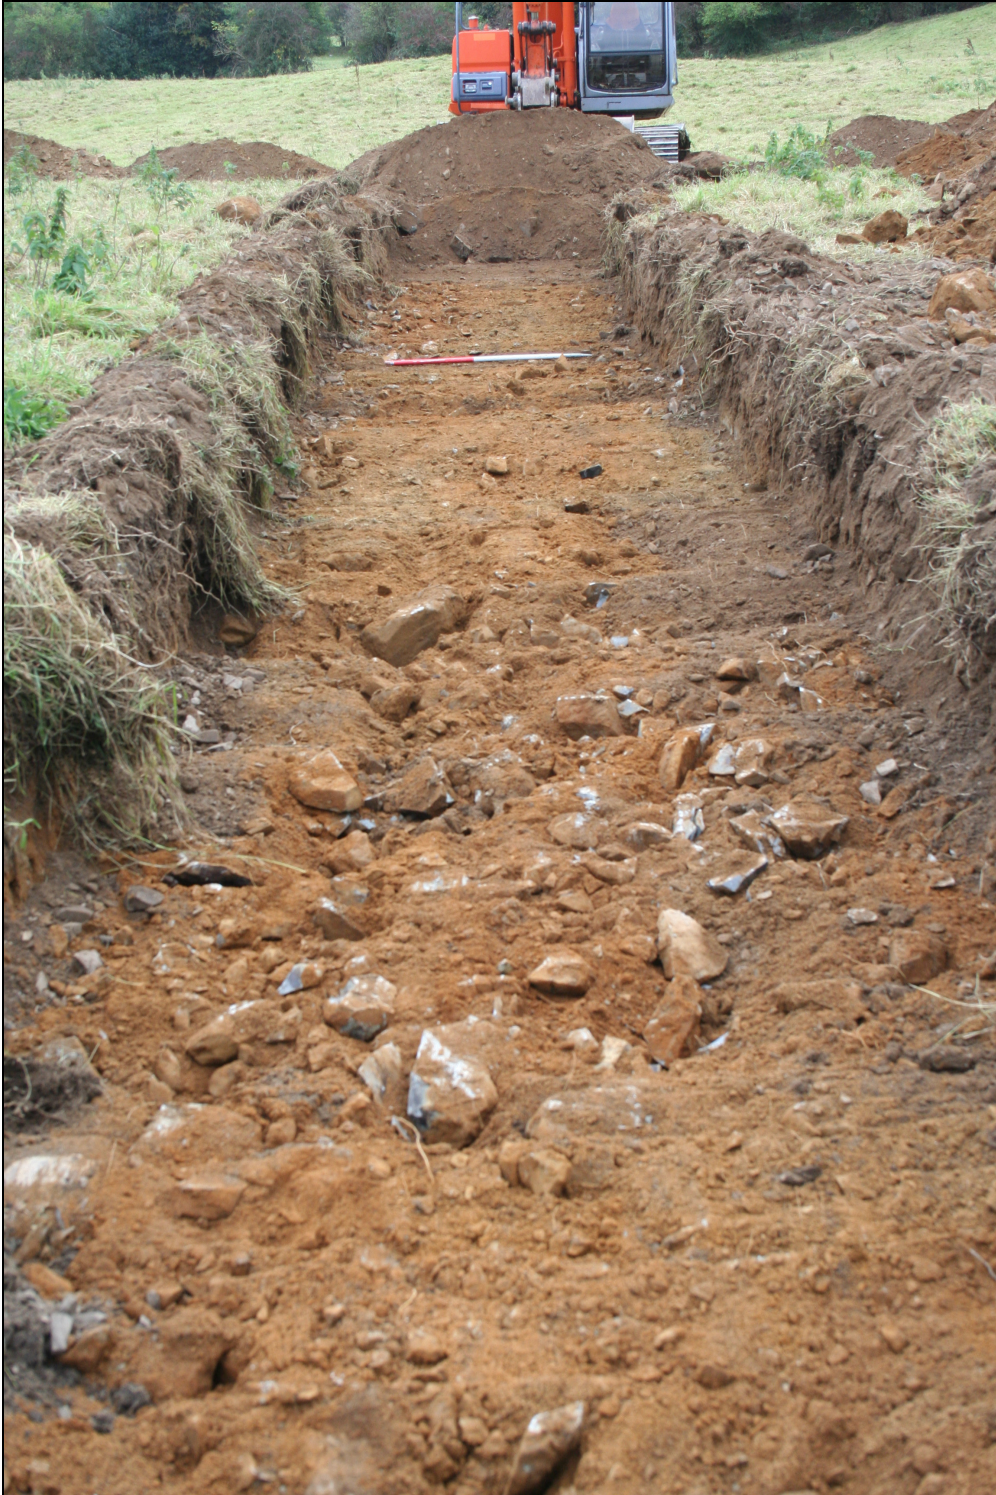
Trench C was excavated running 25 m NW – SE, along the base of a hollow in the proposed development site. The topsoil (Context No. 301) was a light brown sandy loam (approximately 70 / 30% sand:loam), approximately 40 cm in depth. The layer is considered analogous with both Context No. 101 and 201. The topsoil layer (Context No. 301) directly overlay the glacial subsoil (Context No. 302), a reddish orange boulder clay with frequent stony inclusions.

Plate 5 Excavation of Trench C, looking SE, showing topsoil (Context No. 301) directly overlying glacial sub soil (Context No. 302)

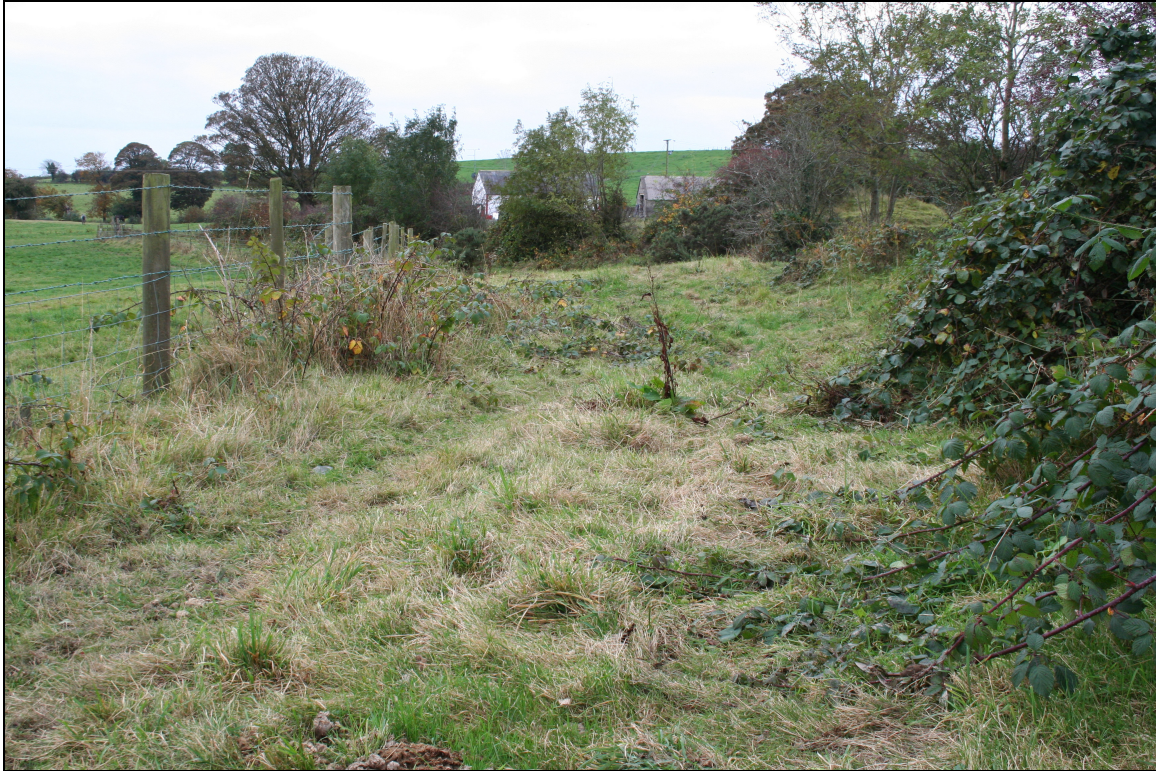
Trenches D and E were excavated along the proposed access way to the development site. This area had frequent rock outcropping, and consequently it was considered unsuitable for mechanical excavation. The two trenches were excavated with hand tools, and revealed that a thin organic rich topsoil (Context Nos. 401 and 501) directly overlay bedrock. The depth of the topsoil layer in both trenches was approximately 10 cm at its maximum. No finds were recorded from Trenches D and E.

Plate 6 General shot of proposed access way for the development site. Trench E was excavated at this area of the access way encountering bedrock at approximately 10 cm.

Given the rock outcropping on the proposed access way to the development site, Trenches D and E were archaeologically excavated as *sondages*, which revealed no archaeological features or artefacts.

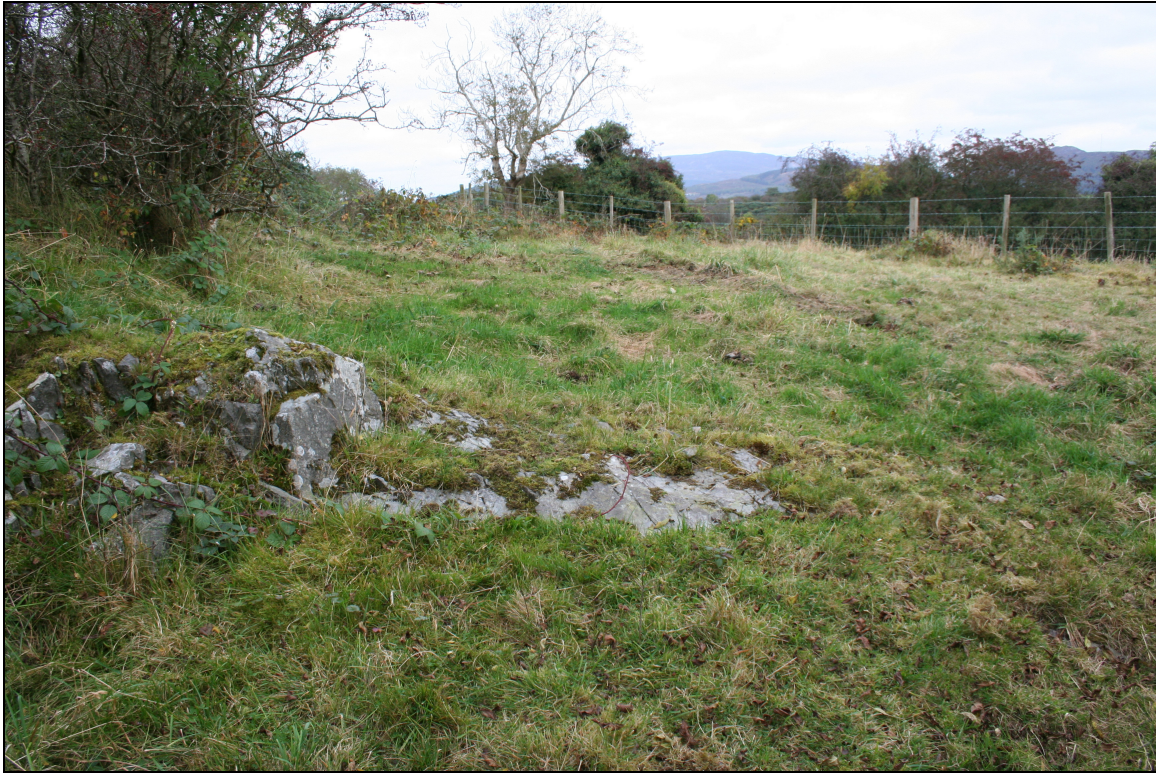
Plate 7 General shot, looking NE, showing the proposed access way to the development site and the frequent bedrock outcropping of the area.
