MONITORING REPORT No. 223

69 DRUMLOUGH ROAD, DRUMGATH,
COUNTY DOWN

LICENCE No. AE/11/32E
EMILY MURRAY

Report Date: 13th April 2011

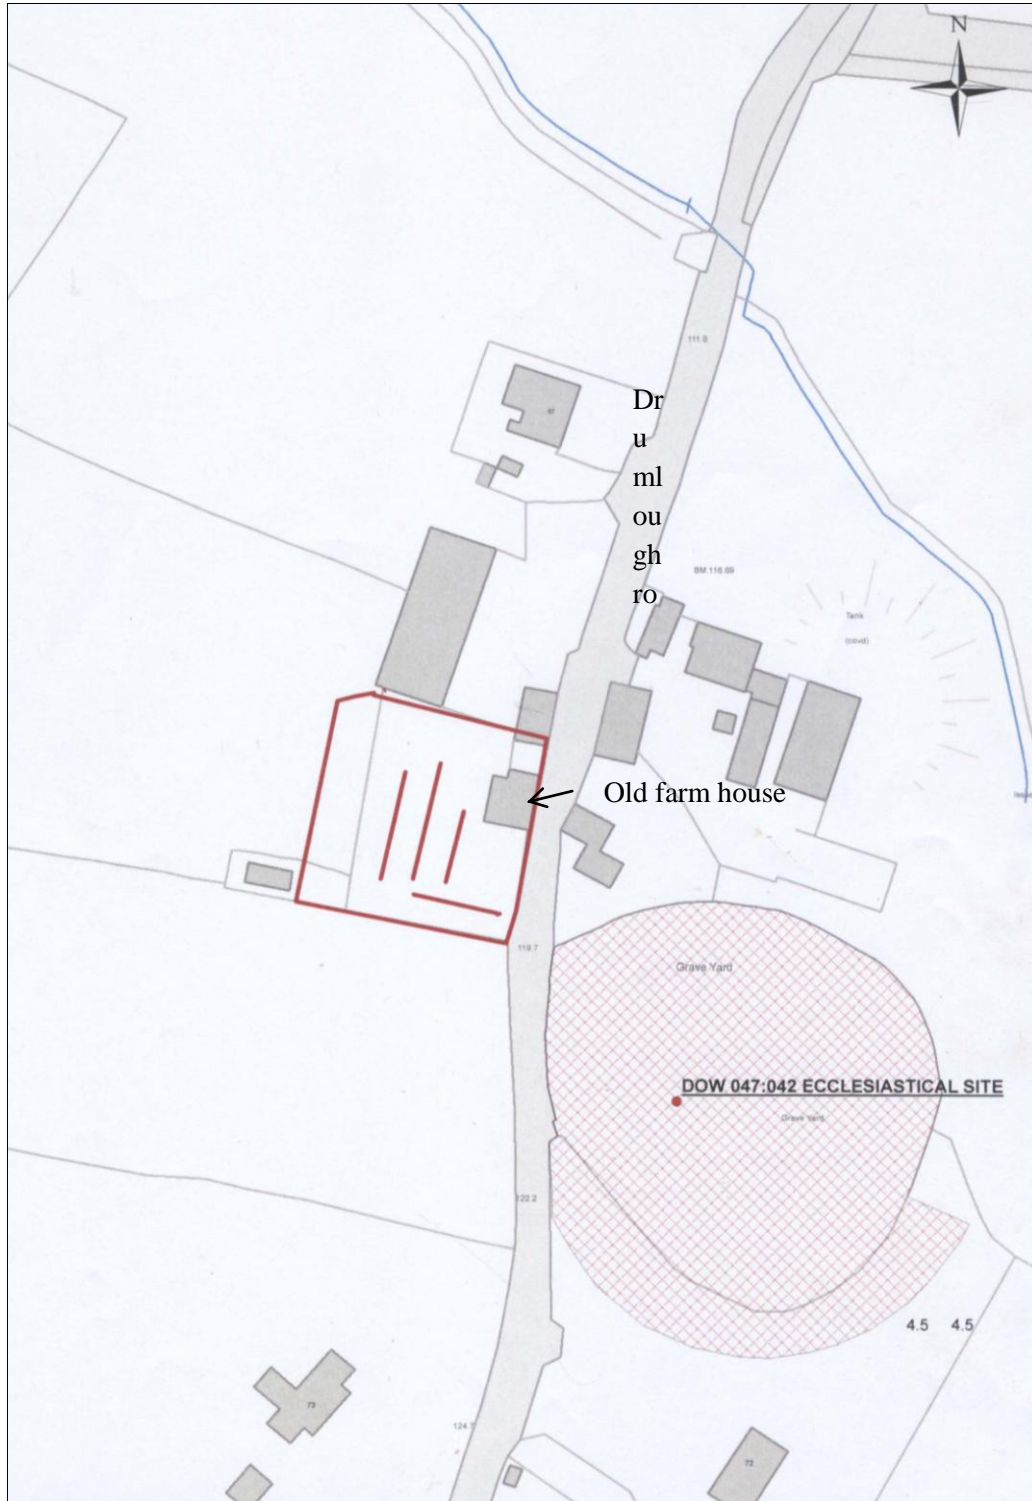
Figure 3 Map of application site (P/2010/1479/F. Scale 1:1000) indicating the proposed location of the evaluation trenches and position of archaeological sites in the immediate vicinity (map provided by G. Howell, NIEA).

Four trenches were opened using a mechanical excavator under archaeological supervision on March 21st, 2011 in the approximate locations as specified by the NIEA case worker, Gail Howell (Figure 3). All four trenches were excavated with a mechanical excavator using a 1.5m wide sheugh bucket and were excavated to the natural subsoil.

Trench 1 (1.5m x 12.5m) was located at the southern end of the yard, running roughly east-west and parallel to the southern boundary fence. Trenches 2 (1.5m x 9.5m), 3 (1.5m x 9.2m) and 4 (1.5m x 8m) were opened perpendicular to it. The northern extents of the latter three were curtailed by the presence of services (electricity and water) running from the standing old farm house that faces onto the Drumlough Road, at the north-eastern corner of the yard, to a mobile home located at the western side of the yard (see Figure 3 and Plate 1).

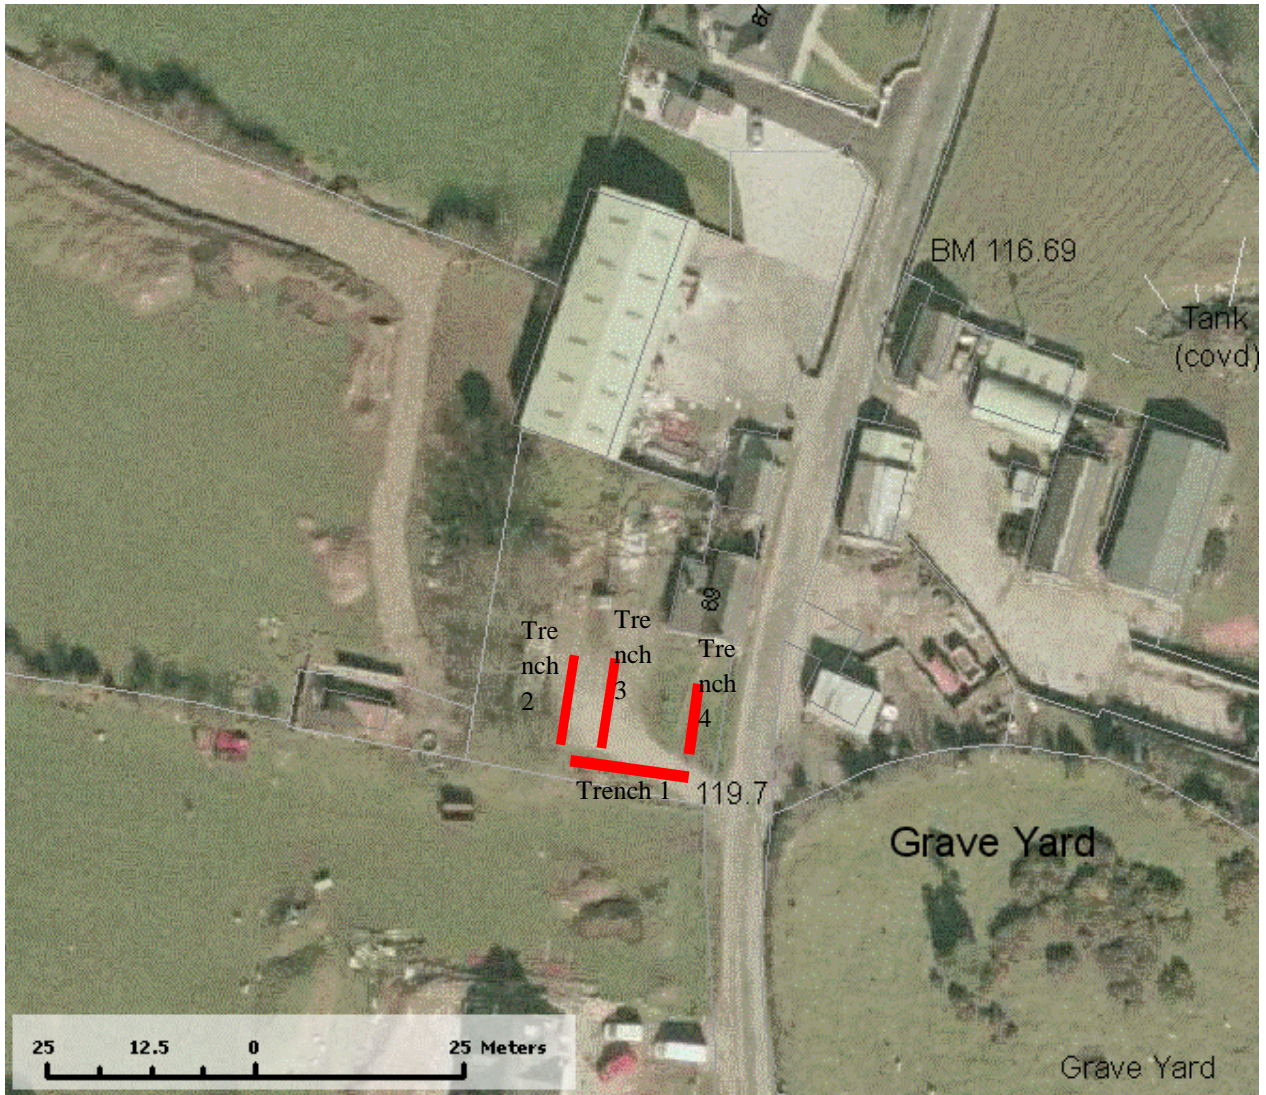
Figure 4 Google-Earth image of the application site, 69 Drumlough Road, showing the approximate location of the evaluation trenches, Trenches 1-4.

Trench 1 measured 1.5m wide and 12.5m long, was orientated approximately east-west and parallel (2.2-2.8m north of) to the fence marking the southern boundary of the yard (Figure 4 and Plate 1). Removal of the loose quarried-stone, that forms the surface of the yard (C.101; 0.05-0.08m thick), exposed a mid-brown silty loam, a remnant topsoil, with occasional stones and roots (C.102; 0.12-0.14m thick). This overlay the orange-brown sandy subsoil which was encountered at a relatively shallow depth of 0.17-0.25m (Plate 2). In the western half of the trench, a line of four sub-circular

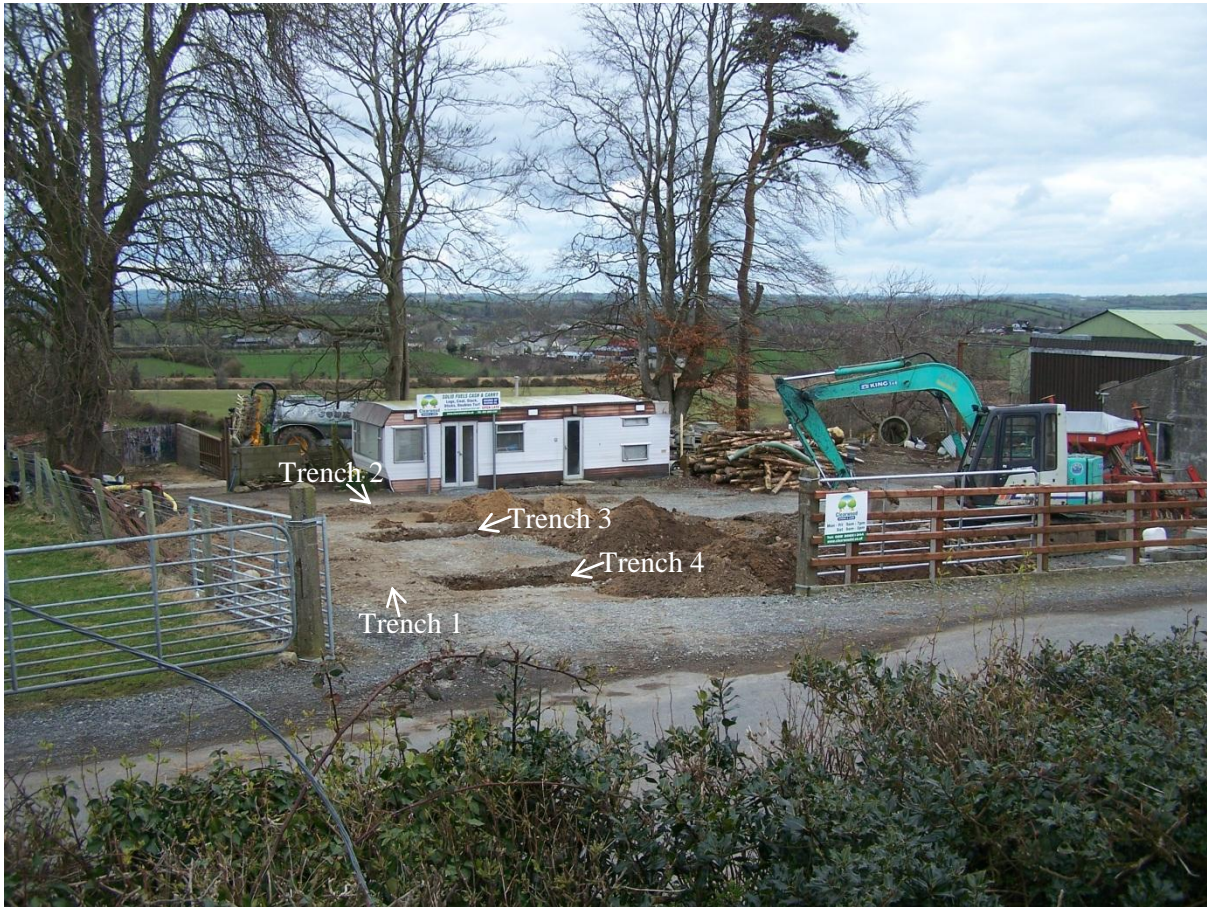
Plate 1 General view of the evaluation site from Drumgath graveyard (looking north-west) and showing the location of the four evaluation trenches (Trenches 1 and 2 are both backfilled).

Trench 3 was opened parallel to, and approximately 4.7m east of, Trench 2 and about 1m north of Trench 1 (Plate 1). Trench 3 measured 1.5m wide and 9.2m long (north-south). The loose gravel (C.301) was removed to expose the loamy topsoil (C.302) which overlay the subsoil encountered at a depth of between 0.19-0.2m. Three irregular spreads of brown loam were uncovered at the northern end of the trench (Plate 6). The southernmost, C.303, was located about midway along the length of the trench and ran into the western baulk. It measured 0.8m north-south at the western edge of the baulk, narrowing to 0.56m towards the centre of the trench, and 0.68m east-west. This was half-sectioned and was found to be a shallow (0.09m deep), uneven-bottomed depression in the subsoil with a single loamy mid-brown fill, C.304, very similar to C.302. Although difficult to distinguish C.302 and C.304, the section-face of the trench would indicate that C.303 cuts the topsoil, C.302 (see Plate 7), suggesting a recent origin for the cut. The fill yielded a single piece each of blackware and cream-ware along with some fragments of charcoal and coal. Just north of this was a larger and more irregular loamy spread (C.305), 1.06m north-south by 0.95m east-west. This was quarter-sectioned (north-west corner excavated) which demonstrated that it contained a single brown loamy fill, C.306, not dissimilar to C.302 and C.304 (Plate 8). C.306 had occasional small rootlets, flecks of charcoal,

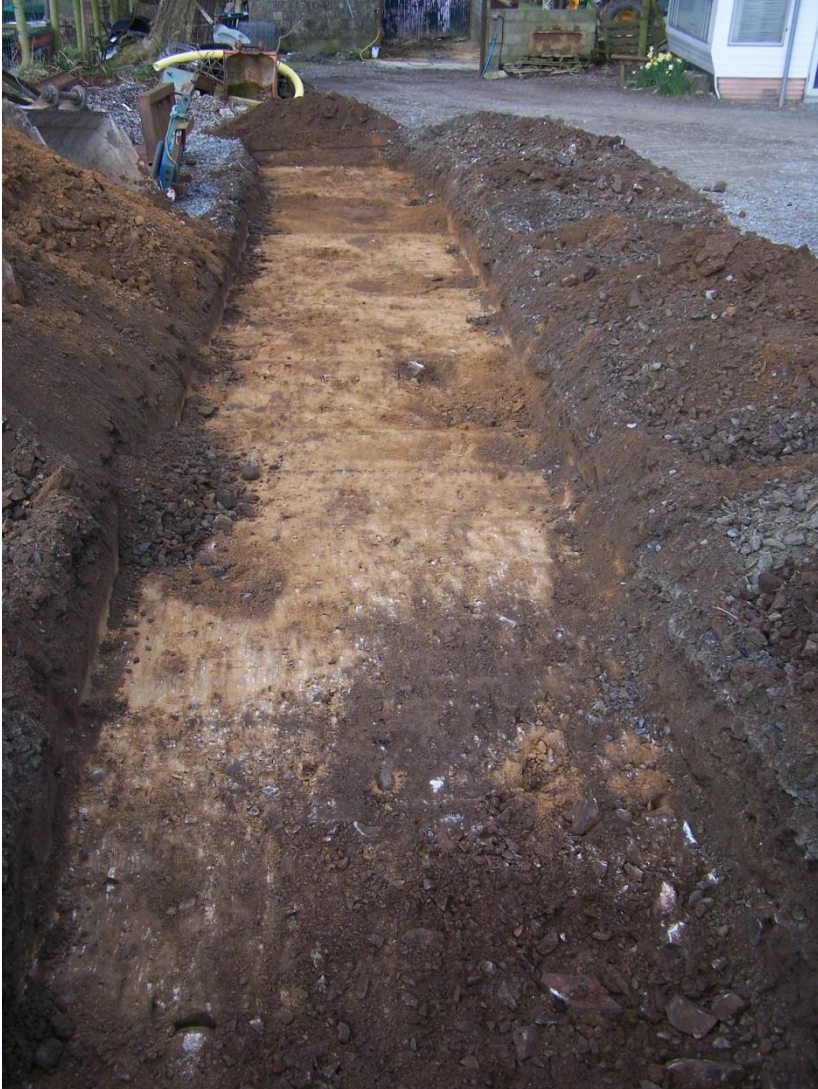
Plate 2 Trench 1 (facing west) with some of the earlier hard-core (C.108) in the foreground, and the subsoil and sub-circular features (C.103-C.106) west of it.

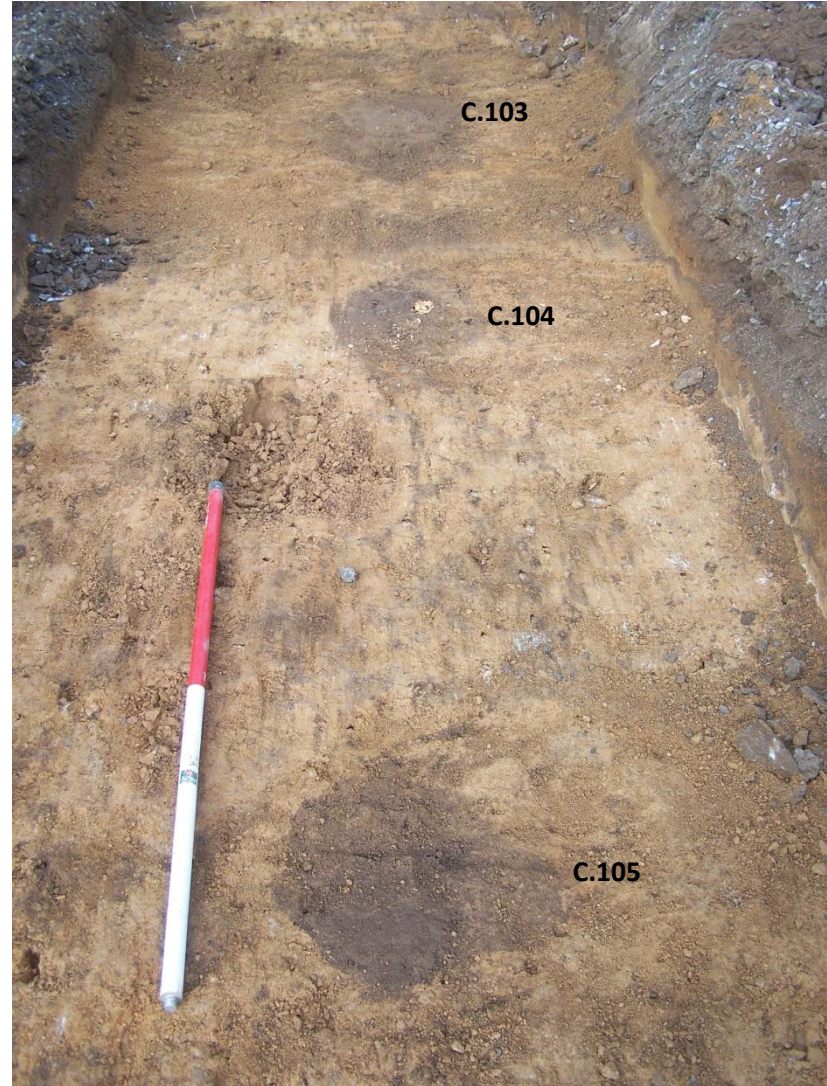
features or spreads of brown loam (C.103, C.104, C.105 and C.106) were uncovered. These measured between 0.3m and 0.6m in diameter and were unevenly spaced, between 0.7 and 1.4 metres apart. One of these (C.105; 0.36 N/S by 0.34 E/W) was half-sectioned and was found to be a relatively steep-sided cut, 0.14m in depth (Plates 3 and 4). It contained a single homogenous fill, a loose grey-brown silty loam with occasional stones and pieces of coal (C.107). Feature C.104, approximately 1.2m west of C.105, had a freshly broken tree- root protruding from close to the centre of the feature. It seems probable that these (C.103, C.104, C.105 and C.106) represent a remnant tree or fence line of no great antiquity. At the eastern end of the trench an earlier loose, quarried-stone/hard-core deposit, with a reddish hue (C.108) was encountered. It ran across the full width of the trench, for a length of between 1m -1.7m from the eastern end of trench. This modern deposit is located in proximity to the yard entrance and may be related to earlier metalling of the yard for heavy farm machinery, or may be associated with the laying of services.

Plate 3 Close up of the sub-circular features at the western end of Trench 1. Feature C.105 in the foreground was half-sectioned.

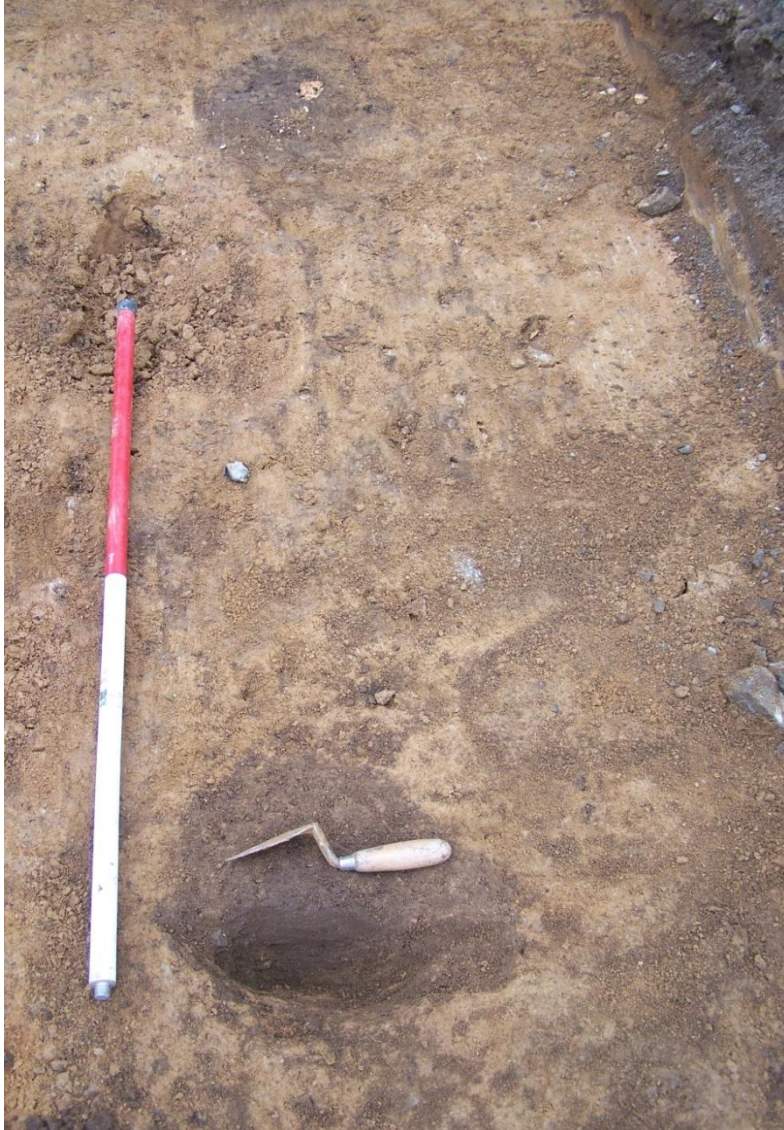
Plate 4 Trench 1, feature C.105: half-sectioned and showing single fill, C.107.

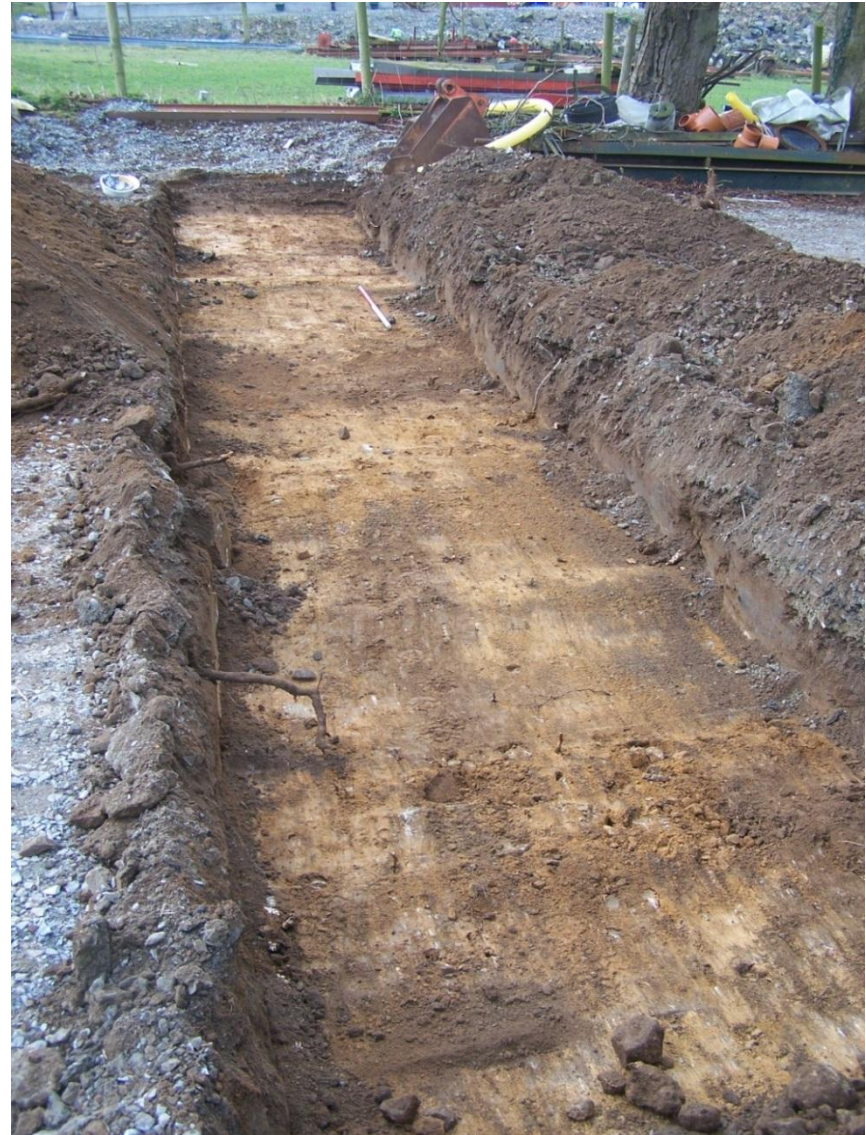
Trench 2 measured 1.5m wide and 9.5m long (approx. north-south) and was located perpendicular to the western end of Trench 1 at the western side of the yard. Again the loose quarried gravel (C.201) was removed to reveal a remnant loamy topsoil (C.202) which overlay the subsoil which was encountered at a depth of between 0.35-0.4m (Plate 5). Three mature trees are located just south of the southern end of this trench and, not unsurprisingly, roots and root disturbance were encountered towards the southern end of the trench. No other features were uncovered.

Plate 5 Trench 2 (facing south): the gravel surface of the yard (C.201), the underlying remnant topsoil (C.202), roots and the subsoil are all visible.

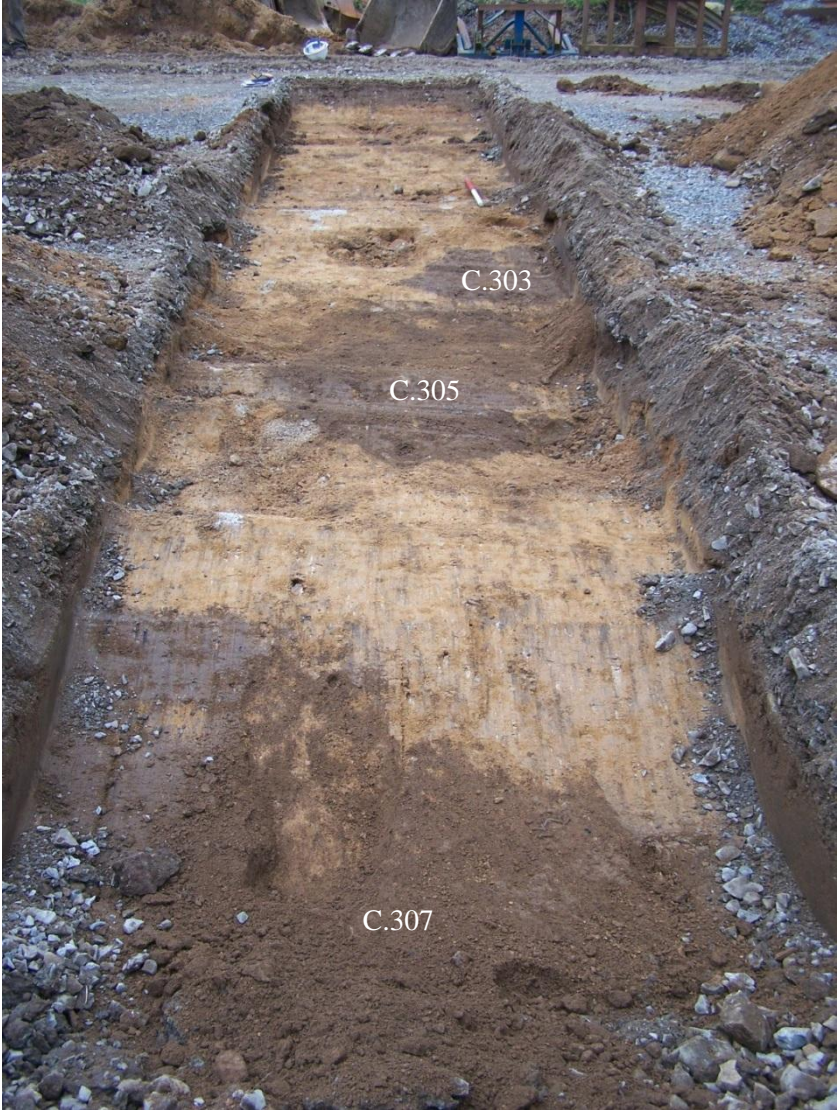
Plate 6 Trench 3 (facing south) showing the three irregular spreads of loam.

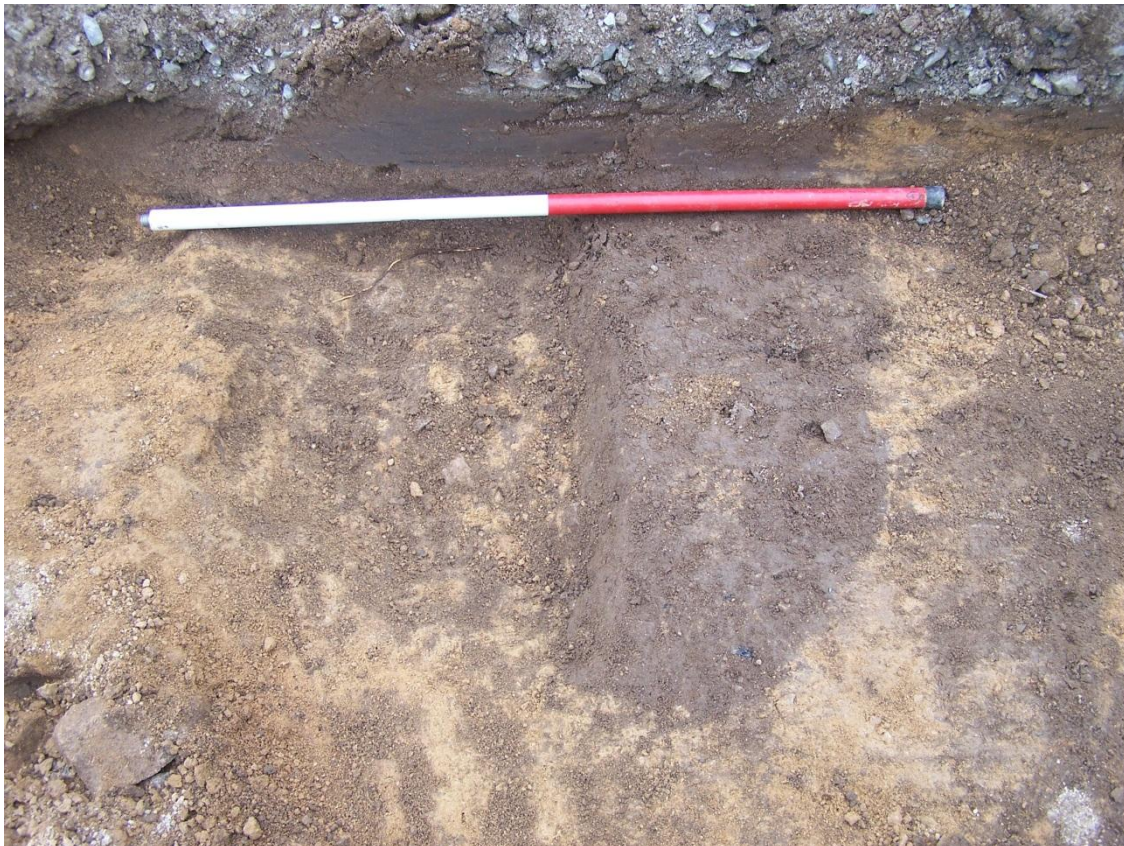
Plate 7 Trench 3, feature C.303 half-sectioned (southern half removed) showing the single homogenous fill, C.304.

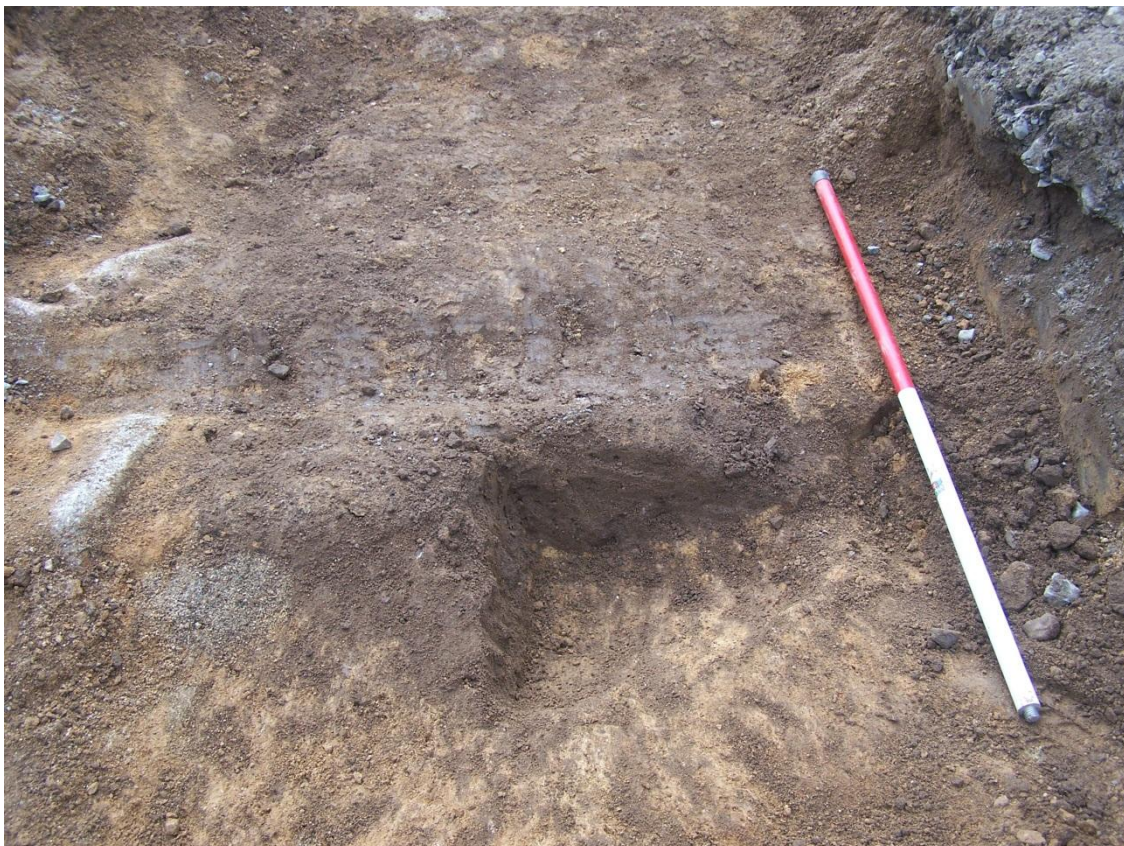
coal and stones. The depression was shallow with uneven irregular edges and 0.17m at its greatest depth. The applicant's father, Mr Brendan Keenan, remembers the gravel-covered yard formerly as the 'high field' where threshers used to be set into the ground. It is possible that some of the anomalous spreads encountered in this trench, and possibly also Trench 4, may relate to this activity.

The northern end of Trench 3 dipped down (Plate 8). A small box trench opened across this feature (running north-south) revealed it to be a shallow depression running across the full width of the trench filled with an homogenous loamy soil (C.308). This probably represents a natural depression or variation in the old ground surface.

Plate 8 Trench 3, feature C.305 quarter-sectioned (south-western quarter excavated) showing single homogenous fill, C.306.

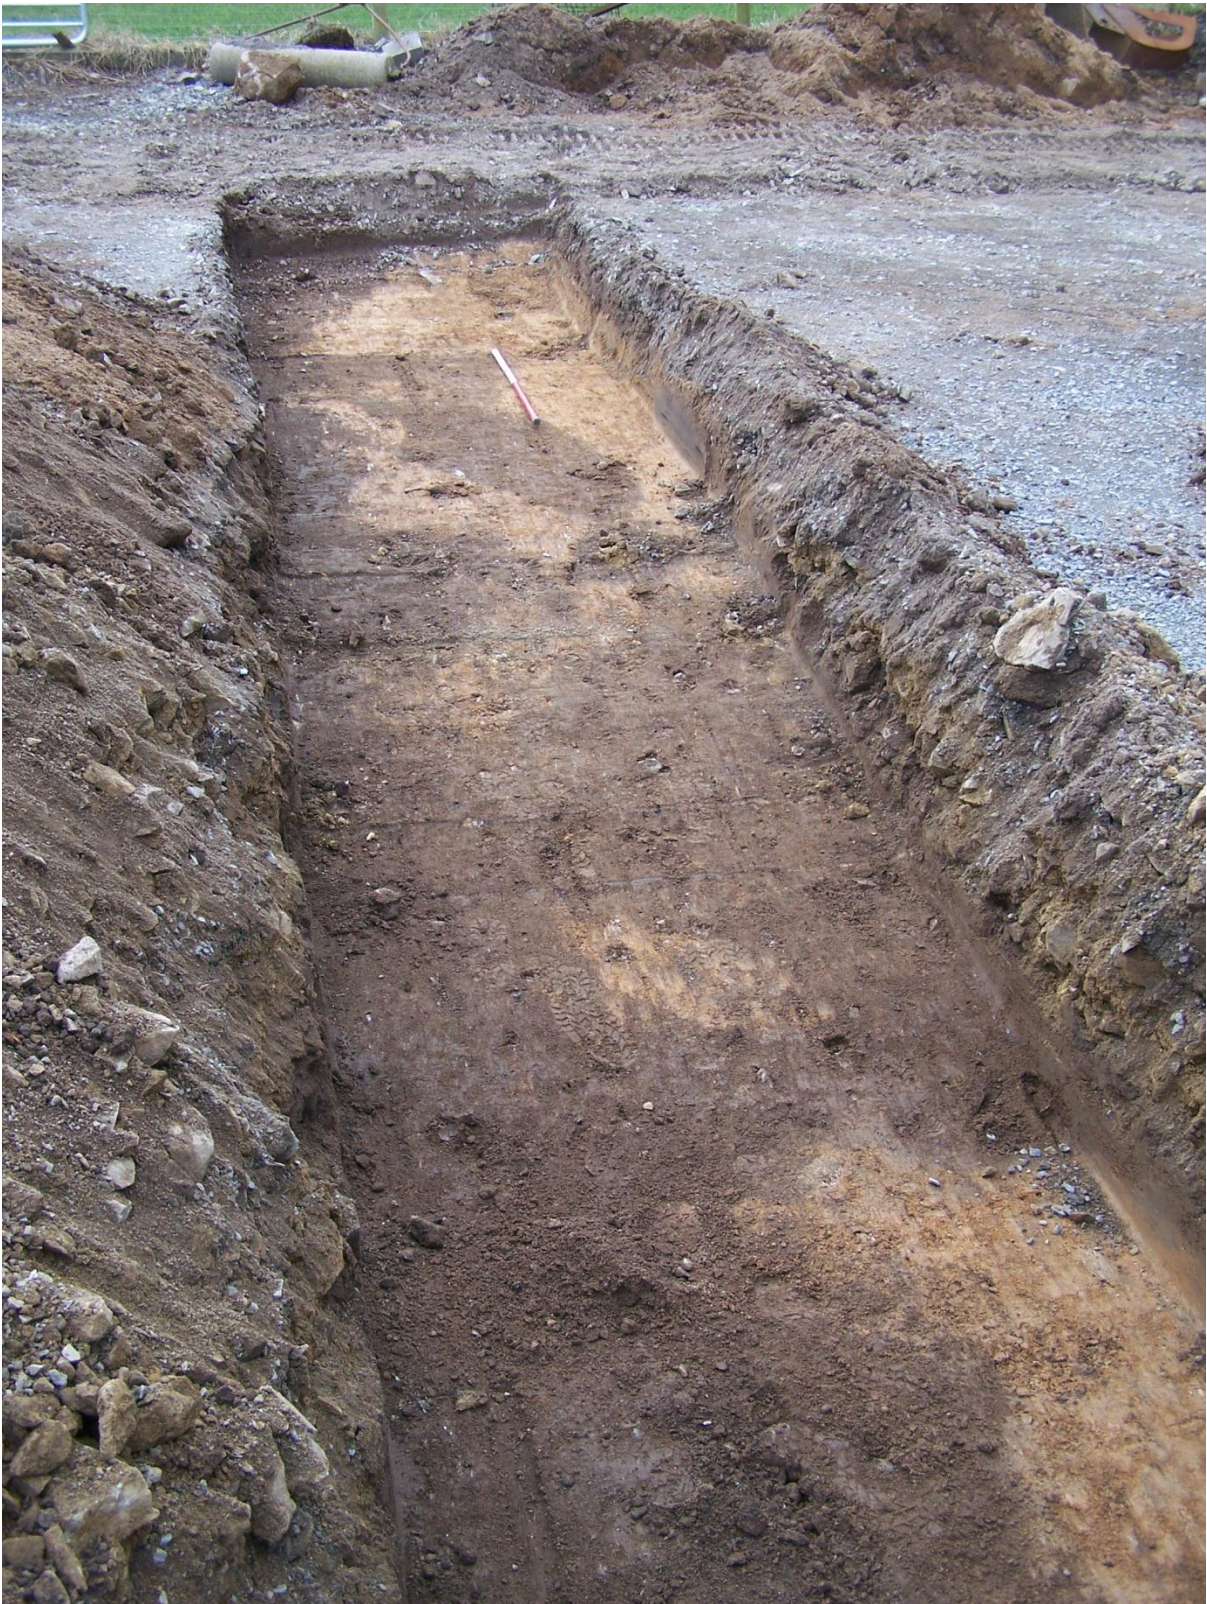
Trench 4 measured 1.5m wide by 8m long (approx. north-south) and was located just 3m west of the eastern boundary of the yard. The gravel (C.401) was removed to reveal an earlier coarser quarried-stone surface, with a yellower hue, extending across the northern half of the trench only (C.402). This sealed the old topsoil horizon (C.403) and the natural subsoil below it. The top of the subsoil was encountered at a variable depth, being deeper at the northern end at 0.5m and shallower to the south at a depth of 0.23m (Plate 9). No cuts, features or finds were recorded but C.403 was observed to fill haphazard hollows and depressions in the subsoil. There was formerly a line of mature trees running south from the old farm house in this location, roughly parallel to the road, which Mr Keenan remembers having been pulled down sometime in the 1960s. It is possible that some the bumps and hollows in the subsoil are related to these trees.

Plate 9 Trench 4, facing south: the earlier hard-core/quarried-stone layer underlying the modern grey-gravel surface of the yard is visible in the east-facing section of the trench to the right of the photo.
