Data Structure Report No. 119

Excavations at Retreat, Cushendall, Co. Antrim

EXCAVATIONS AT RETREAT
CUSHENDALL
CO. ANTRIM

**On behalf of the Heart of the
Glens Landscape Partnership**

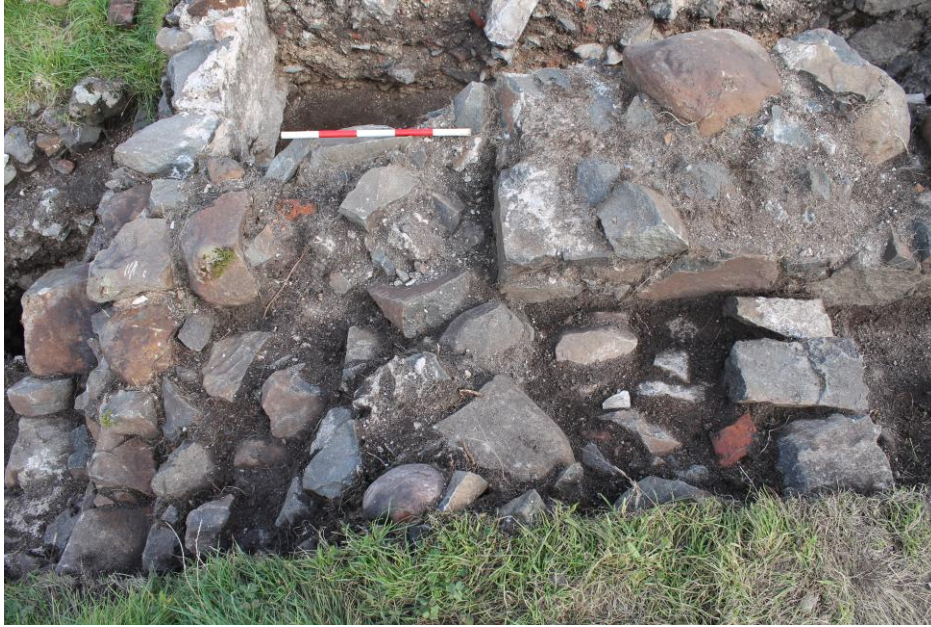
Figure 29: Rubble fill deposit (Context No. 312) that blocked access to the south-western most wing of the structure, looking north-east. NB: scale = 0.5m.

Removal of the demolition deposit revealed an episode of re-use within the structure. This took the form of rubble blocking up an alcove (Context No. 311) made in the internal division wall of the room (Context No. 305) and a blockage of a doorway leading into the south-western wing of the house (Context No. 312). In both cases these deposits (Context Nos. 311 and 312) consisted of large angular blocks of basalt that averaged 0.3m in length.

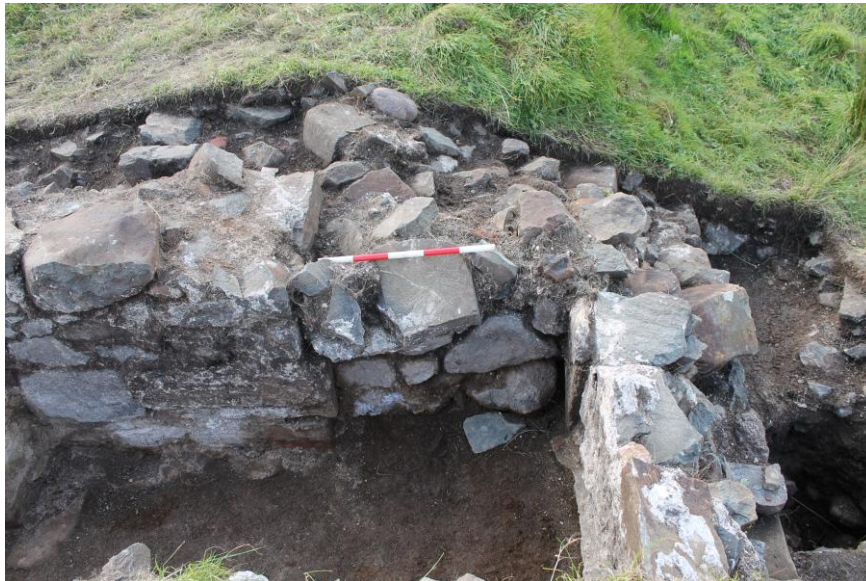
Figure 30: View of rubble fill deposit (Context No. 312) blocking the doorway, looking south-west. Also visible is the floor surface (Context No. 308) with the ephemeral impression of floor boards. NB: Scale = 0.5m.

Neither of these deposits were mortared together, although some of the stones had traces of mortar adhering to them, suggesting they originated from the demolition of the walls of the house. It is unclear as to the function of these blockages, or indeed the date they were made. However, it is probable that they relate to an attempt to more effectively manage the building, perhaps for the housing of livestock, following the abandonment of the dwelling house.

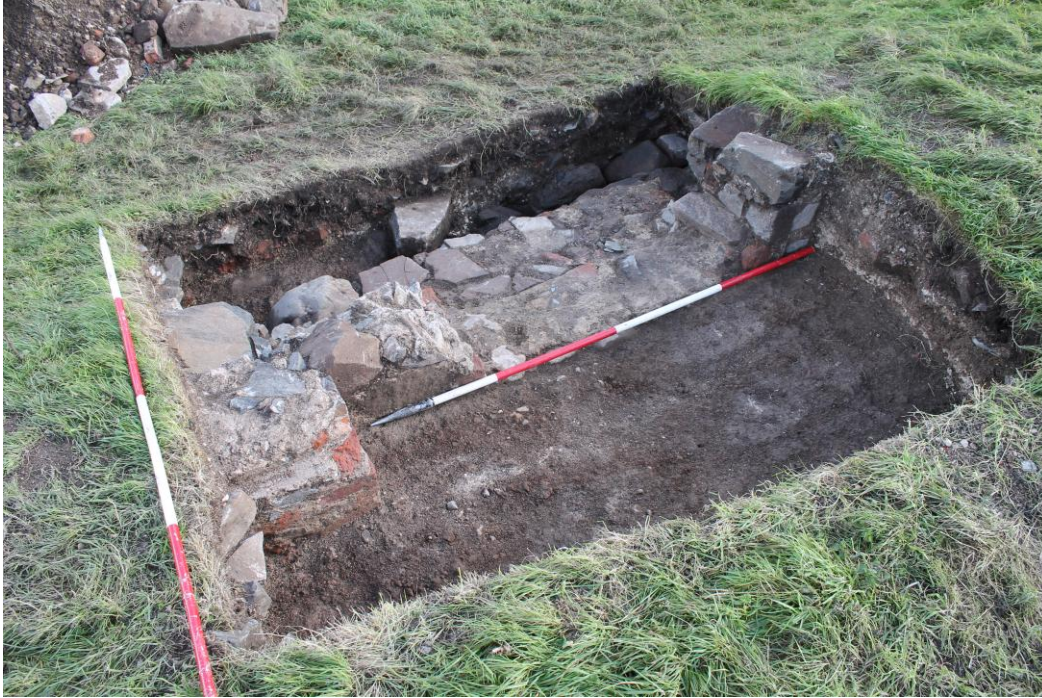
Figure 34: Post-excavation view of Trench Four looking south-east. This shot shows the doorway and threshold, as well as the remnants of the wooden floor (a similar deposit to that encountered in Trench Three – Context No. 308).

The two stretches of wall physically overlay the threshold (Context No. 406) into the structure. This feature consisted of a collection of brick, rounded and angular stone and broken sand stone slabs, firmly mortared together to create a relatively flat surface. It is likely that a sandstone slab would have sat directly upon this surface and that this has been removed and re-used elsewhere (a shattered length of sandstone slab was visible mortared into the base of Context No. 404). The threshold (Context No. 406) had a maximum length of 1.5m (north-east/south-west) and width of 0.96m (north-west/south-east).

The floor surface encountered in the north-western portion of the trench (Context No. 407) consisted of a mid-reddish brown gravelly clay (similar to the floor deposit encountered in Trench Three – Context No. 308). As with Trench Three, discreet south-west/north-east depressions were noted indicating the presence of floor boards.

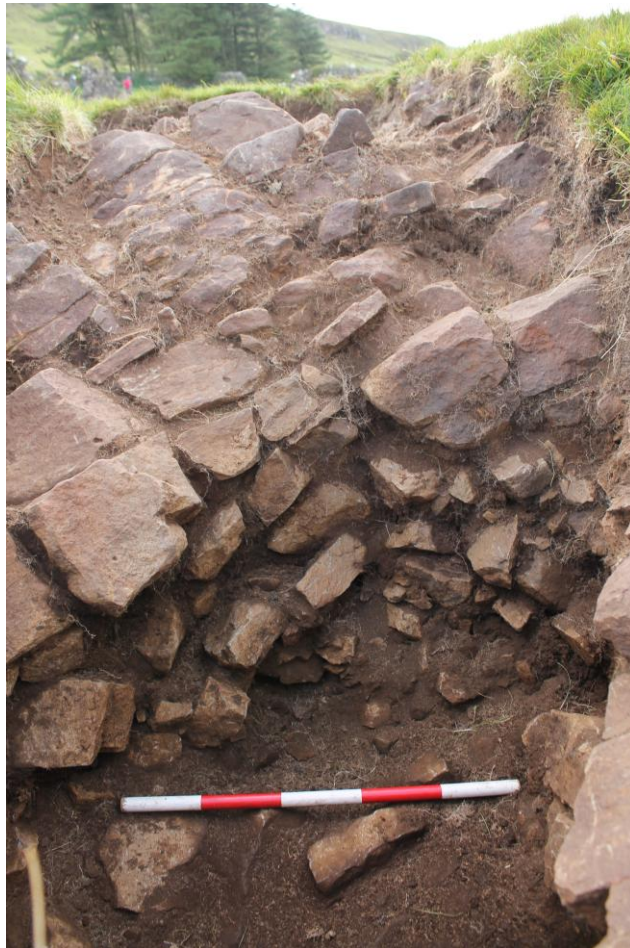
Figure 39: Detail of the structure of the kiln (Context No. 505), looking south-west (scale = 0.5m).
