# Survey Report

Reference: Survey Report No. 75

Survey of Second World War  
Military Base  
Derrymore  
County Armagh

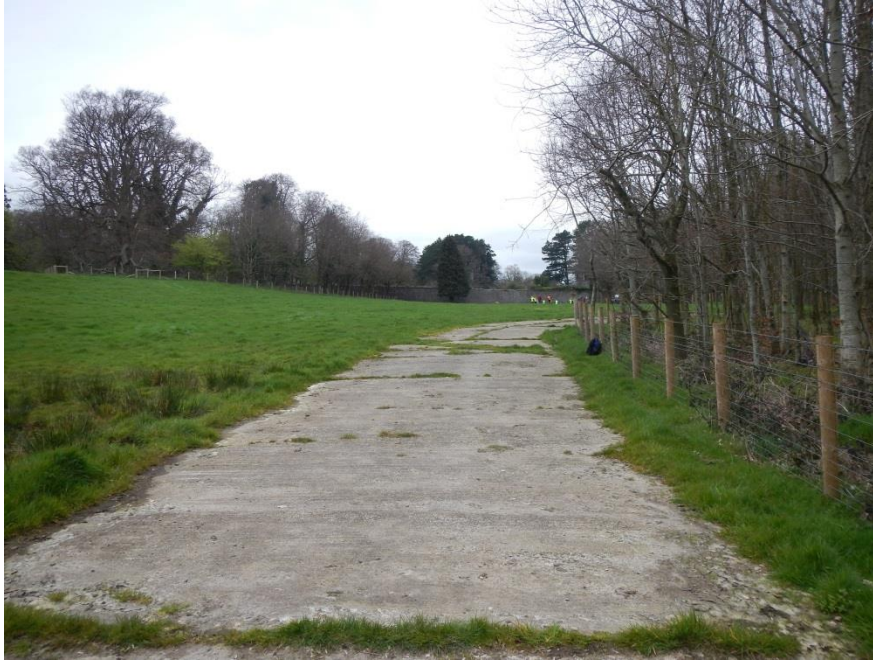
Figure 07: View of eastern access road, looking north

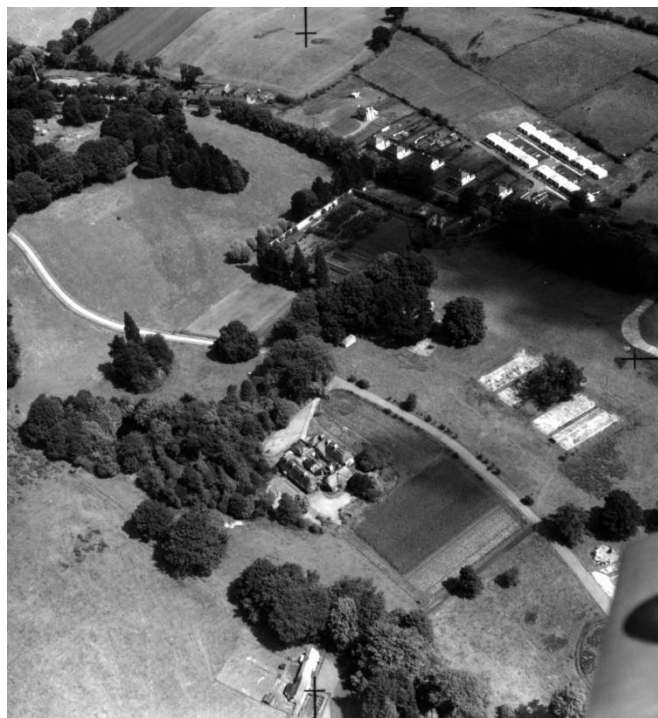
These hut platforms were observed during an aerial survey of the area in the 1960s (figure 08), but since then, the area has changed into grassland, although the concrete bases might still be present below ground level.

Figure 08: Aerial photograph looking north-east (*St Joseph's JN 071*)

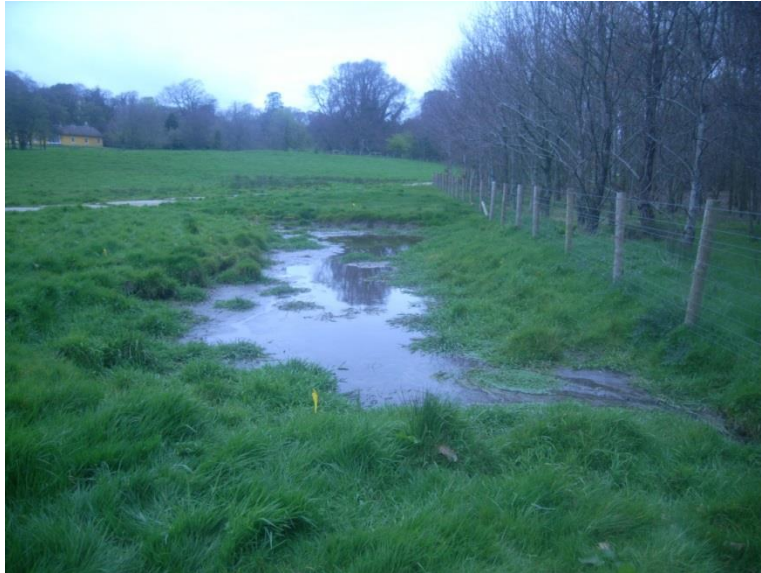
The feature, designated Pond No.1 by the Survey Group is recorded as Site 5 on Figure 03, is currently used to encourage wildlife such as frogs to inhabit the area and has recently been extended by National Trust staff. However, it was noted that this was already a water-filled area and it is possible that this feature was the remains of a fire dam. These were (and still are) employed in areas such as military bases and forestry plantations where water supplies for firefighting are inadequate. To compensate for this, a number of pits are excavated around the site, which are usually allowed to fill with water naturally, or are kept filled using site drainage systems. These can be used to supply water for firefighting if the need arises.

Figure 10: View of pond No. 1, which may originally have originally been a fire dam, looking north-west

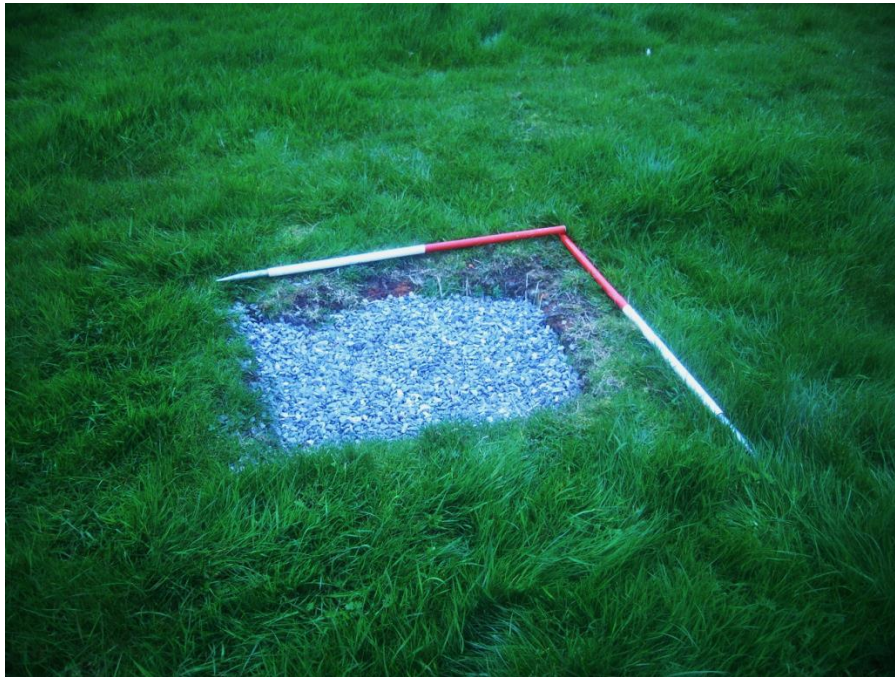
Figure 11: View of brick-lined drain inspection box, looking west, recently filled in by the National Trust for safety reasons.

The presence of an inspection pit associated with drain water in the area of No. 1 pond suggests that the pond was kept topped up using waste water from the military base.

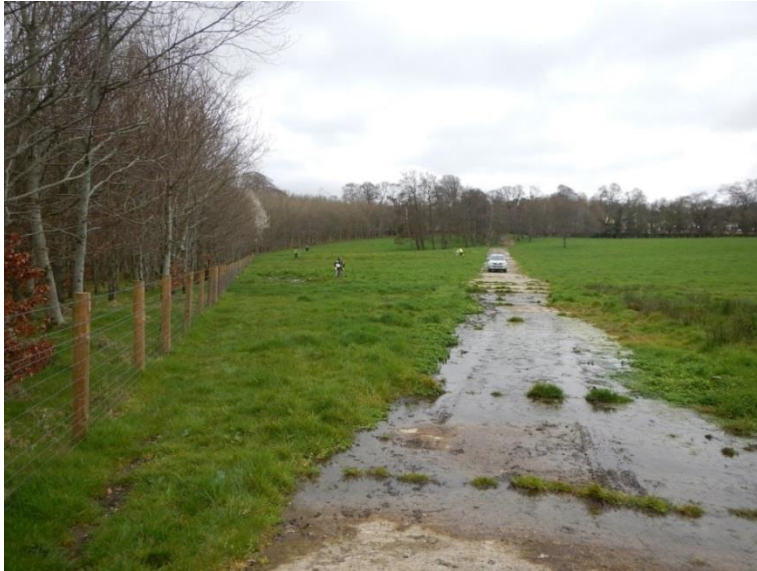
Figure 12: View of eastern access road, looking south. Pond No. 1 is to the left of the vehicle and the large raised base and Pond No. 2 are adjacent to the stand of trees in the background

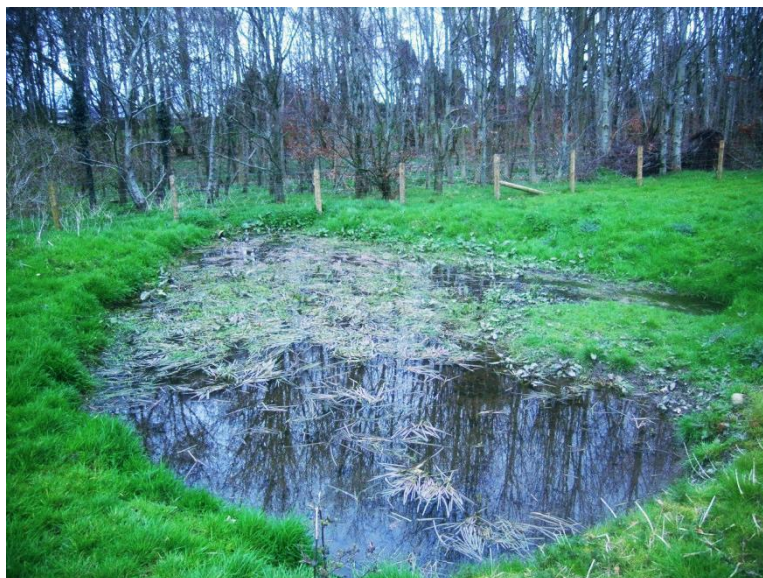
Figure 15: View of pond No. 2, which may originally have been a fire dam, looking west
