ULSTER ARCHAEOLOGICAL SOCIETY

Survey Report: No. 8

**Survey of Yew Terraces, Castle Ward, County Down
UAS/02/07**

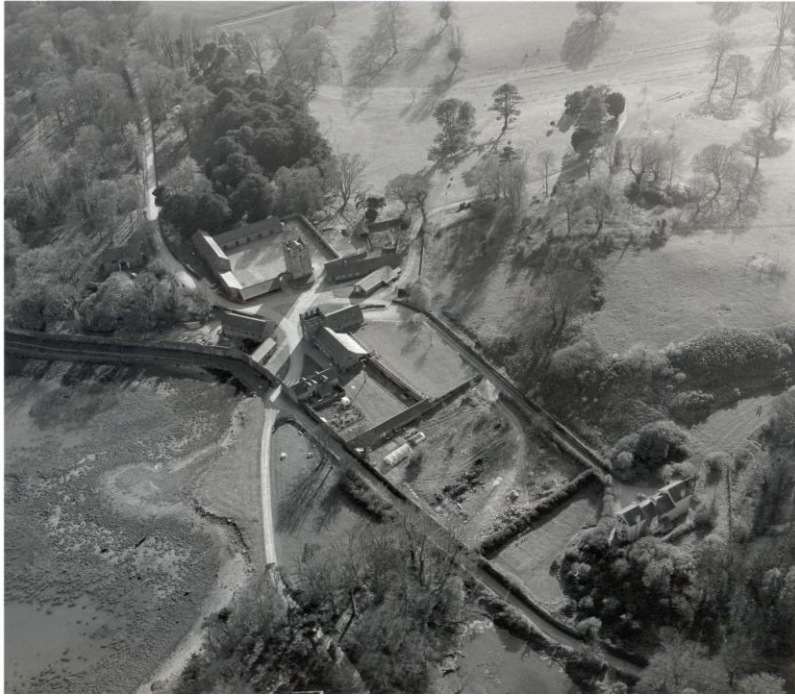
Figure 11: Aerial photograph of Yew Terraces, 1985, *Queen's University Belfast*

A series of aerial photographs were taken in 1985 by Barrie Hartwell of Queen's University Belfast. One photograph captured the Tower House, the Farmyard and also the Yew Terraces (23-4-85-5-7 see Figure 11 above). Another aerial photograph was taken in 2008 by Yvonne Griffiths. This photograph captured much of the formal garden landscape, including the Yew Terraces (see Figure 12 above).

Tantalisingly, both aerial photographs (Figures 11 and 12) seem to suggest the possibility of a closer alignment of the Yew Terraces with the Jacobean house than with the former Queen Anne House. During the course of the excavation of the Queen Anne House in 2008 (Murray, forthcoming), it was discovered that the alignment of the Queen Anne House was east-west, whilst that of the Yew Terraces was south-west/north-east. The Jacobean house may have been an addition to the Castle Ward Tower House and constructed on its east-south-east face.

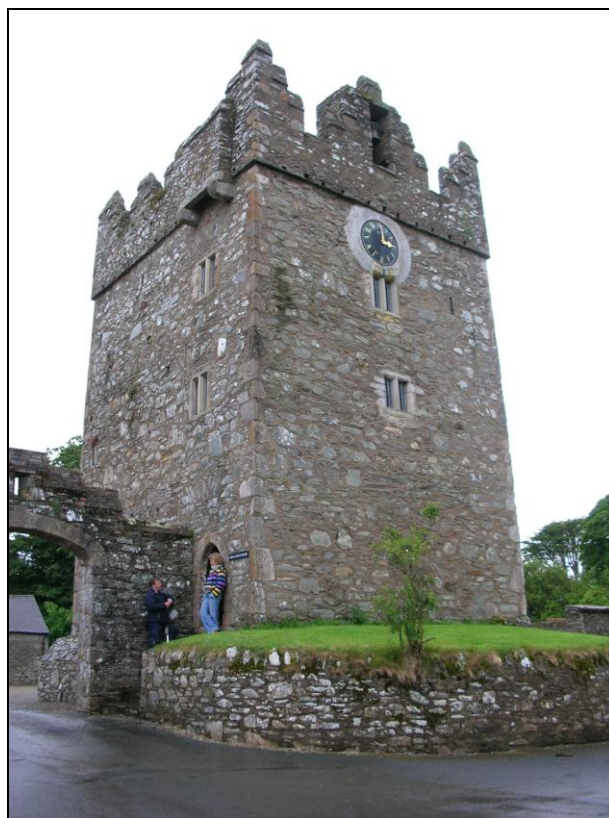
Figure 15: View of Old Castle Ward from north-east, with possible adjoining Jacobean house on left

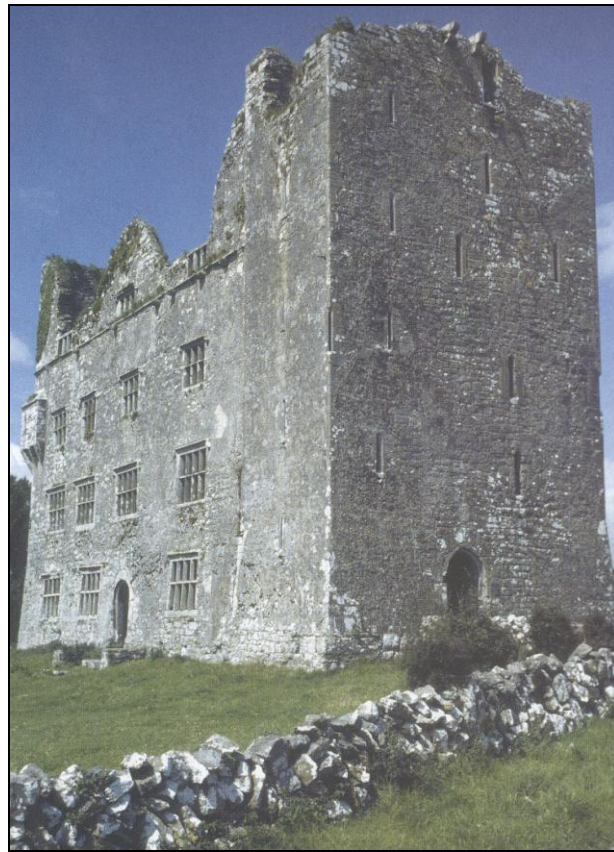
Figure 16: Leamaneh Castle, County Clare (after Jones, 2004)

A similar structural situation occurred at Leamaneh Castle in County Clare, where ‘the eastern portion is a fifteenth-century tower house while the western portion is a seventeenth-century manor house’ (Jones 2004, 148). Associated with the later manor house was ‘a walled formal garden which included a fish pond, a summer house and a “turret walk” along the wall, where one could stroll and view the garden’ (ibid.).

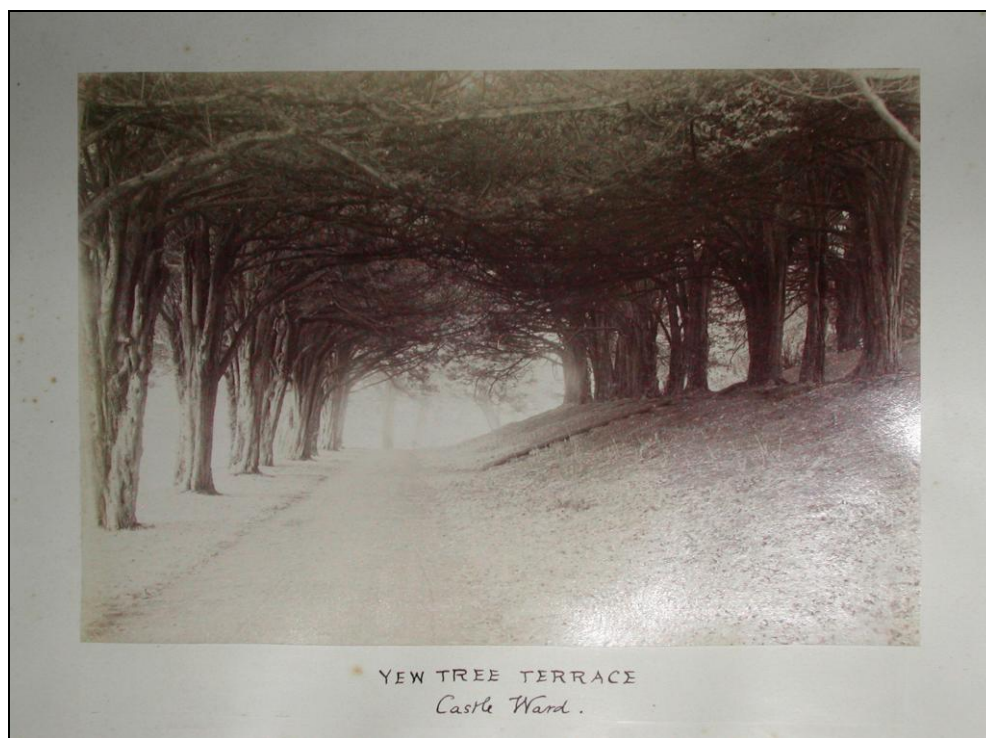
Figure 18: Mary Ward's painting of the Yew Terraces, c. 1860.

In addition to problems with dating yew trees generally, the trees currently located in the Yew Terraces bear little resemblance to those depicted in a painting by Mary Ward in about 1860, as can be seen in Figure 18.

The trees depicted in 1860 appear to have been shaped and maintained in such a manner as to provide a sheltered walkway. Barrie Hartwell of Queen's University Belfast has suggested this may have been used by the ladies of the time, as a private means of gentle exercise outdoors. By 1985 aerial photography revealed that the Yew Terraces had become heavily overgrown (See Figure 12). Evidently, the National Trust undertook a programme of maintenance, involving the Yew Trees. Figure 13 demonstrates just how radical that process has been.
